ARROW 2 CONTROL BOXES

DEVELOPMENT PROGRAM PROGRESS REPORT

AVRO AIRCRAFT LIMITED

July 11th 1958

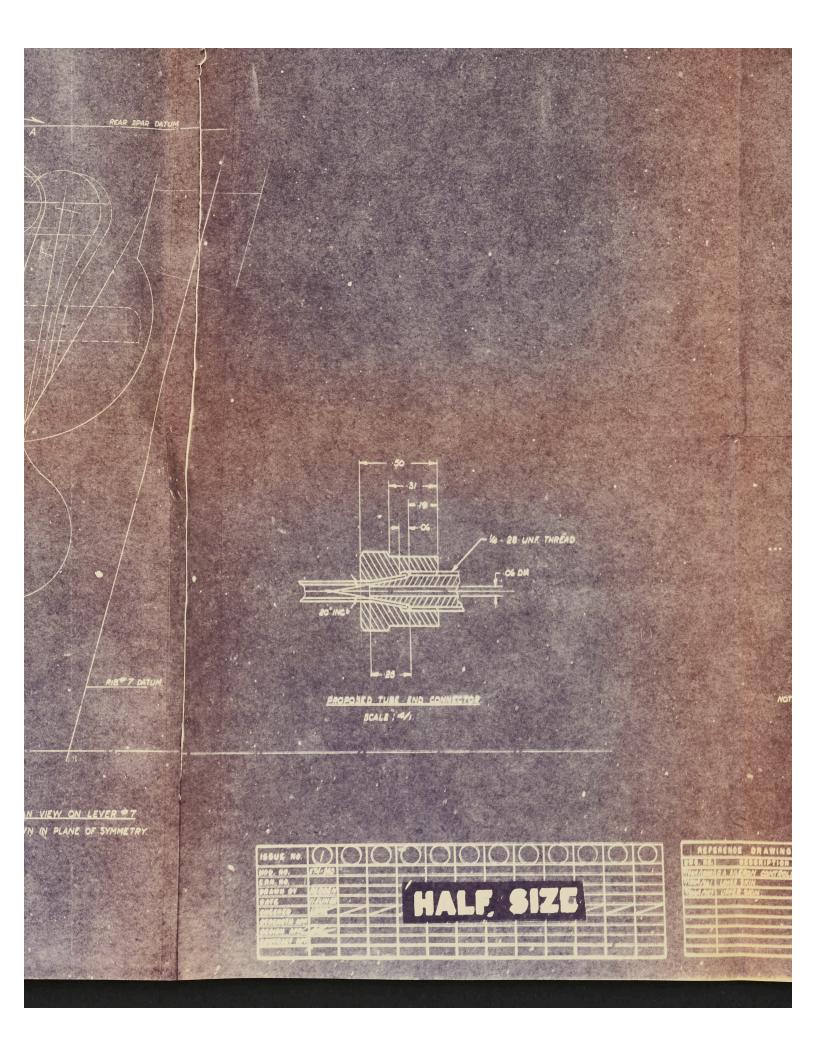
SECTION A-A TUBING OMITTED FOR CLARITY

5 DUE TO POSITION OF LUBRICANT CONNECTOR, LINK WILL NEED 4 EXISTING METHOD OF LUBRICATION REQUIRES REMOVAL OF LOWER FAIRINGS ATTACHED BY MAXIMUM OF 15 COUNTERSUNK SCREWS. S EXISTING PARTS CAN BE MODIFIED WITH THE EXCEPTION OF LEVER-WHICH REQUIRES ADDITIONAL MATERIAL AS SHOWN. 2 LEVER #7 IS SHOWN AS BEING TYPICAL FOR ALL LEVERS ALTHOUGH DETAIL INVESTIGATION WILL BE REQUIRED TO DETERMINE INDIVIDUAL PIPE RUNS ETC. I THIS INVESTIGATION IS BASED ON THE ASSUMPTION THAT SUITABLE FLEXIBLE NYLON TUBING WILL SECOME AVAILABLE. 。 第15章 "我们是在1950年,我们就是1950年,我们就是1950年,我们就是1950年,我们就是1950年,我们就是1950年,我们就是1950年,我们就是 REPERENCE DRAWINGS NECT AVEO AIRCRAFT LIMITED CONTRACTOR REPORTED -0115-518

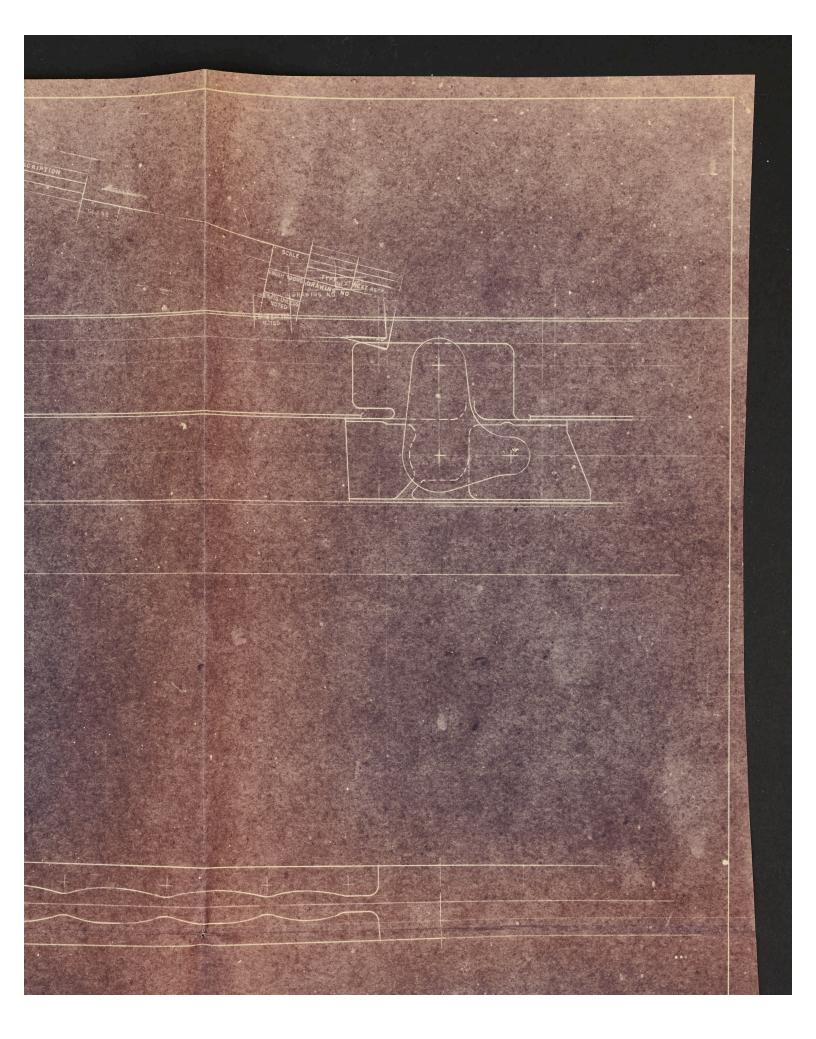
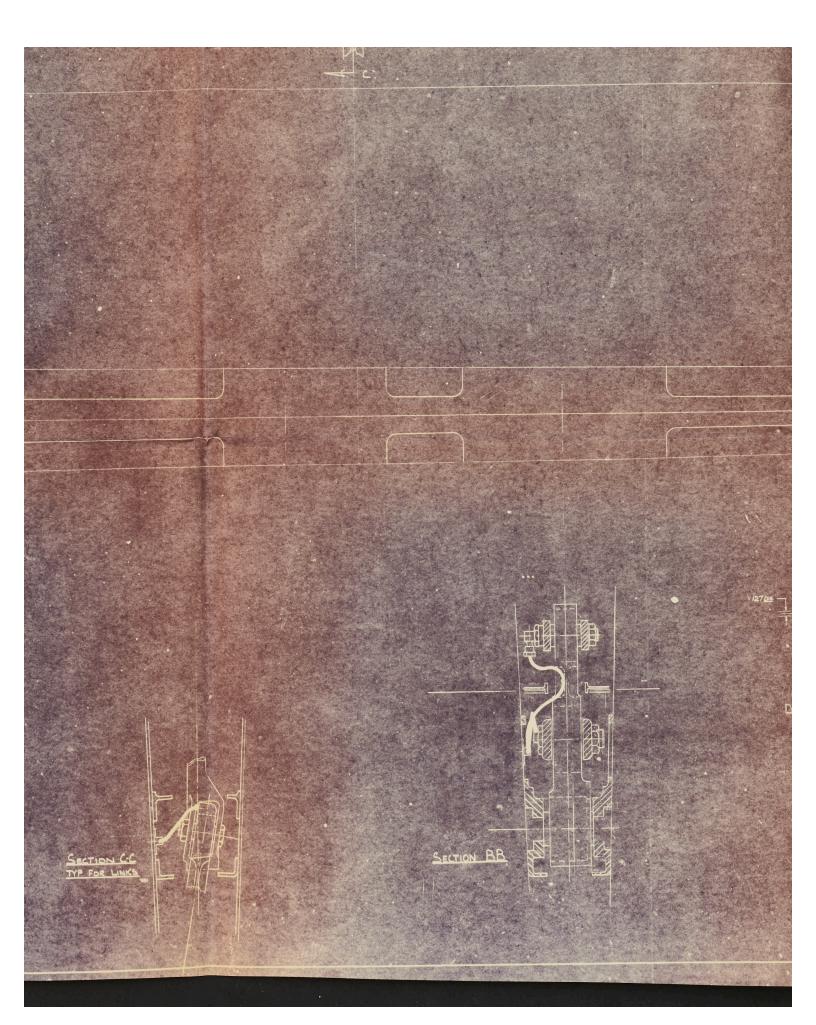
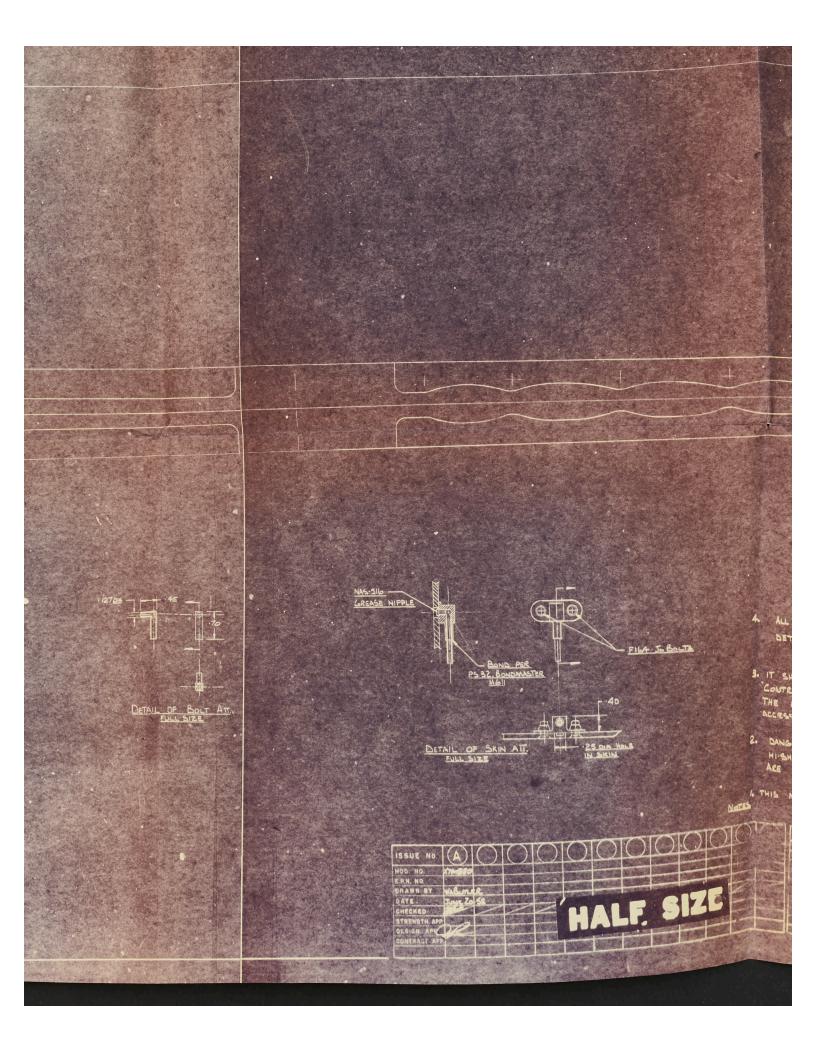
SECTION AA SECTION C.C. TYP FOR LEVERS

ALL SKID LUBRICATION POINTS ON THIS INDESTIGATION ARE ATTACHED TO EXISTING BETACHABLE PLUGS, THESE WOULD REQUIRE MODIFICATION. 3. IT SHOULD BE POINTED OUT, THAT AT PRESENT, LUBRICATION POINTS IN THE EUODER CONTROL BOX' ARE MODERATLY ACCESSABLE, WITH THE EXCEPTION OF THE POINT AT THE RUNDLE JACK , WHICH DECESSITATES THE REMOUAL OF RUDDER JACK ACCESS DOOR . 2. DANGER EXISTS IN THAT THE TUBE MAY BECOME LODGED BEHIND ONE OF THE MANY
HISHEAR PINS USED IN THE CONSTRUCTION OF CONTROL BOX, ALSO AS THE CONTROLS
ARE ACTUATED. THE LUBRICACTION TURE WILL IN PLACES, RUB LIGHTLY ON THE STRUCTURE THIS METHOD OF LUBRICATION IS SUBJECT TO OBTAINING IN ON FLEXIBLE NYLON TUBE. REFERENCE DRAWINGS AVRO AIRCRAFT LIMITED DESCRIPTION MALTON INVESTIGATION METHOD TO SIMPLIFY LUBY OF 153.4
