**The Persistence of Sail in the  
Age of Steam  
Underwater Archaeological Evidence  
from the Dry Tortugas**

**Donna J. Souza**

Brown University  
Providence, Rhode Island

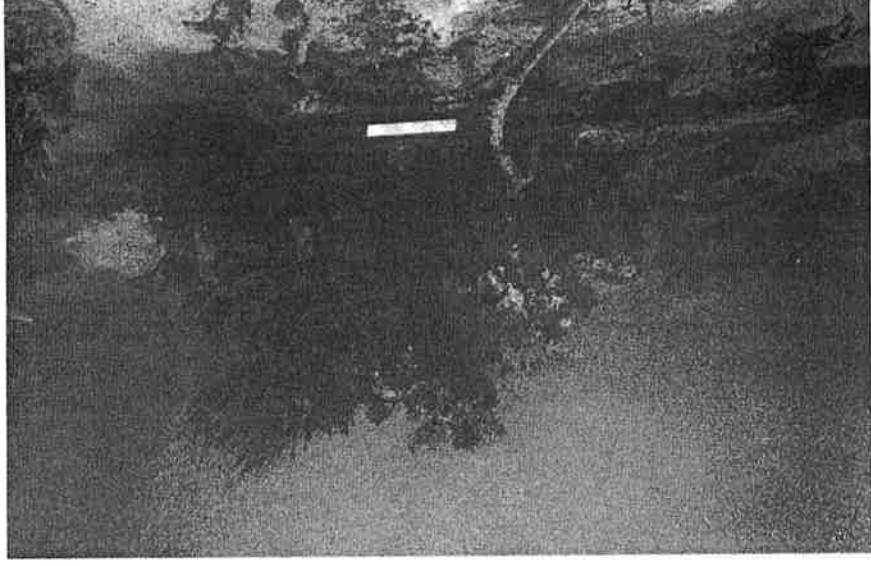
Figure 4.7. The windlass from B013-030.

The windlass (Figure 4.7) is well articulated with a connecting drive shaft that worked in conjunction with a capstan that is located in close association. The overall length of the windlass is 7 feet. It has two wildcat hubs, one on each end of the windlass. Each hub is 1 foot, 2 inches wide with a diameter of 2 feet, 5 inches.
