## CharlestonWISE Impact Project Historic House Information

Prepared by: Mariah Schwartz  
Prepared for: Sustainability Institute  
 Historic Charleston Foundation  
Date: July 21, 2011

Location Address: The William Hughes House  
 21 Lamboll Street  
 Charleston, SC 29401

### House Data Sheet

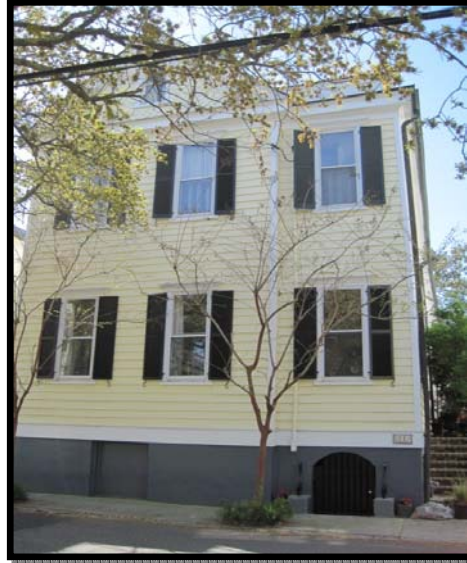
System	Material / Type	Notes
Exterior Walls	Wood	Weatherboard siding; shingles on the north gable
Roof	Metal, standing seam	
Framing	Wood	
Windows	Wood, double-hung	1/1 lite
Foundation	High Stuccoed Brick	
Piazza / Porch	Wood	2-story, west elevation, portions enclosed
