SOUTH CAROLINA LONGCOUNTRY
PROJECT 1963
UNDER DIRECTION OF UNITED STATES DEPARTMENT OF THE INTERIOR
NATIONAL PARK SERVICE, BRANCH OF PLANS AND DESIGN

THE ROBINSON-AIKEN NECESSARY BUILDING
NAME OF STRUCTURE
CHARLESTON, SOUTH CAROLINA
45 ELIZABETH STREET
CHARLESTON COUNTY S.C.

SURVEY NO. SC-277
HISTORIC AMERICAN BUILDINGS SURVEY
SHEET 2 OF 2 SHEETS
NAME OF DRAWER
FIRE & WATER

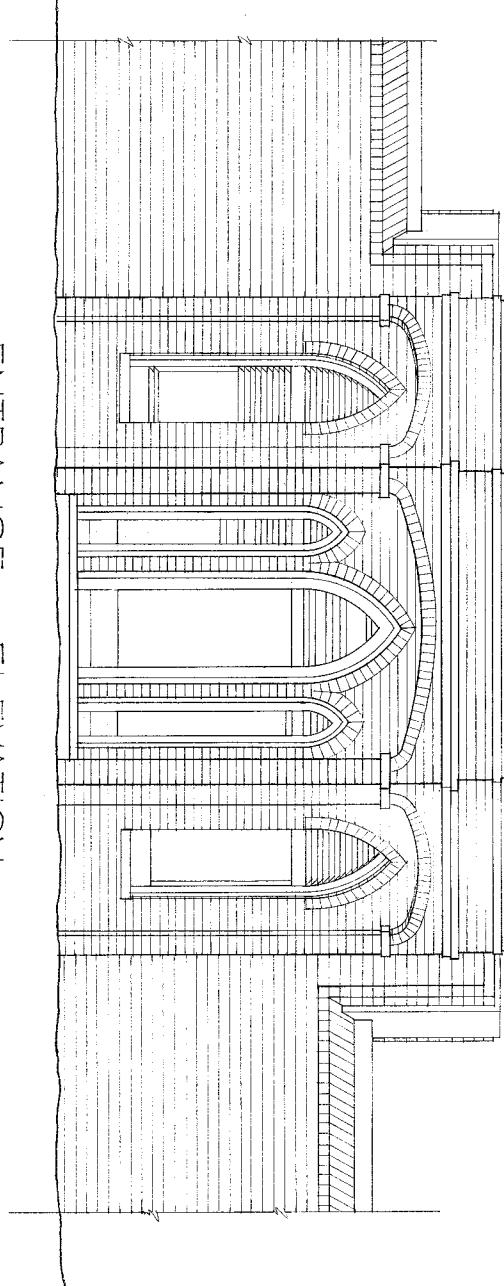
ENTRANCE ELEVATION
SCALE $\frac{1}{2}'' = 1'-0''$

NOTE: CONDITION OF STRUCTURE
MASONRY - GOOD.
ROOF - EVIDENCE OF A FLAT ROOF;
SCANTY DETERIORATED REMAINS.
INTERIOR - WOOD AND PLASTER WALL FINISH DETERIORATED.
REMAINS OF WOODEN FLOOR.
NO REMAINS OF SEATS.
