# Nanotechnology & Materials Testing Using Nanoparticles to Tag Consolidants to Determine Depth of Penetration

**Grant No.** MT-2210-10-NC-03

**Organization:** New York State Office of Parks,  
Recreation & Historic Preservation

**Date:** June 30, 2011

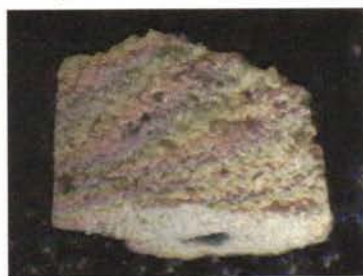
**Image 9. Nanoparticle-Matrix Compatibility Test**

Evident T2 EviDot™ Maple Red-Orange applied to mortar sample under halogen light.

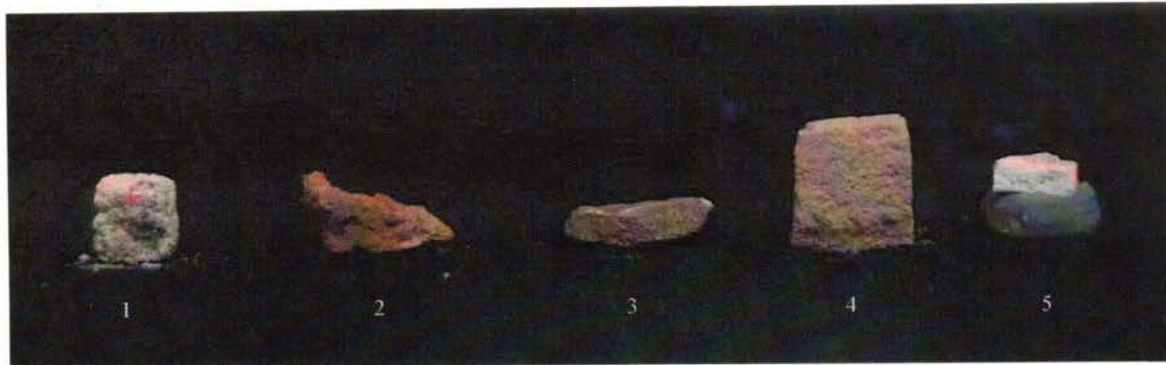
**Image 11.**

**Nanoparticle– Matrix Compatibility Test 2.1**

eBioscience eFluor™625 in xylene  
under uv (350nm) & halogen light

1.Mortar, 2.brick, 3.sandstone, 4.adobe, 5.gesso

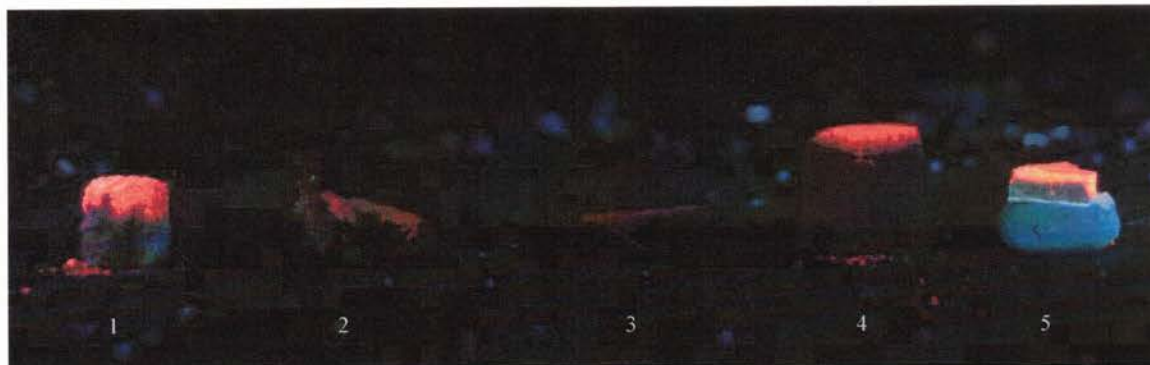
**Nanoparticle– Matrix Compatibility Test 2.1**

<sup>2</sup>It was theorized that the outer shell of the nanoparticle was effected by the electrostatic forces of the matrix. An attempt was made to remove the outer shell of the nanoparticle to reduce the electrostatic forces. However, this process quenched the nanoparticles.

**Image 12.**  
**Nanoparticle– Matrix Compatibility Test 2.1**  
Sun Innovations™ YVE1005 in water  
under halogen light  
1.mortar, 2.adobe, 3. plaster 4.brick

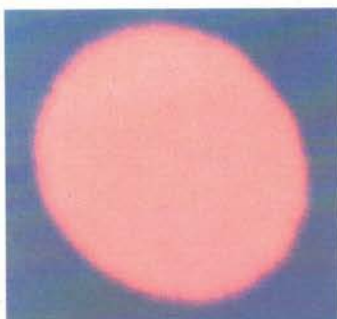
**Image 11. Nanoparticle-Consolidant Compatibility –Filter Paper Test**

Evident T2 EviDot™ Maple Red-Orange & Paraloid B72 applied to filter paper under ultraviolet light (350nm).

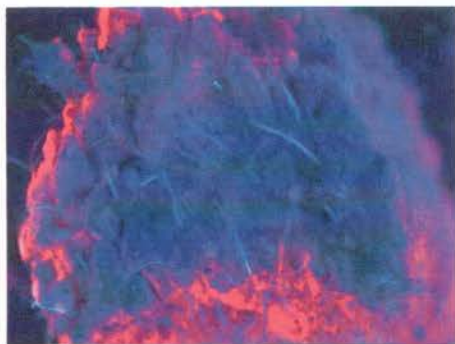
**Image 11.**  
**Nanoparticle/Consolidant–**  
**Matrix Compatibility Test**  
Evident T2 EviDot™ Maple Red-Orange & Paraloid B72 applied to a plaster sample under ultraviolet light (350nm).

- The Evident T2 EviDot™ Maple Red-Orange & Paraloid B72 successfully penetrated all of the selected matrices without separating out of solution. The nanoparticles traveled with the Paraloid B72. This was also observed with Lascaux P550, PVA- AYAA and cyclododecane.
- The Sun Innovations™ YVE1005 and Isinglass successfully penetrated all of the selected matrices, except sugar cubes, without separating out of solution. The nanoparticles traveled with the isinglass. This was also observed with dilute solutions of Ethulose. Sugar cubes were not tested with aqueous consolidants.

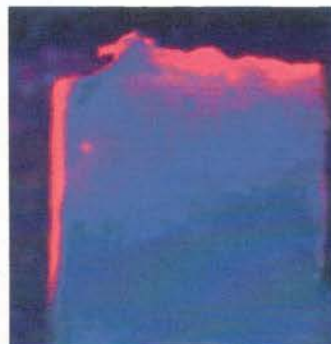
**Image 12.**  
**Nanoparticle/Consolidant–**  
**Matrix Compatibility Test**  
Evident T2 EviDot™ Maple Red-Orange & Paraloid B72 applied to a marble sample under ultraviolet light (350nm).

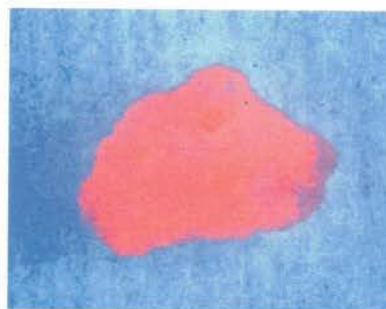
**Image 16.**  
**Nanoparticle/Consolidant–  
Matrix Compatibility Test**  
Evident T2 EviDot™ Maple Red-  
Orange & Paraloid B72 applied to a  
sugar cube under ultraviolet light.  
Unconsolidated material has been  
removed. Entire sample fluoresces.

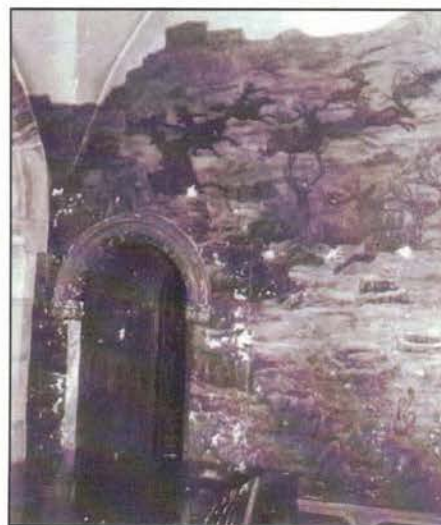
Image 1. Robert Chanler Mural c.1920's  
Coe Hall, Planting Fields, State Park

The mural has been deteriorating since its construction. There are letters documenting flaking paint just months after its completion. Investigations have found that the delamination is occurring primarily at the interfaces between the gesso layer and plaster layers.

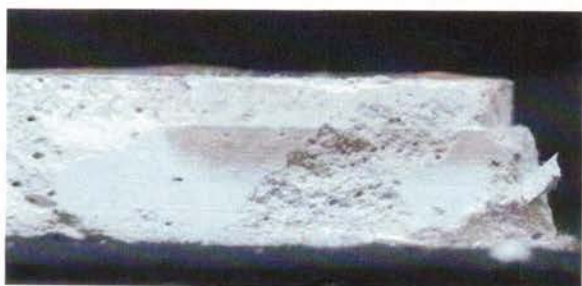
Image 2. Crossection  
Mural mockup treated with Paraloid B72 tagged with  
Evident T2 Evi Dot™ Maple Red-Orange under halo-  
gen light. 100x magnification

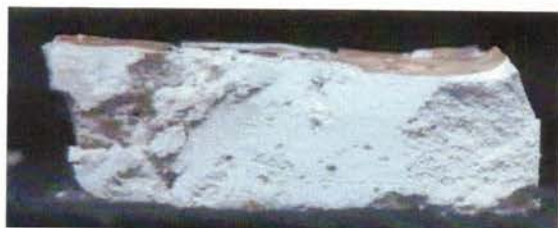
Image 4. Crossection  
Mural mockup treated with Isinglass tagged with  
Sun Innovations™ YVE1005 under halogen light.  
100x magnification

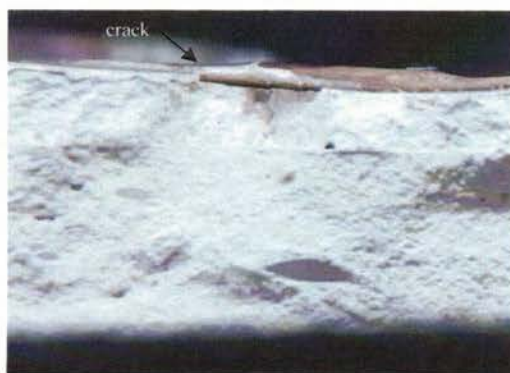
Image 6.  
Mural mockup treated with Paraloid B72  
tagged with Evident T2 Evi Dot™ Maple Red-  
Orange under halogen light.  
100x magnification

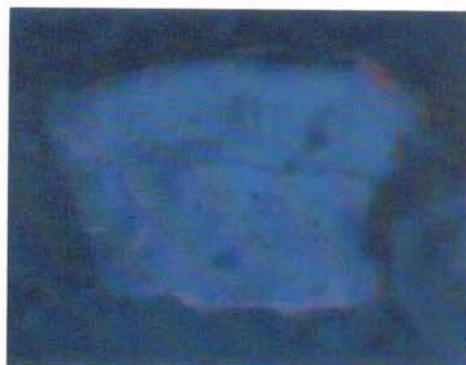
Image 10.  
Mural sample S-E1 under 325nm UV light  
300x magnification.

This sample was immersed in isinglass tagged with Sun Innovation™ YVE1005 (1 µl of nanoparticles in 1ml of consolidant solution). The sample was allowed to dwell in the solution for over an hour with frequent agitation to encourage penetration of the consolidant. The sample was then removed from the consolidant and allowed to dry. A crosssection of the sample was taken and examined under uv light. The nanoparticles revealed that the isinglass was completely unable to penetrate any of the layers of the samples.

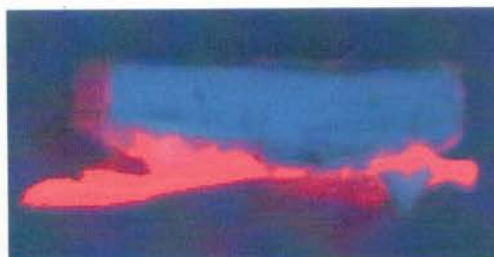
Image 16.  
Mural sample S-N1 under 325nm UV light  
300x magnification.

This sample was immersed in isinglass tagged with Sun Innovation™ YVE1005 (1 µl of nanoparticles in 1ml of consolidant solution). The sample was allowed to dwell in the solution for over an hour with frequent agitation to encourage penetration of the consolidant. The sample was then removed from the consolidant and allowed to dry. A crosssection of the sample was taken and examined under UV light. The nanoparticles revealed that the isinglass was completely unable to penetrate any of the layers of the samples.

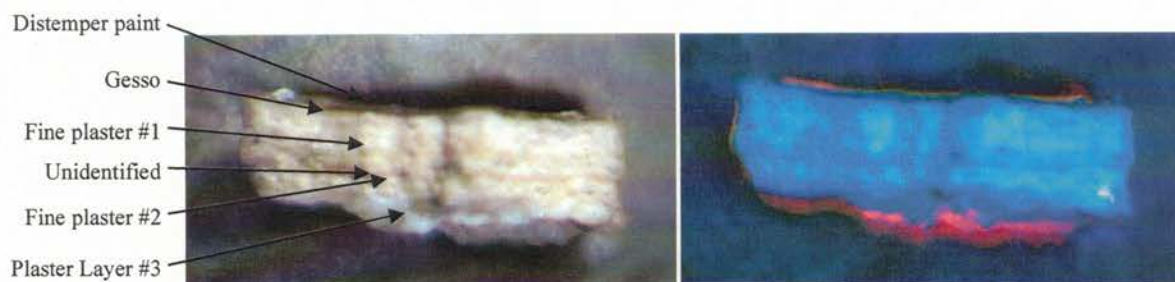
This sample was immersed in Lascaux P550 tagged with tagged with Evident T2 Evi Dots™ Maple Red-Orange (1µl of nanoparticles in 1ml of consolidant solution). The sample was allowed to dwell in the solution for over an hour with frequent agitation to encourage penetration of the consolidant. The sample was then removed from the consolidant and allowed to dry. A cross-section of the sample was taken and examined under UV light. The Lascaux P550 did not penetrate through the sample.

Image 19.  
Mural sample S2 under halogen light  
300x magnification.

Image 20.  
Mural sample S2 under 350nm UV light  
300x magnification.
