OFFICE OF HISTORIC PRESERVATION  
INDIVIDUAL STRUCTURE SURVEY FORM

HISTORIC NAME: Engine Co. #6  
LOCATION: 801 Clinton St.

MUNICIPALITY: Hoboken

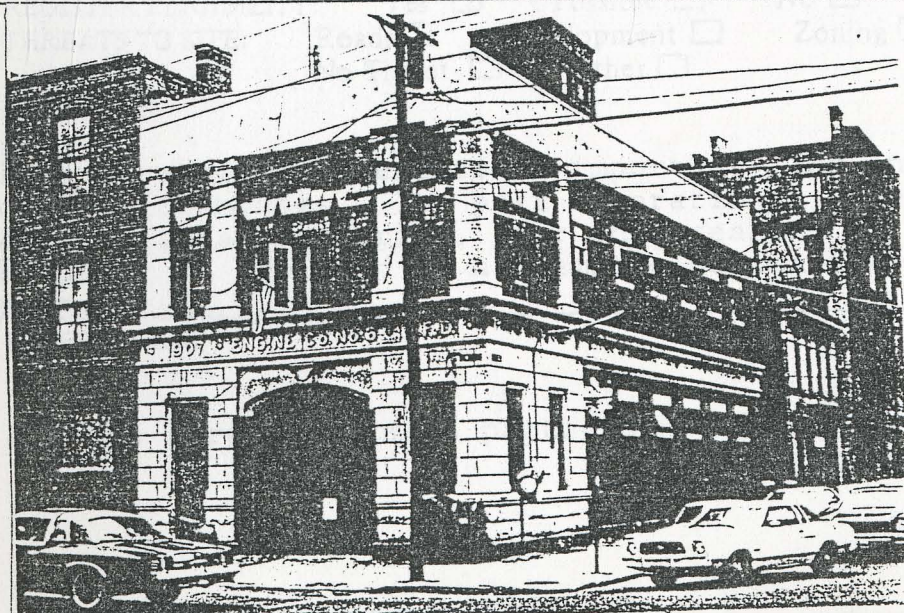
Additional Architectural Description: The basement storey features bluestone foundation trim, two courses of rough-hewn limestone which support a smooth stone sill. This forms the base of a rusticated limestone ground floor. The arched opening for the engine door is centered on the principal Clinton St. facade. The engine door is flanked by a window to the south and a door to the north. Both window and door are of equal height, and filled with multi-paned square art glass transoms. Above the engine door is a grouping of three windows. The central one is wider than those flanking it, and has casement windows. These have keystone lintels and art glass transoms as do those of the ground floor. The grouping is framed by two Ionic pilasters with 10" bases. The capitals have garlands below each of the volutes. A stone entablature between the second and first stories bears the 1907 construction date and "Engine Co. No. 6, H.F.D." The cornice was removed c. 1980.

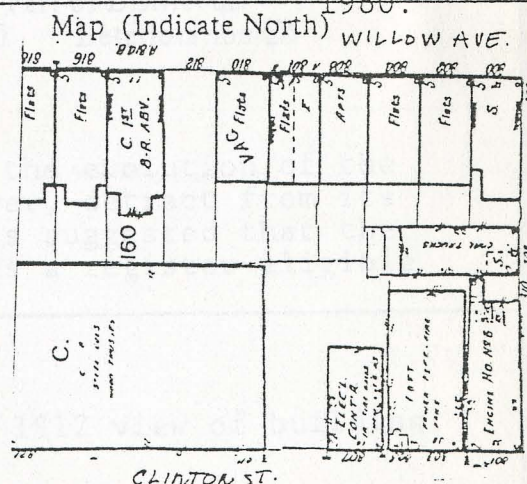
Situated on the corner of a streetscape which is of similar height. Its principal facade is oriented toward Clinton St., and the motifs of the front facade continue two bays along the side street facade.
