None Hurt, Little Damage as America's First Jet Airliner Crash Lands With Undercarriage Up Anxious A. V. Roe officials and workers swarm around their pet job, three years a-making, down on her jet nacelles.

Jetliner Slides in at Malton When Landing Gear Fails

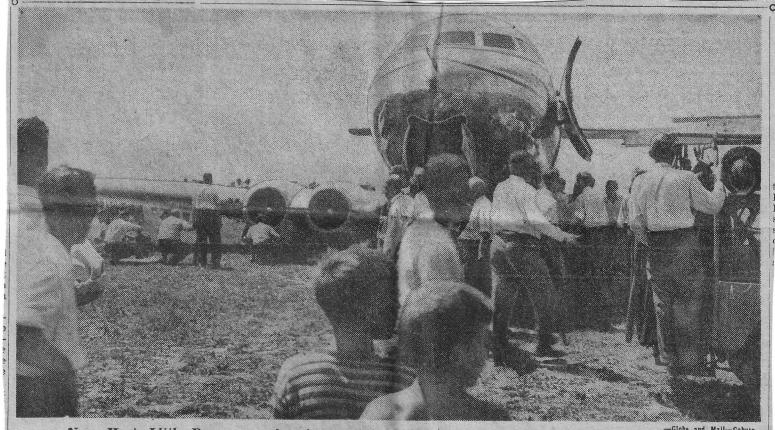
The 50-passenger jet plane—the second commercial jet aircraft to take the air anywhere in the world—was but slightly damaged. An official of A. V. Roe (Canada), makers of the plane, said last night that the jet tubes, which protrude 10 feet behind the wing, and the rear tail-skid were bent. That was the only damage, he said.

The plane's three methods of lowering the undercarriage all failed. She slid to a stop on her belly with only one of her three wheels lowered.
