FTC-TDR-61-56
January 1962

AVROCAR FLIGHT EVALUATION

AIR FORCE FLIGHT TEST CENTER
EDWARDS AIR FORCE BASE, CALIFORNIA
AIR FORCE SYSTEMS COMMAND
UNITED STATES AIR FORCE

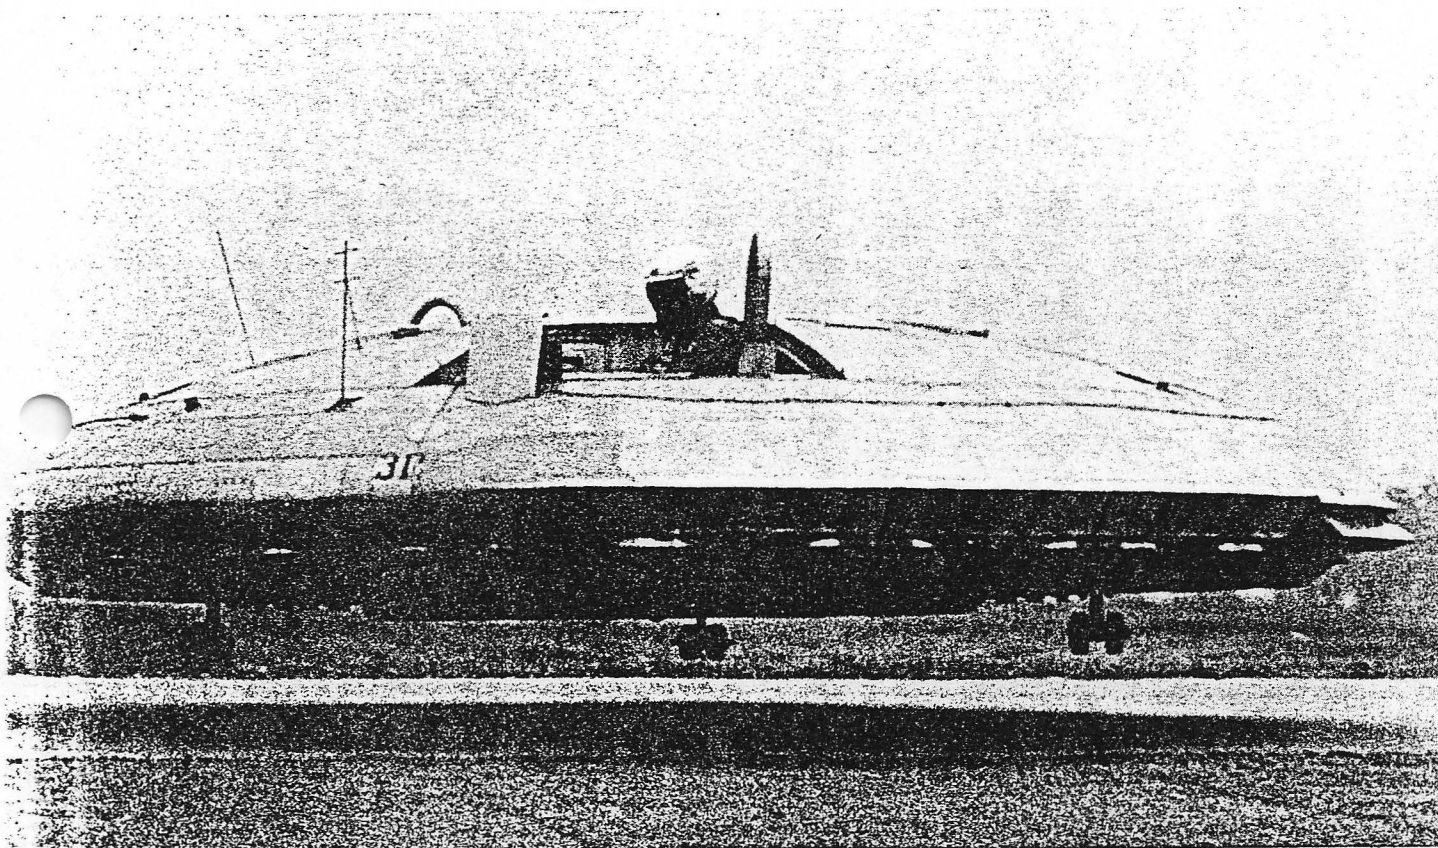
AVROCAR HOVERING ABOUT
1 FOOT ABOVE THE CONCRETE

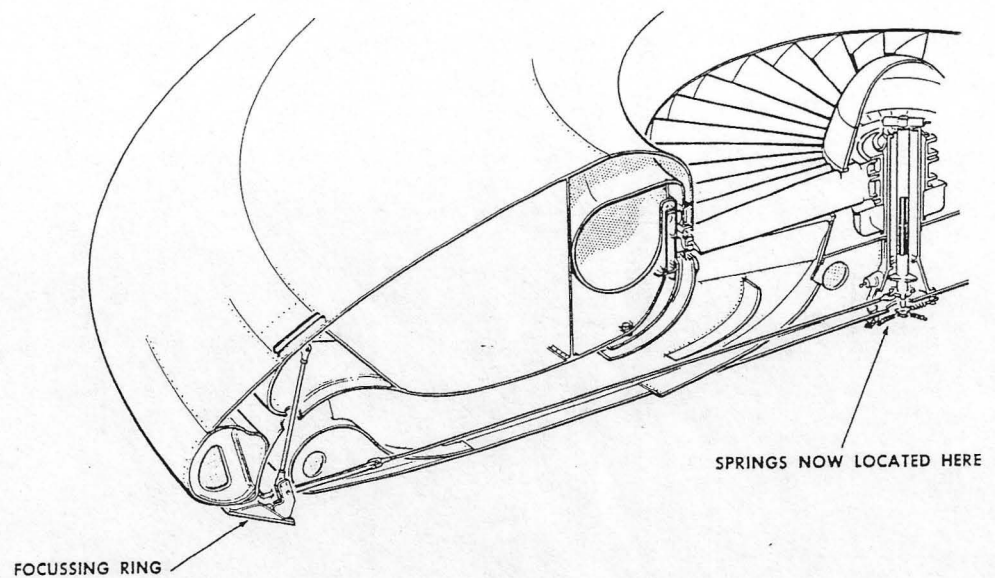
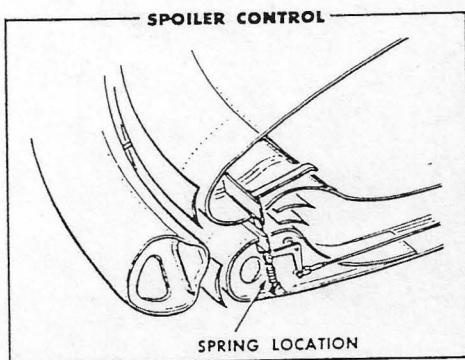
CONTROL MECHANISM COMPARISON

FOCUSSING RING CONTROL

FIGURE 1.
ORIGINAL SPOILER CONTROL SYSTEM AND PRESENT
FOCUSSING RING CONTROL SYSTEM. PERIPHERAL
NOZZLE FOR HIGH SPEED FLIGHT IS NOT SHOWN.

The first free flight, which was conducted on the second vehicle, was on 12 November 1959. At this time, the aircraft was fitted with the original nozzle spoiler control system (Fig. 1). Two continuous rings or spoilers were fitted in the throat of the annular nozzle. The projection of the spoilers controlled the direction of the jet efflux. The spoiler control produced pitching and rolling moments by destroying lift on one side and not creating more lift on the opposite with the result that the aircraft lost height during maneuvering flight. Since the lift loss was greater than expected, the spoiler control was replaced with a focussing ring control.

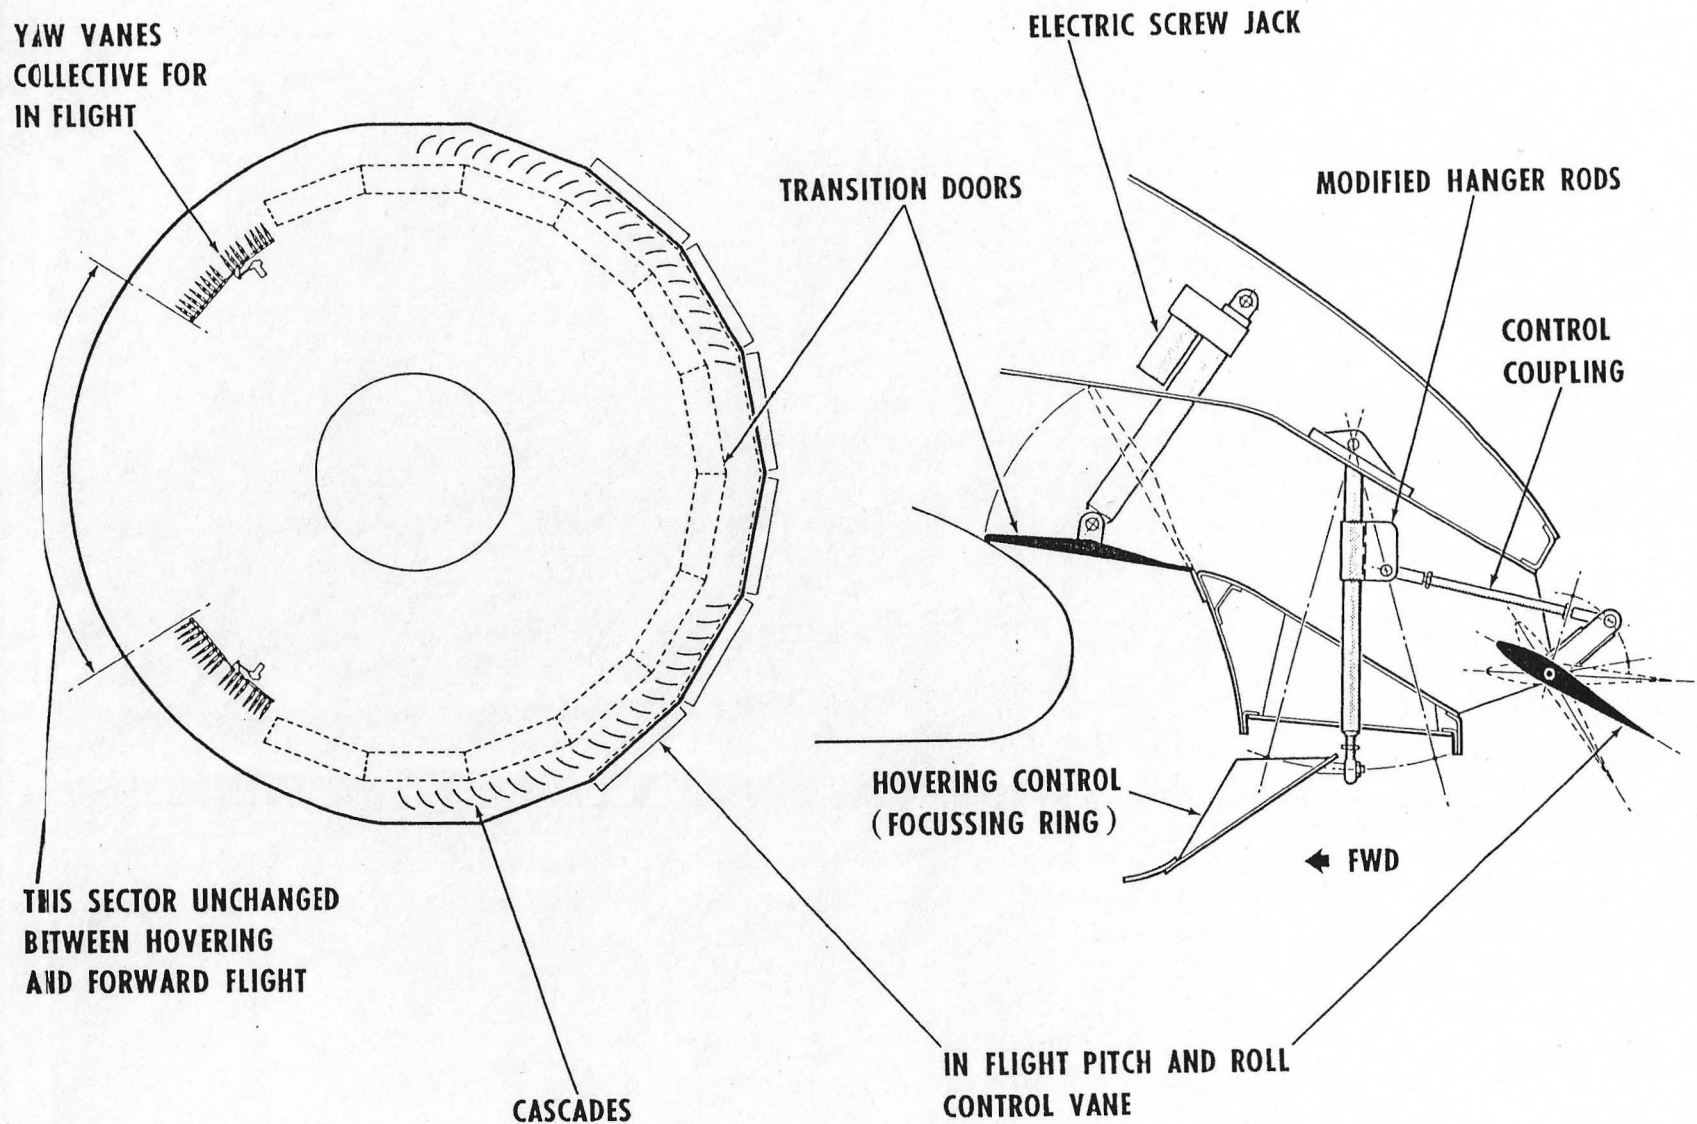
FIGURE 3.
AYROCAR CONTROL SYSTEM.

A focussing ring (Figs. 2 and 3) is located in the exhaust of the annular nozzle. The focussing ring is attached to the upper body structure by 18 links symmetrically positioned around the periphery. Bearings in the ends of the attachments permit the focussing ring to be moved in any horizontal direction. Longitudinal and lateral control is obtained during low speed flight by displacing the focussing ring as shown in Fig. 2. A pneumatic boost is incorporated in the control system.

Yaw control vanes (Fig. 3) are located forward of the lateral centerline of the vehicle and upstream of the annular nozzle. The yaw vanes are operated by pneumatic jacks.

With the transitional doors open, a jet sheet or jet flap extends from the rear of the aircraft. Six vanes, each occupying 20 degree segments at the rear 120 degrees of peripheral nozzle, control of the jet flap. These six vanes are hinged and coupled to the control system in such a manner as to operate in conjunction with the focussing ring control (Fig. 3).

Longitudinal and lateral control power is much less than that obtained during the first evaluation. A modified focussing ring suspension system (Fig. 3) was incorporated in the aircraft which increased the hinge moment of the focussing ring. To overcome the higher hinge moment, the plenum chamber pressure of the pneumatic control system was increased from 20 to 30 psi. The increased plenum chamber pressure does not fully compensate for the high hinge moment and, consequently, the travel of the focussing ring is less than that obtained previously. (B 5, A 2)

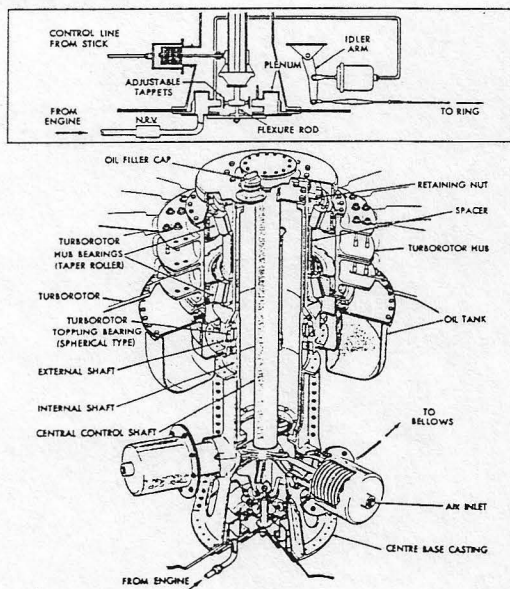
FIGURE 4.
TURBOROTOR SHAFT ASSEMBLY AND
DIAGRAM SHOWING CENTER CONTROL
POST AND PNEUMATIC CONTROL SYSTEM.

The turborotor, which acts as a large gyroscope, is mounted on a spherical bearing and is allowed to move freely within a very small angle (about $\frac{1}{4}$ degree) normal to its axis. The gyroscopic precessional motion is coupled into the flight control system to give the vehicle automatic stability (Fig. 4). (B 6)

The relative motion of the gyro is stepped up, with a mechanical linkage, into the central control post which is connected to the focussing ring through a number of cables. When the aircraft is pitching or rolling, the gyro applies a stabilizing control input. The pilot control input, which also acts on the central control post through pneumatic bellows, overrides the gyro input.

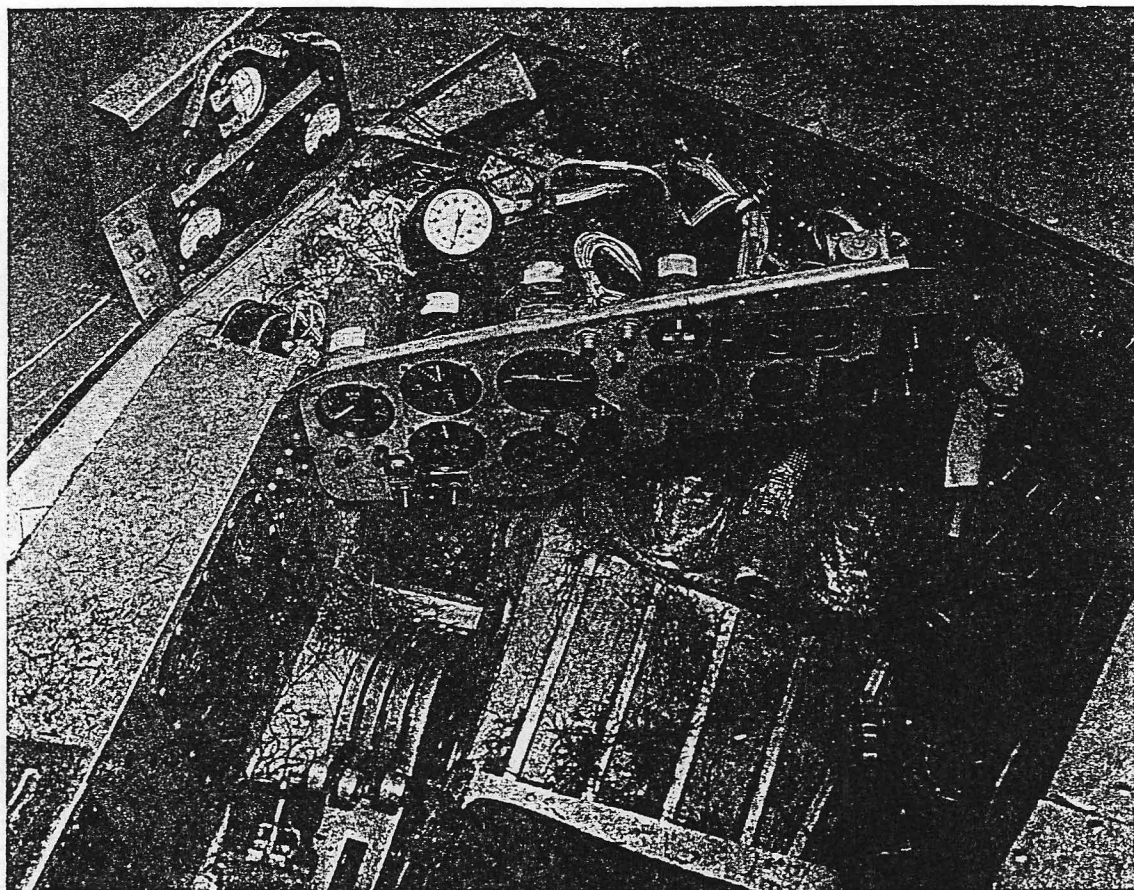
FIGURE 5
VIEW OF COCKPIT AFTER FLIGHT OVER
GRASSY AREA ENGINE INSTRUMENTS
ARE LOCATED ON SIDE PANEL ABOVE
THROTTLES

The engine instruments are located on the left side of the cockpit above and adjacent to the throttles (Fig. 5). The engine instruments are difficult to monitor because of their location and because of a large parallax. Ease of monitoring engine instruments is a major factor since ground height, control power, and aircraft stability are dependent on the power setting. The engine instruments should be located in a more visible area in front of the pilot.

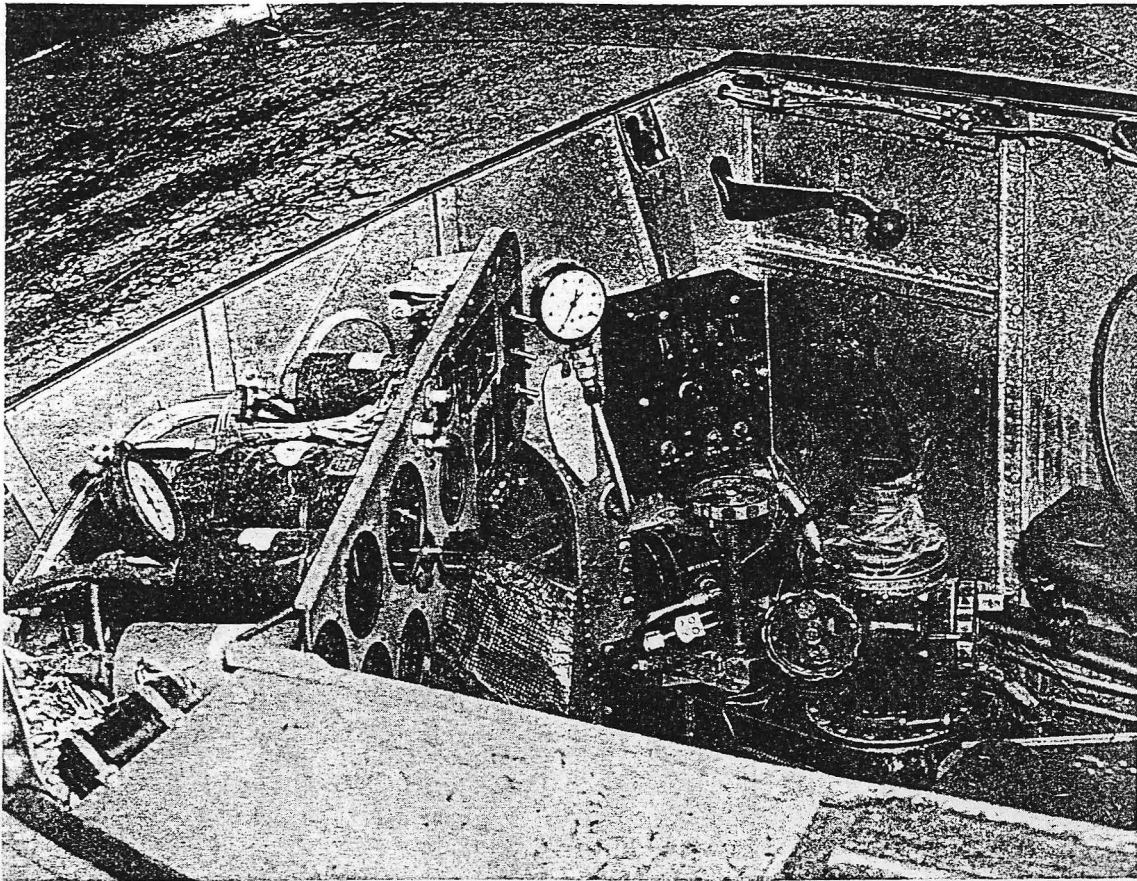
FIGURE 6
VIEW OF COCKPIT SHOWING CONTROL
STICK WITH ROTATING GRIP AND THE
THREE TRIM CONTROLS

A control stick, which extends about 14 inches above the pivot point, is located in front and to the right of the pilot as shown in Fig. 6. The control

stick is displaced in a conventional manner for longitudinal and lateral control. Directional control is obtained by rotating the control grip. Additional clearance is required between the control grip and the right bulkhead. Right lateral control is limited because the back of the hand contacts the bulkhead prior to reaching full right control displacement. Directional control should be provided by conventional foot pedals. It is difficult to rotate the control grip without radially displacing the control stick. Consequently, lateral and/or longitudinal inputs are inadvertently induced during directional inputs. When the directional control is rotated to the left, lateral control is further reduced because the wrist contacts the right bulkhead. (A 5)

provided to select the engine to be started (Fig. 6). A starter switch is actuated, at 10 percent rpm the ignition switch is actuated, and the throttle is advanced to the GROUND IDLE position. At 20 percent rpm the ignition and starter switches are turned OFF. The procedure is then repeated for the next engine. All three engines can be started in less than 1 minute and engine warm-up is not required. The generators are turned ON at 50 percent rpm, ground power is removed, and the aircraft is ready for take-off.

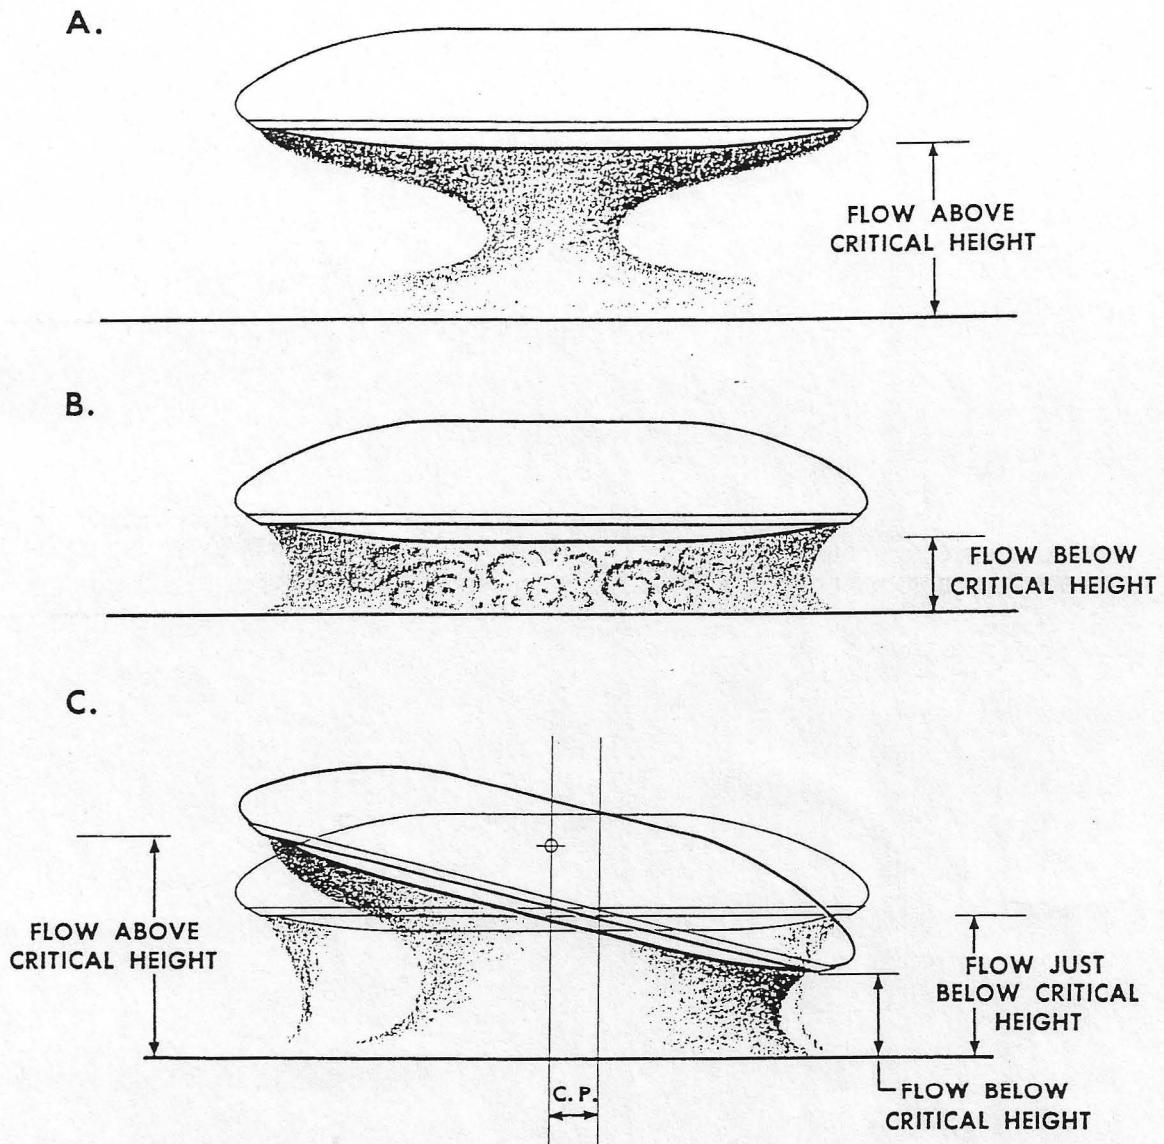
JET FLOW REGIMES IN AREA OF CRITICAL HEIGHT

FIGURE 7
DIAGRAM ILLUSTRATING THE CAUSE OF
GROUND CUSHION INSTABILITY AT THE
CRITICAL HOVERING HEIGHT

If too much power is added during the take-off, the aircraft will reach a ground height that results in an unstable ground cushion. The unstable ground height, about 2 feet from the bottom of the wheels to the ground, is called the critical height (Fig. 7). At critical height, the aircraft pitches and/or rolls in an unpredictable, uncontrollable manner. The motion is rapid, and is

usually an oscillatory, coupled motion about the longitudinal and lateral axes. The motion is termed "hubcapping." At critical height, control inputs are effective only in controlling the general flight path of the aircraft. Control inputs do not appear to aggravate the erratic instabilities caused by the ground cushion. (B 1, A 3)

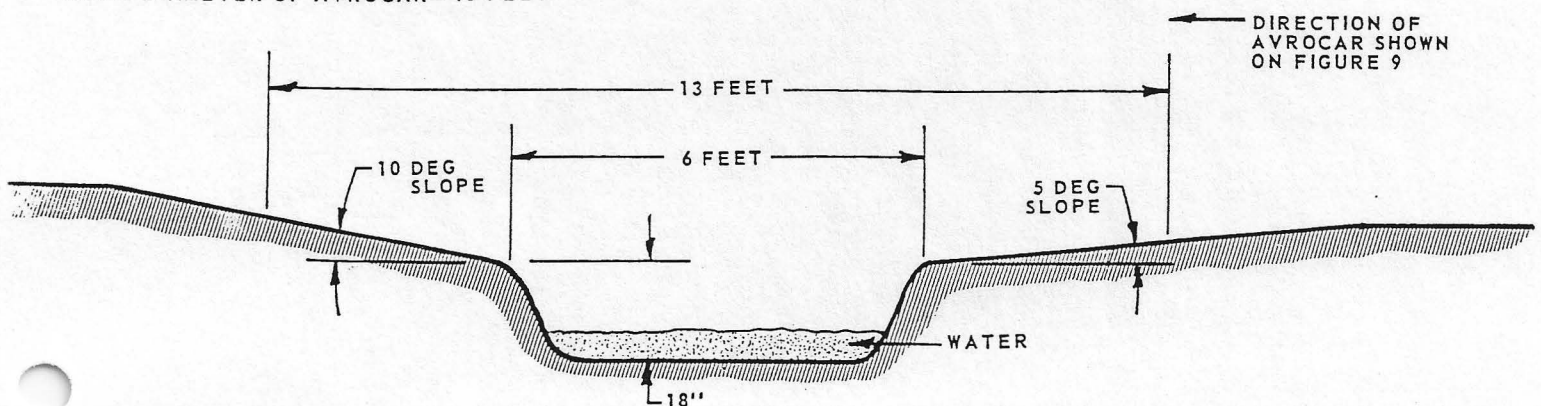
FIGURE 8
DIMENSION OF LARGE DITCH

NOTE: DIAMETER OF AVROCAR- 18 FEET

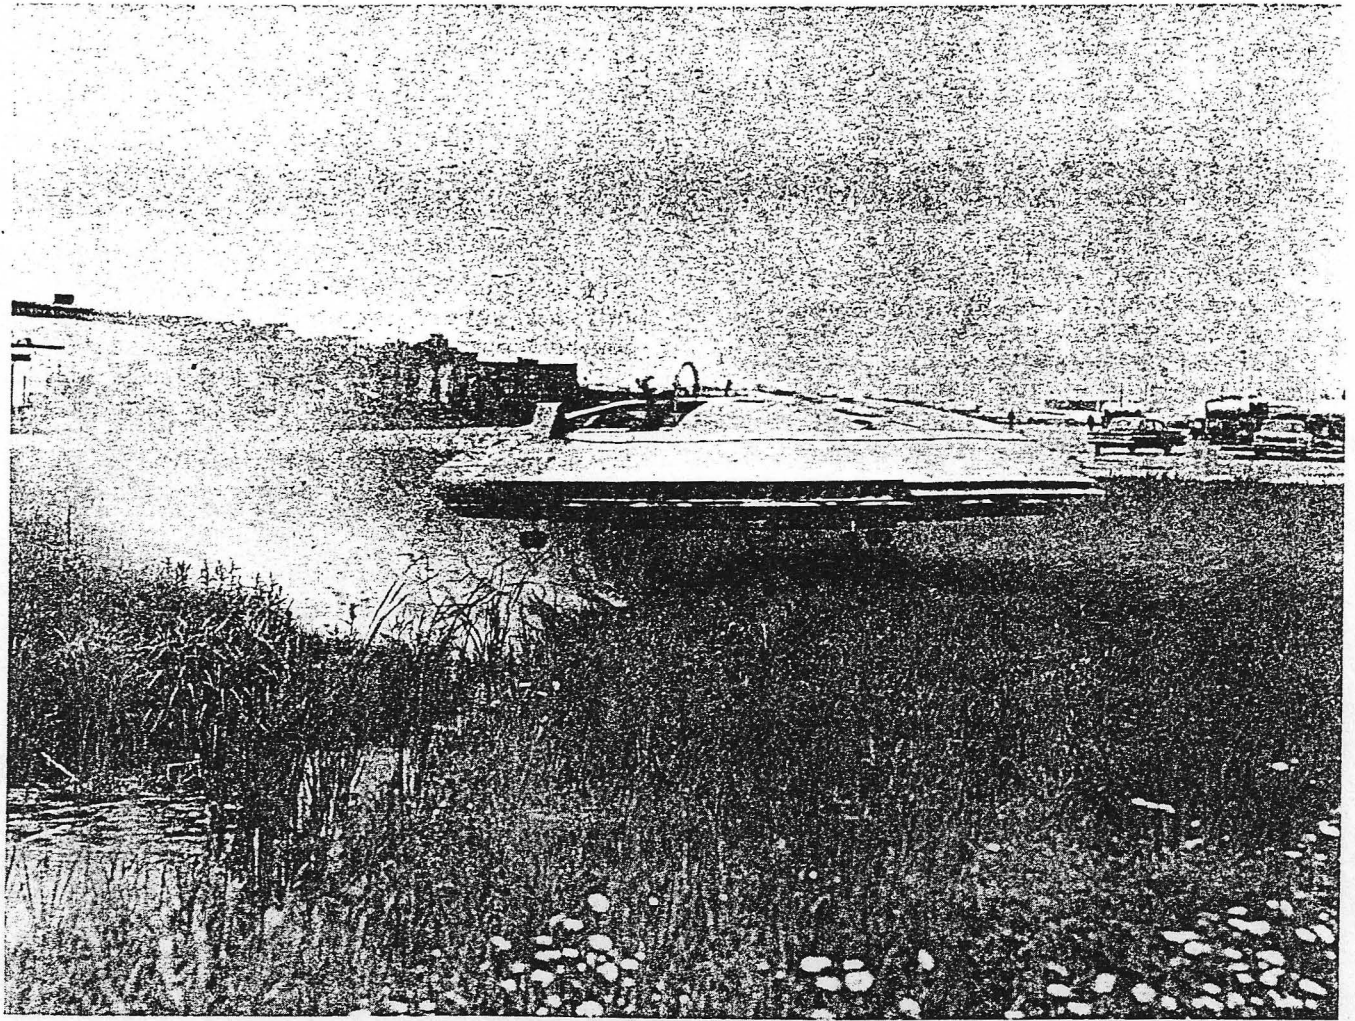
FIGURE 9
AVROCAR CROSSING THE LARGE DITCH.
AIRSPEED ABOUT 10 KNOTS. NOTE AVROCAR
IS ABOUT $\frac{1}{2}$ OVER FIRST EDGE OF THE
DITCH BUT AIRCRAFT IS STILL LEVEL
