QCX  
AVRO  
ARROW  
QTR-  
1958-3  
Copy-2

# **AVRO ARROW**

## **quarterly technical report**

**ARROW**  
**QUARTERLY TECHNICAL REPORT**

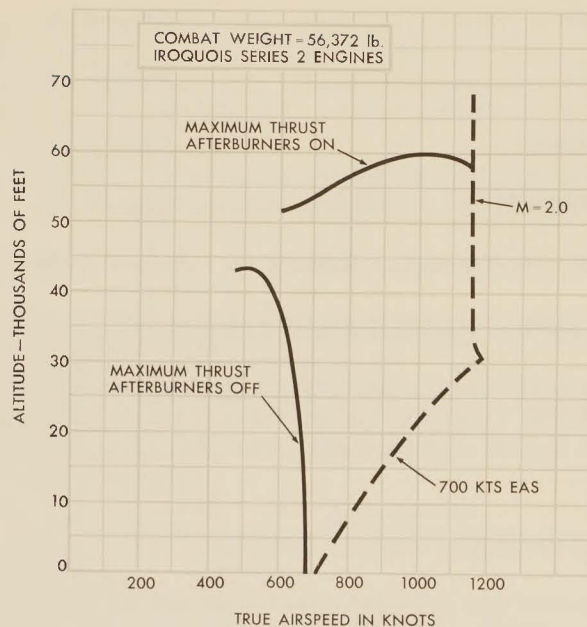
FIG. 4 ARROW 2 - MAXIMUM LEVEL SPEED

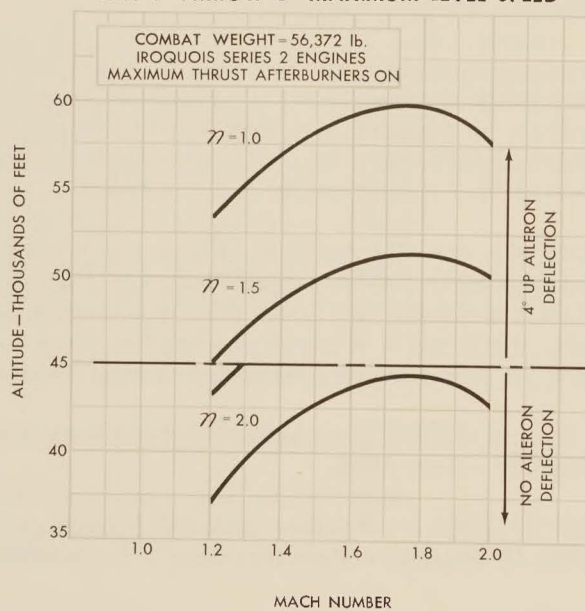
FIG. 5 ARROW 2 - MANOEUVRABILITY

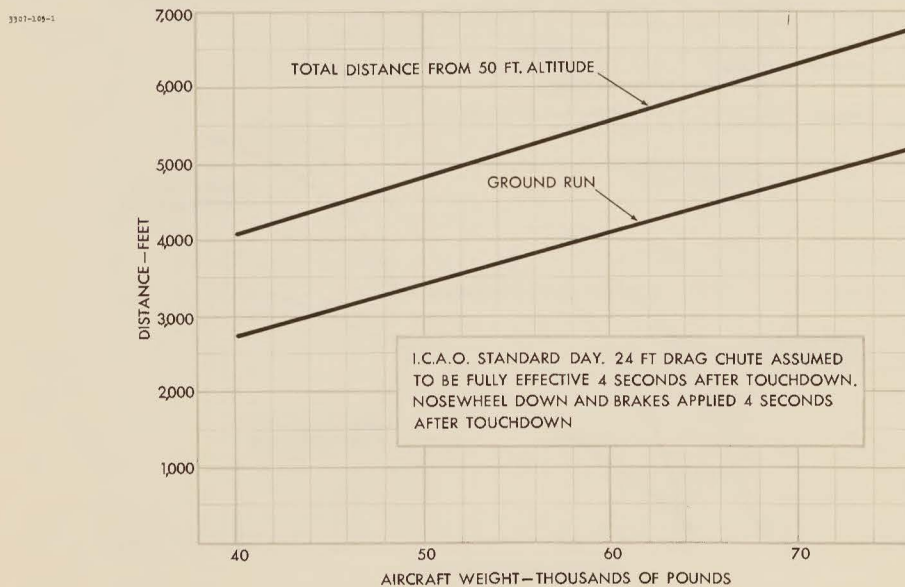
FIG. 9 ARROW 2 - LANDING DISTANCE AT SEA LEVEL

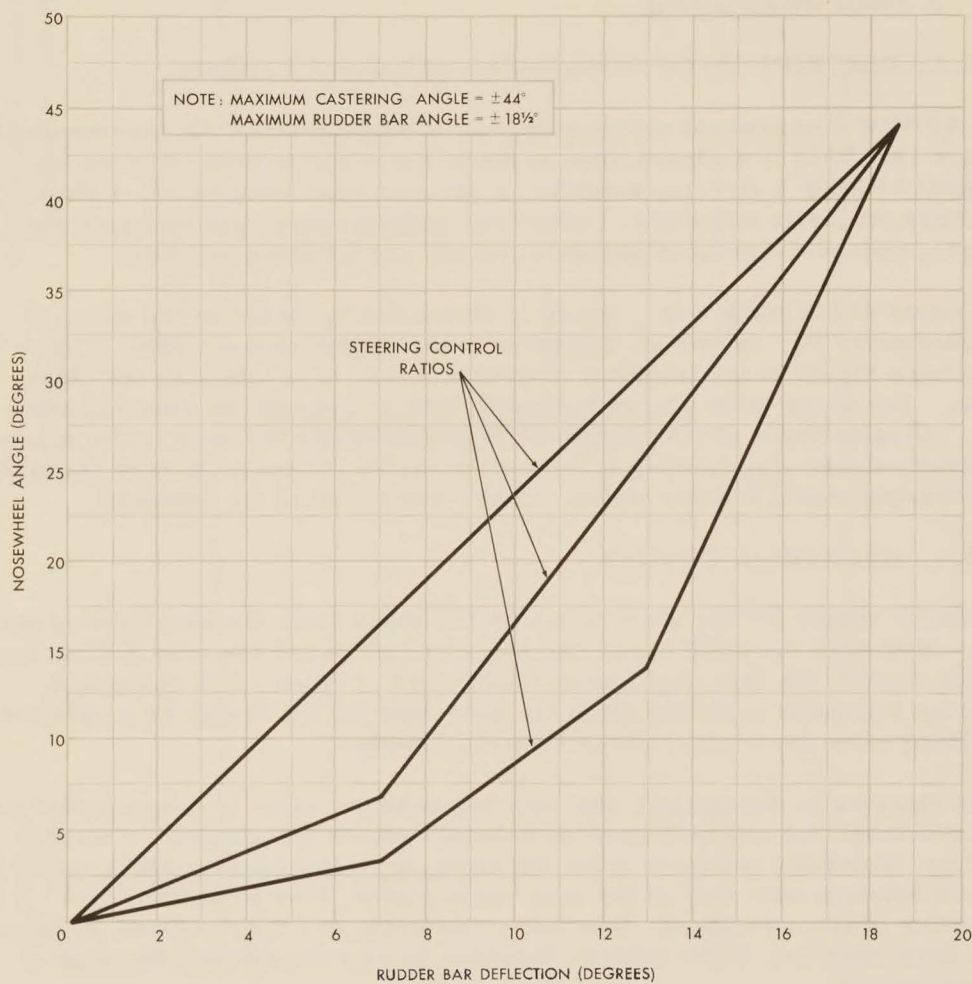
FIG. 17 NOSEWHEEL STEERING CONTROL CHARACTERISTICS (TRIAL INSTALLATION)

Preliminary design of an electro-hydraulic nosewheel steering system, to replace the original mechanically-operated arrangement, has now been completed. Trial installation and flight testing will be conducted on aircraft 25202 in order to develop an operational system for ARROW 2.
