| Number | Title | Author | Company | Date |
|---|---|---|---|---|
| 1796-63-8 | BASIC TEXT OF PRESENTATION ON NEW POLYMER INSULATOR HIGH VOLTAGE TRANSMISSION LINES AT PRESS MEETING ON MAY 8, 19633 | Peltosalo, A.E. | Insulator Dept<br>Baltimore, MD<br>General Electric | 5/8/1963 |
| IEEE CP<br>63-1039 | A POLYMER INSULATOR FOR HIGH VOLTAGE TRANSMISSION LINES | Vose, FC<br>Nichols, FS | General Electric<br>Balto & Pittsfield | 3/26/1963 |
| IEEE CP<br>64-36 | SOME CHARACTERISTICS OF POLYMER INSULATORS FOR HIGH VOLTAGE TRANSMISSION LINES | Vose, Fred C. | GE-Insulator Dept<br>Baltimore, MD | 11/11/1963 |

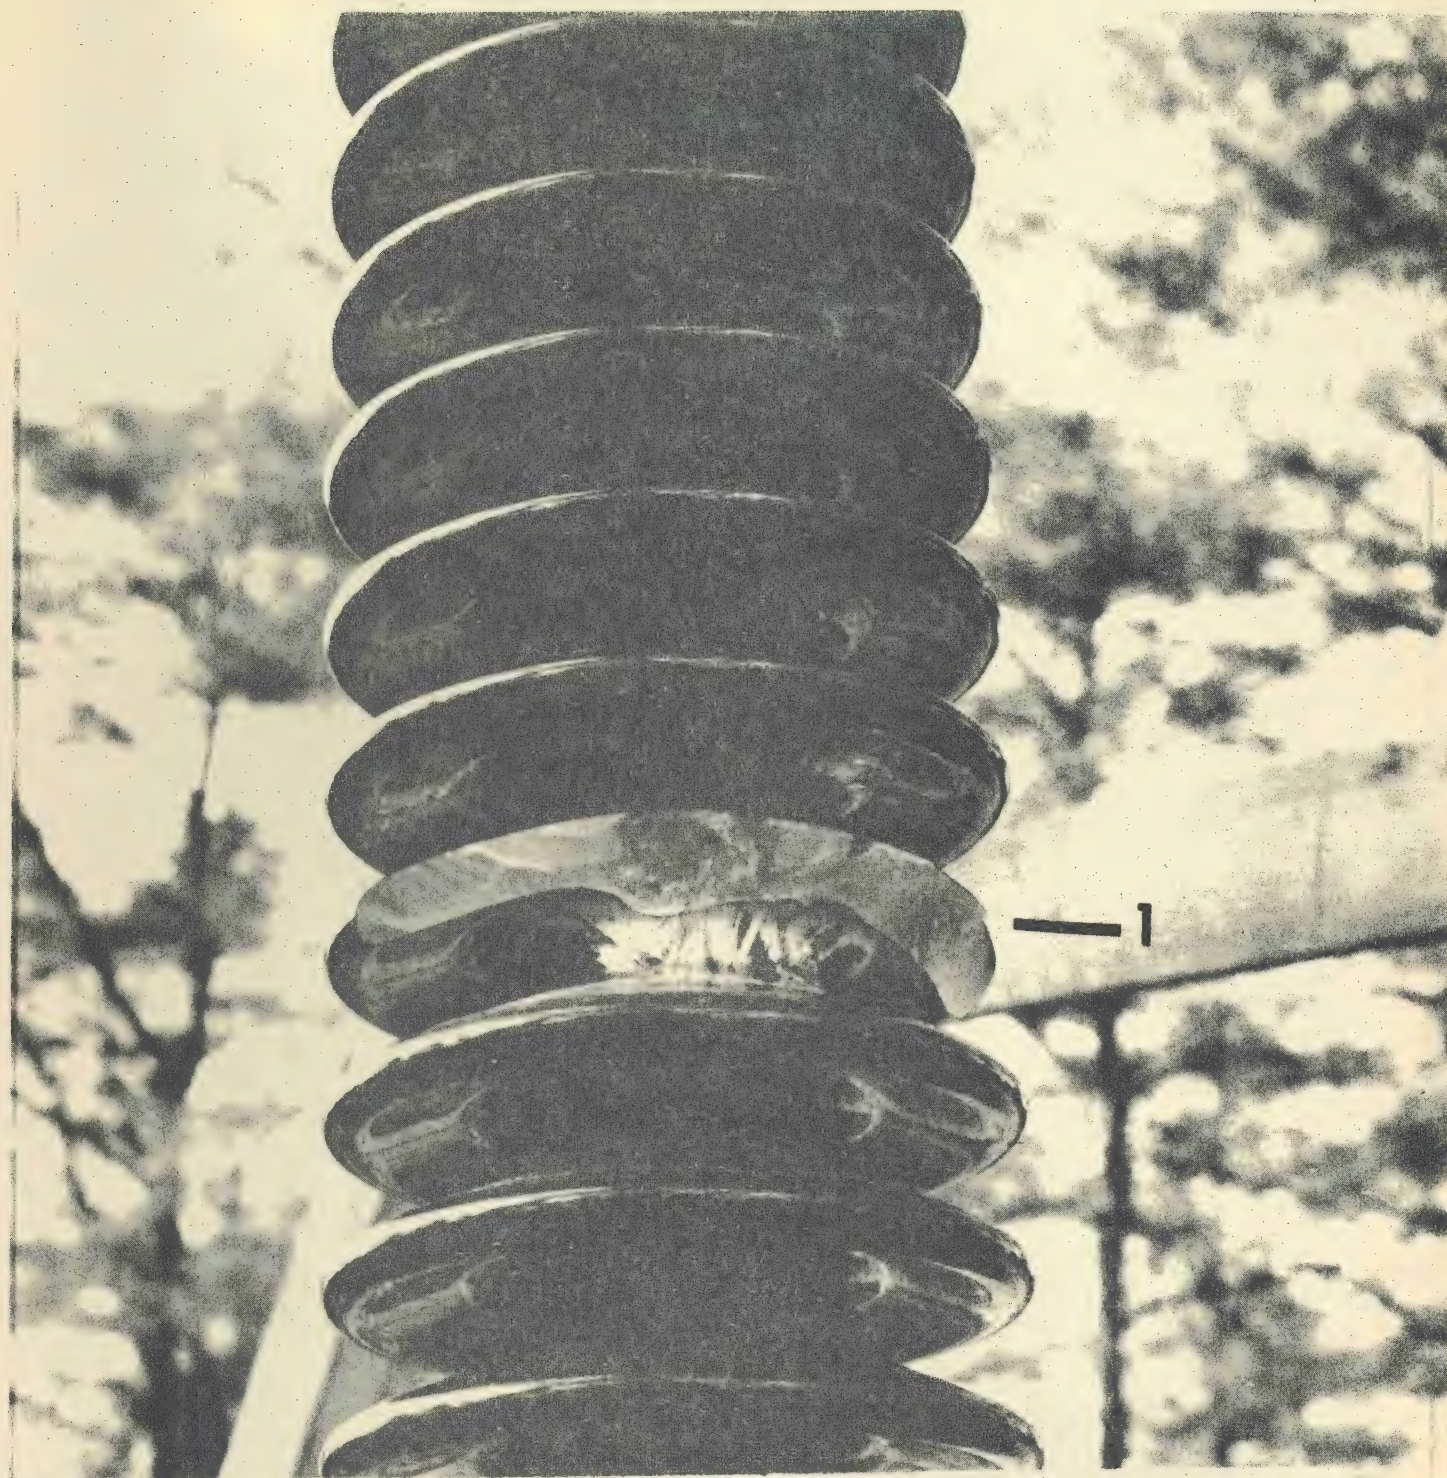
Lapp Strut - 22 long rifle - broke hood - no apparent damage to center column (1 shot).

As was expected, very little damage was done by the 22 long rifle fire. The post insulator, with relatively thin hood sections, sustained damage to the hoods but apparently none to the central core. The Locke Unispar had no damage on several successive firings, either due to hits on the porcelain shells or on the caps. The Polymer unit, again with relatively thin hoods, sustained limited breakage of the hoods, but no damage to the core.

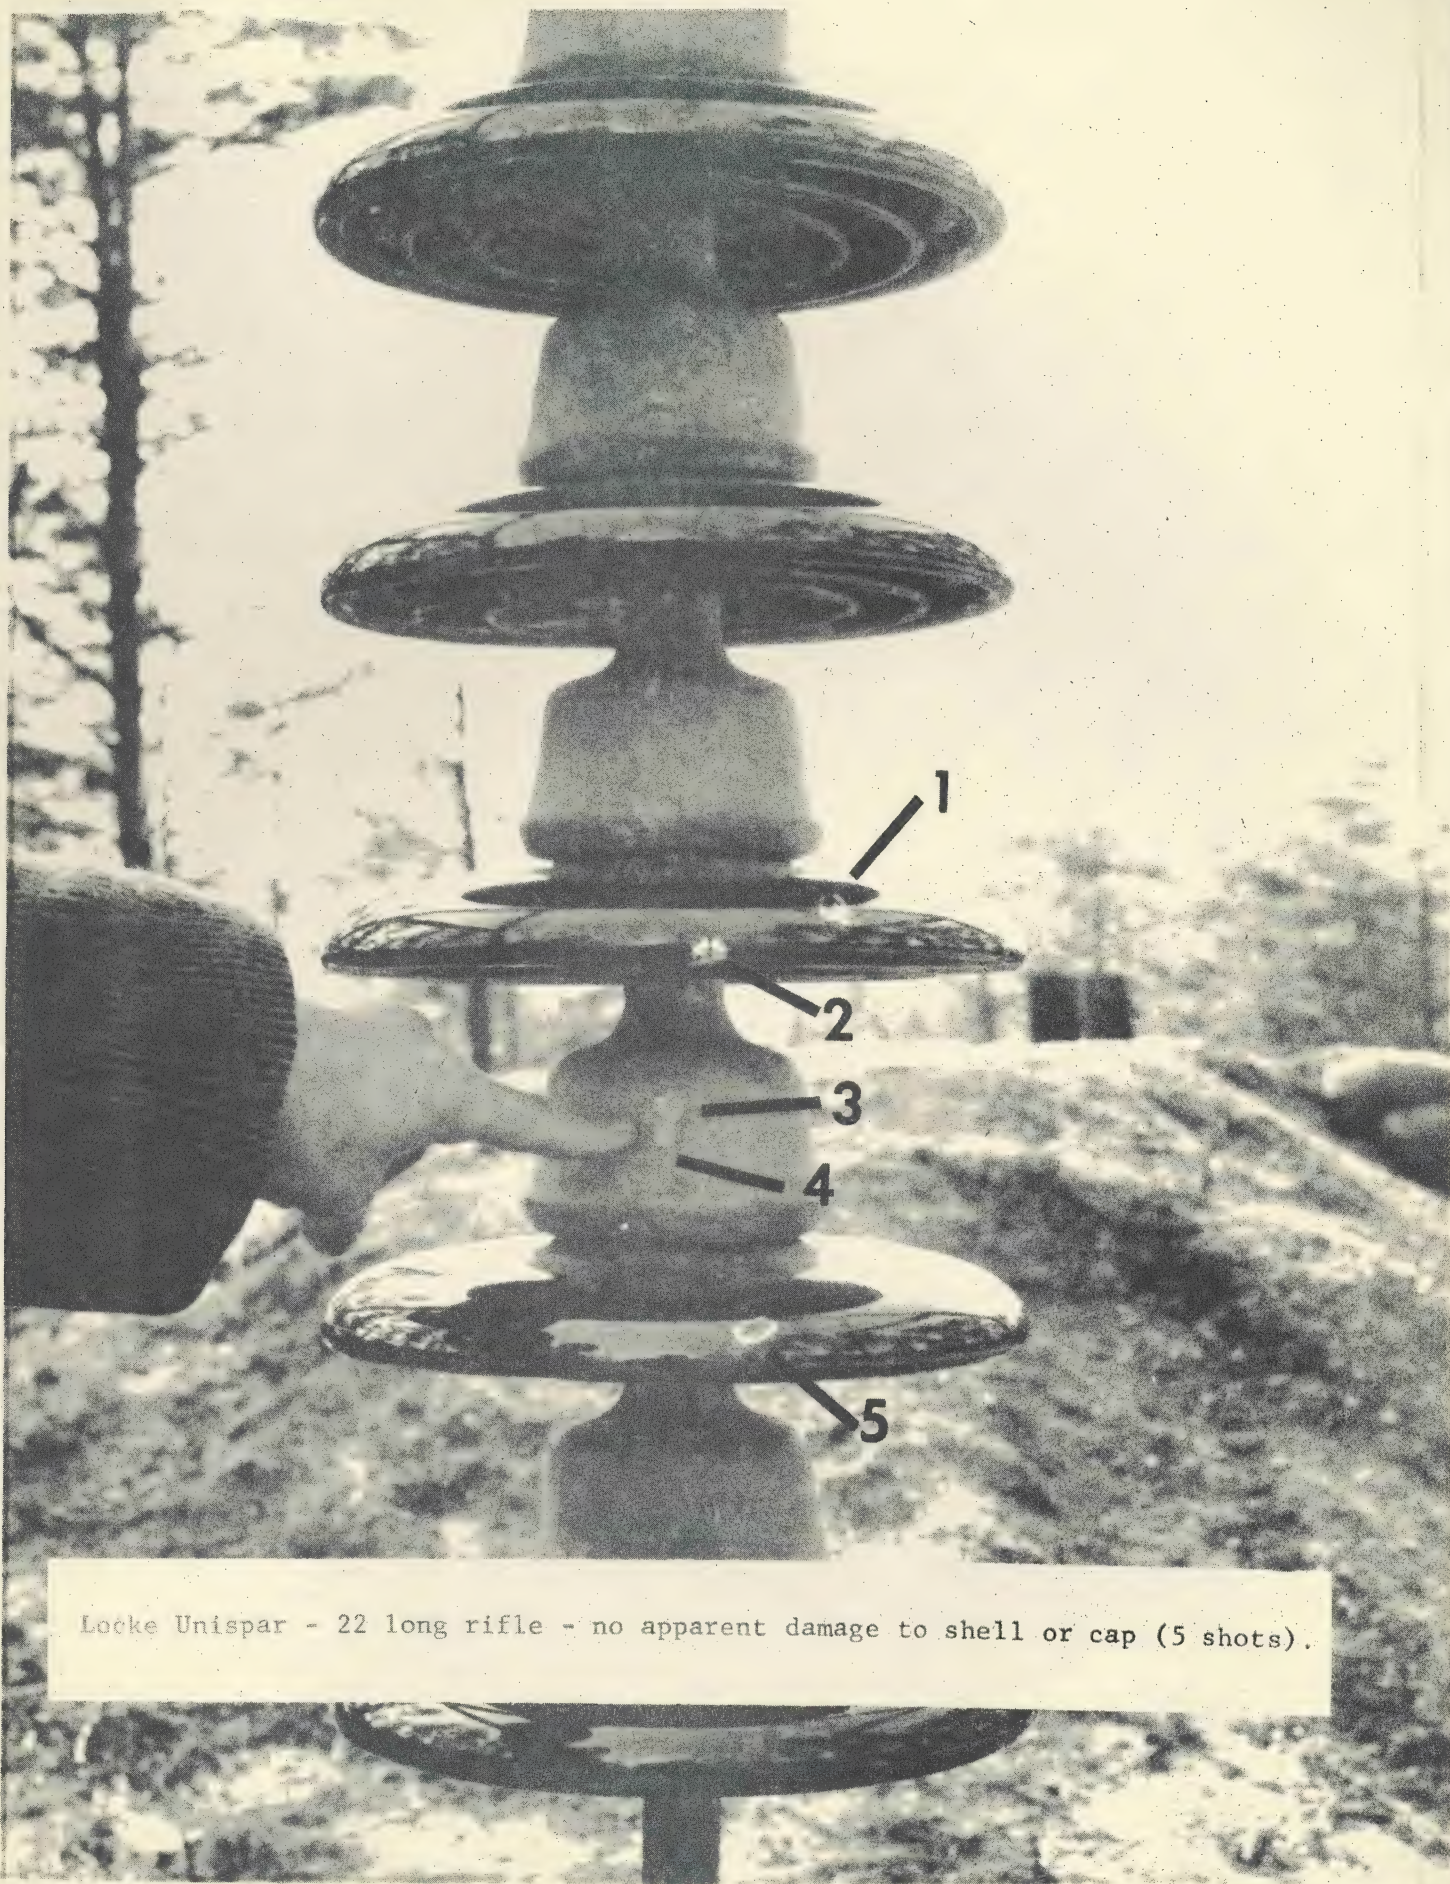
Locke Unispar - 22 long rifle - no apparent damage to shell or cap (5 shots).

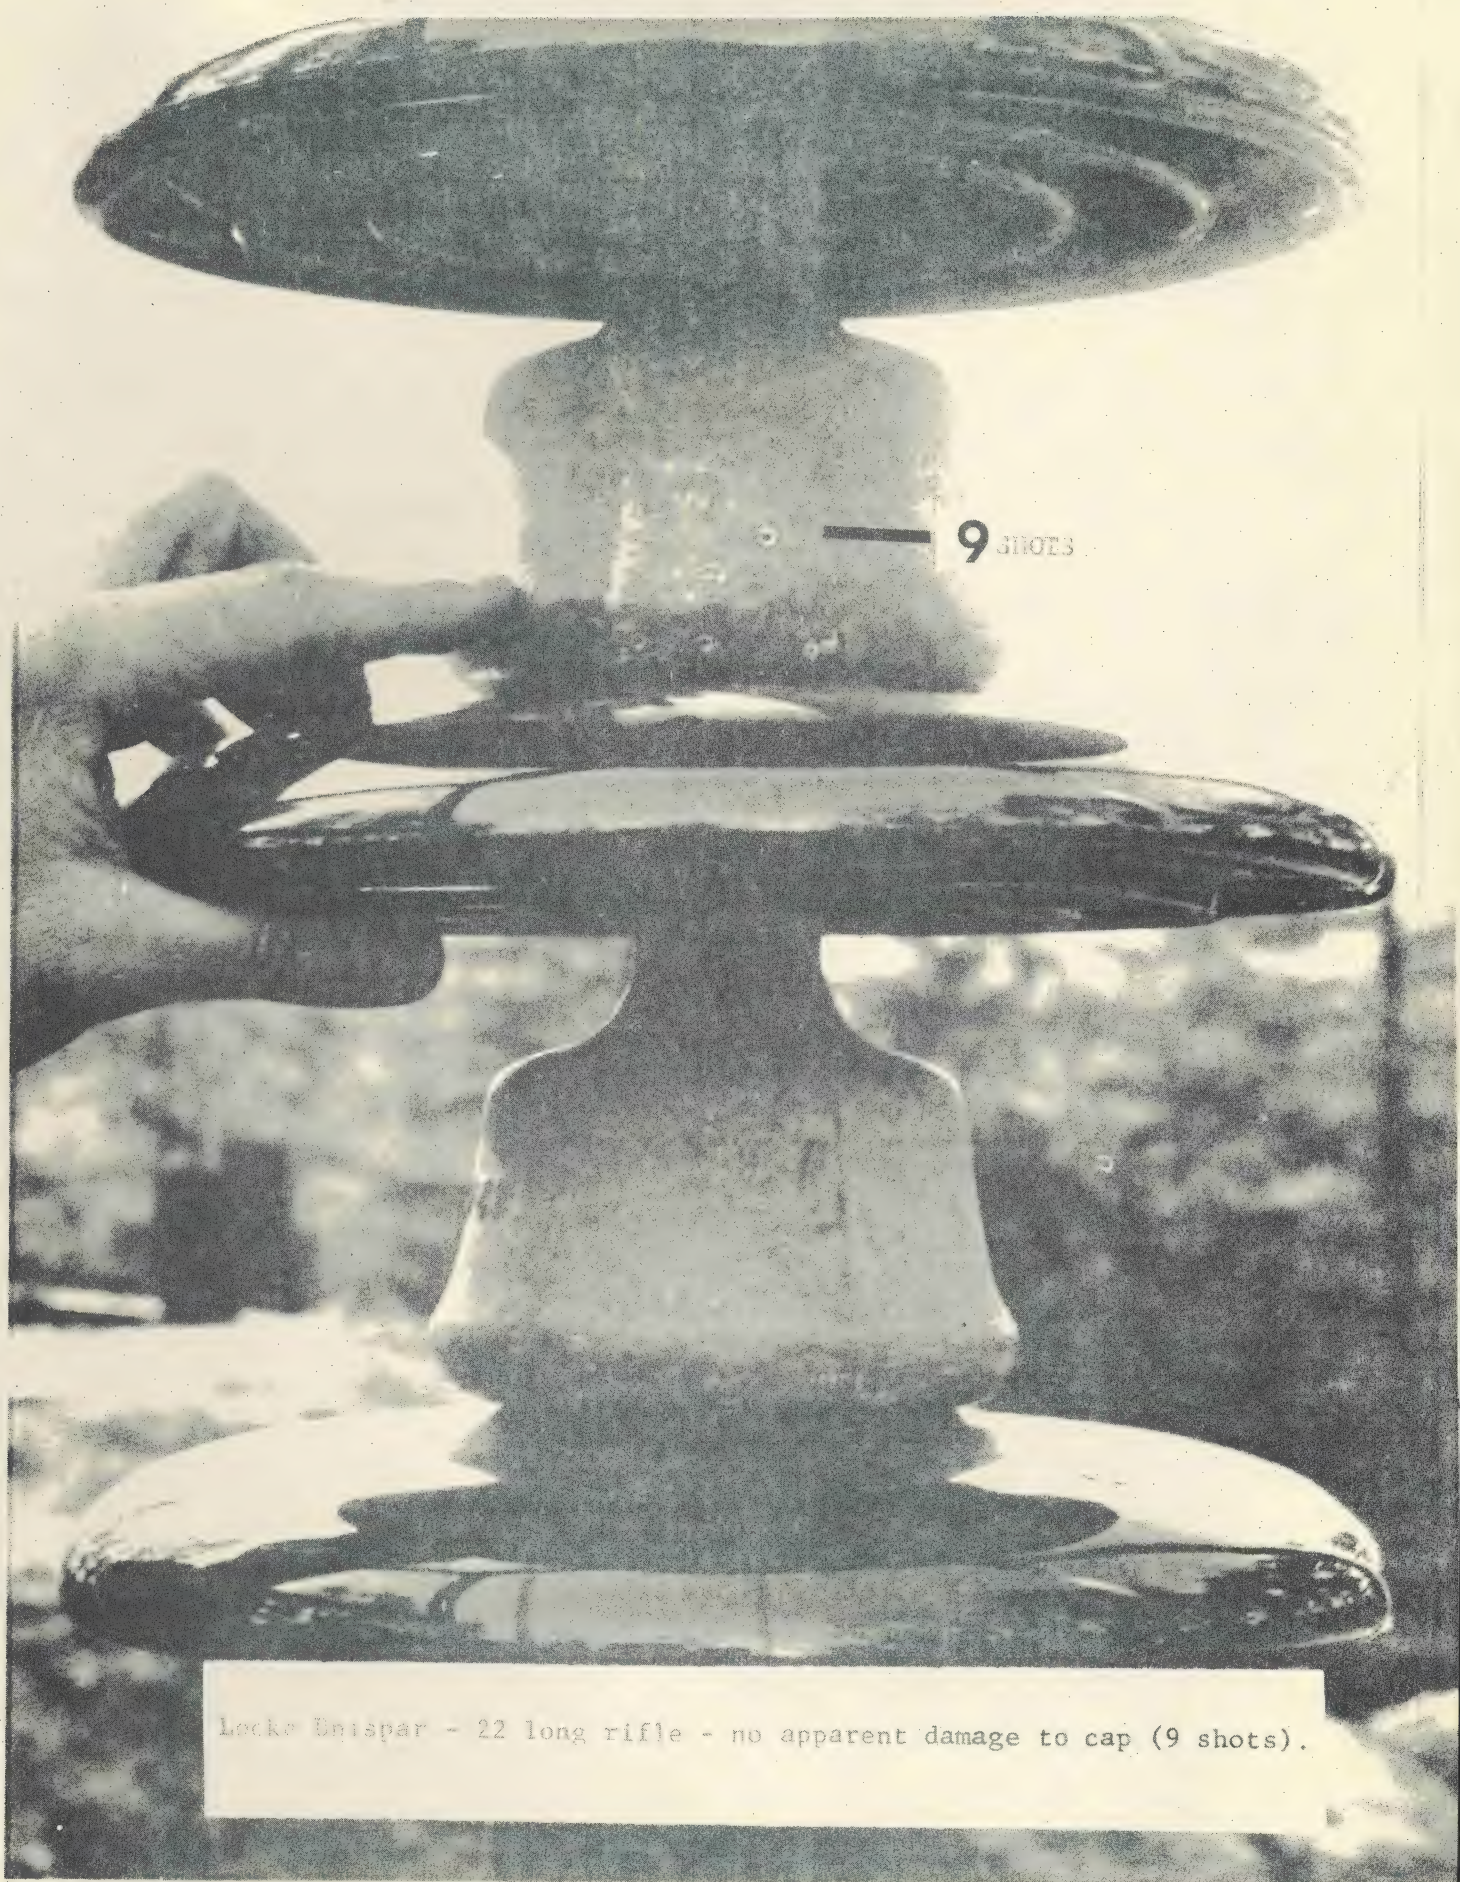
Locke Boissar - 22 long rifle - no apparent damage to cap (9 shots).

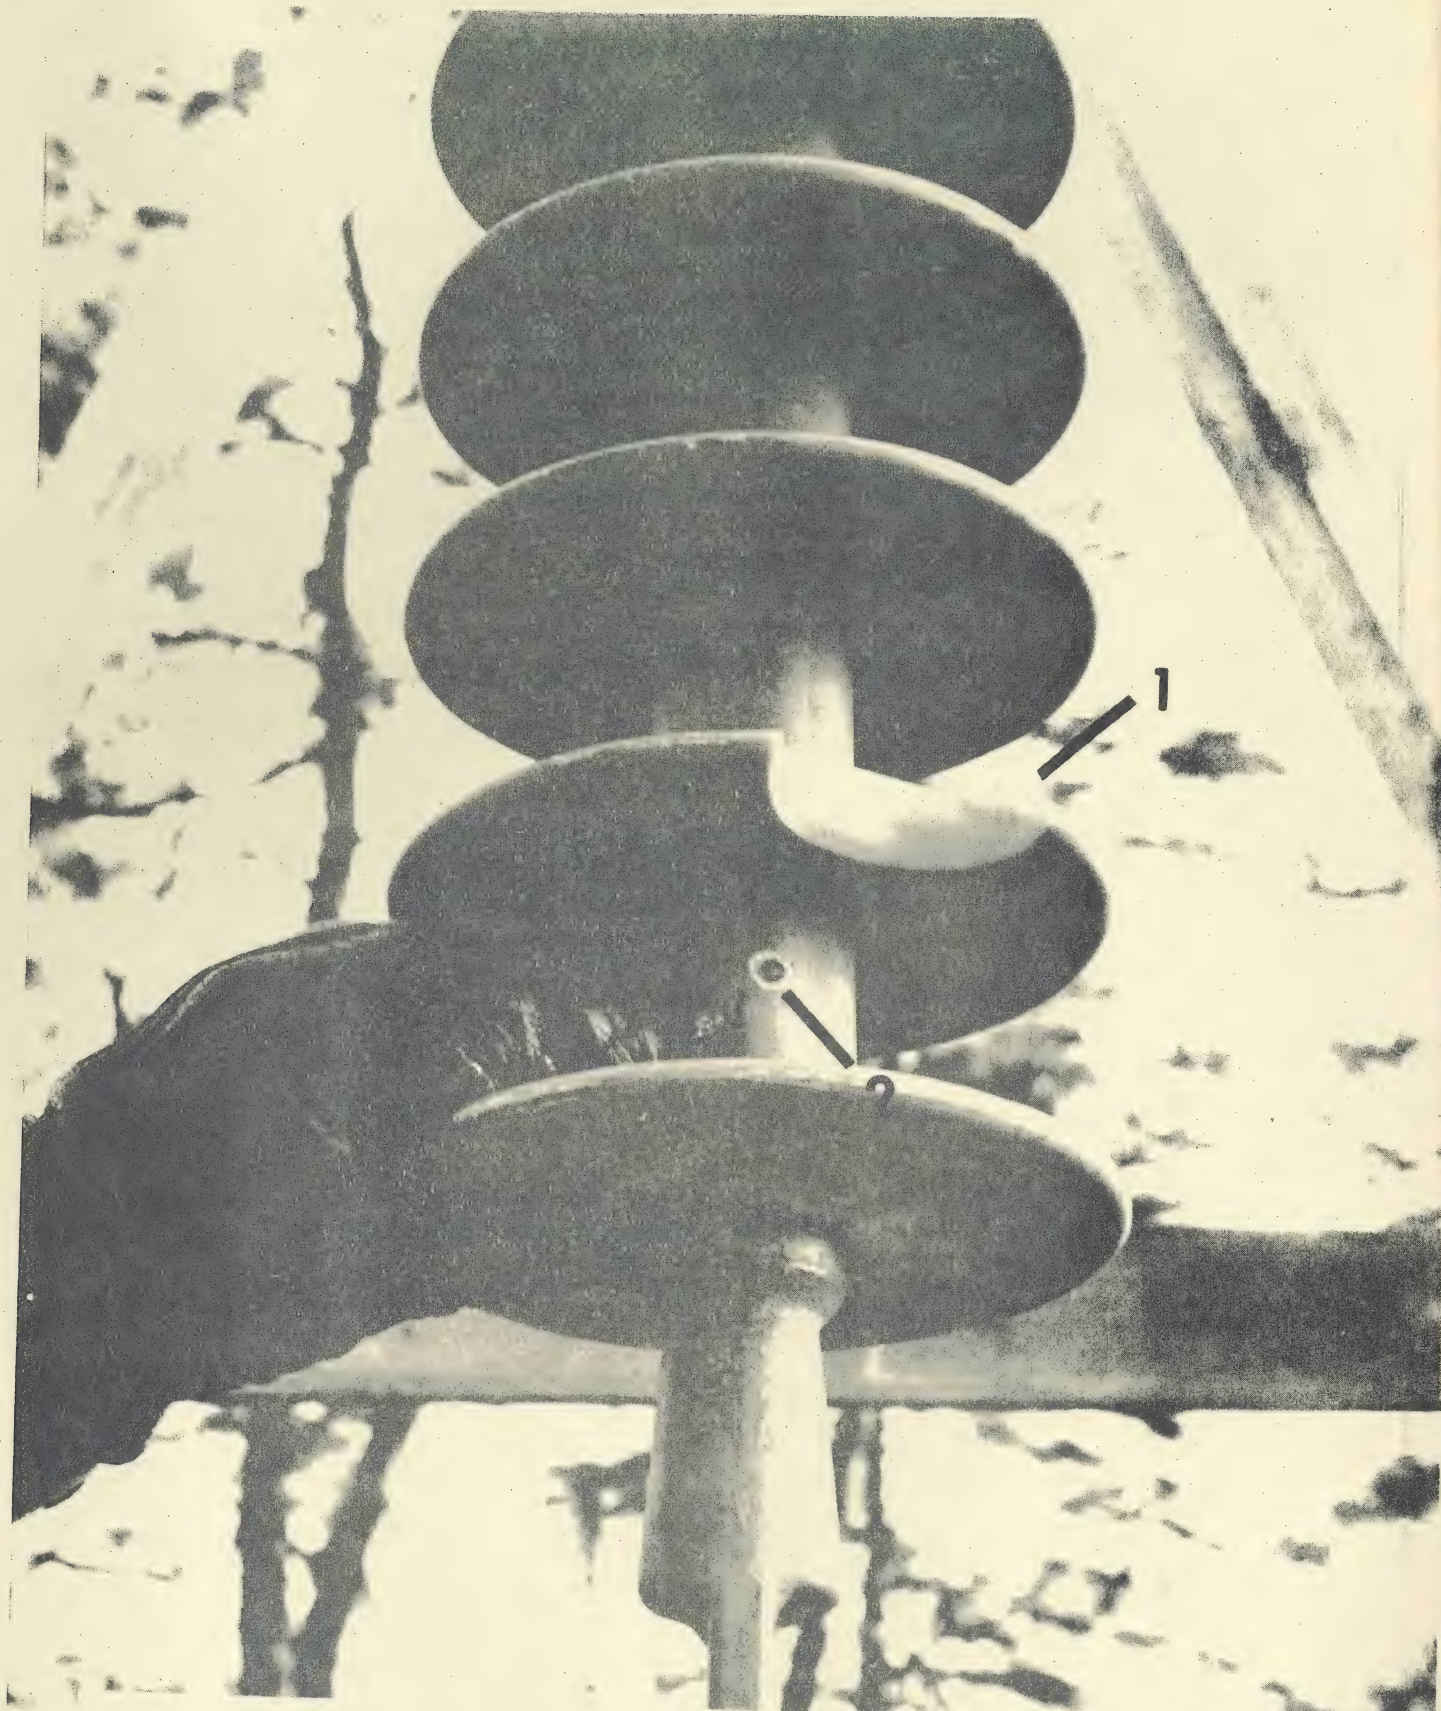
Locke Polymer - 22 long rifle - broke hood - no apparent damage to center column (2 shots).

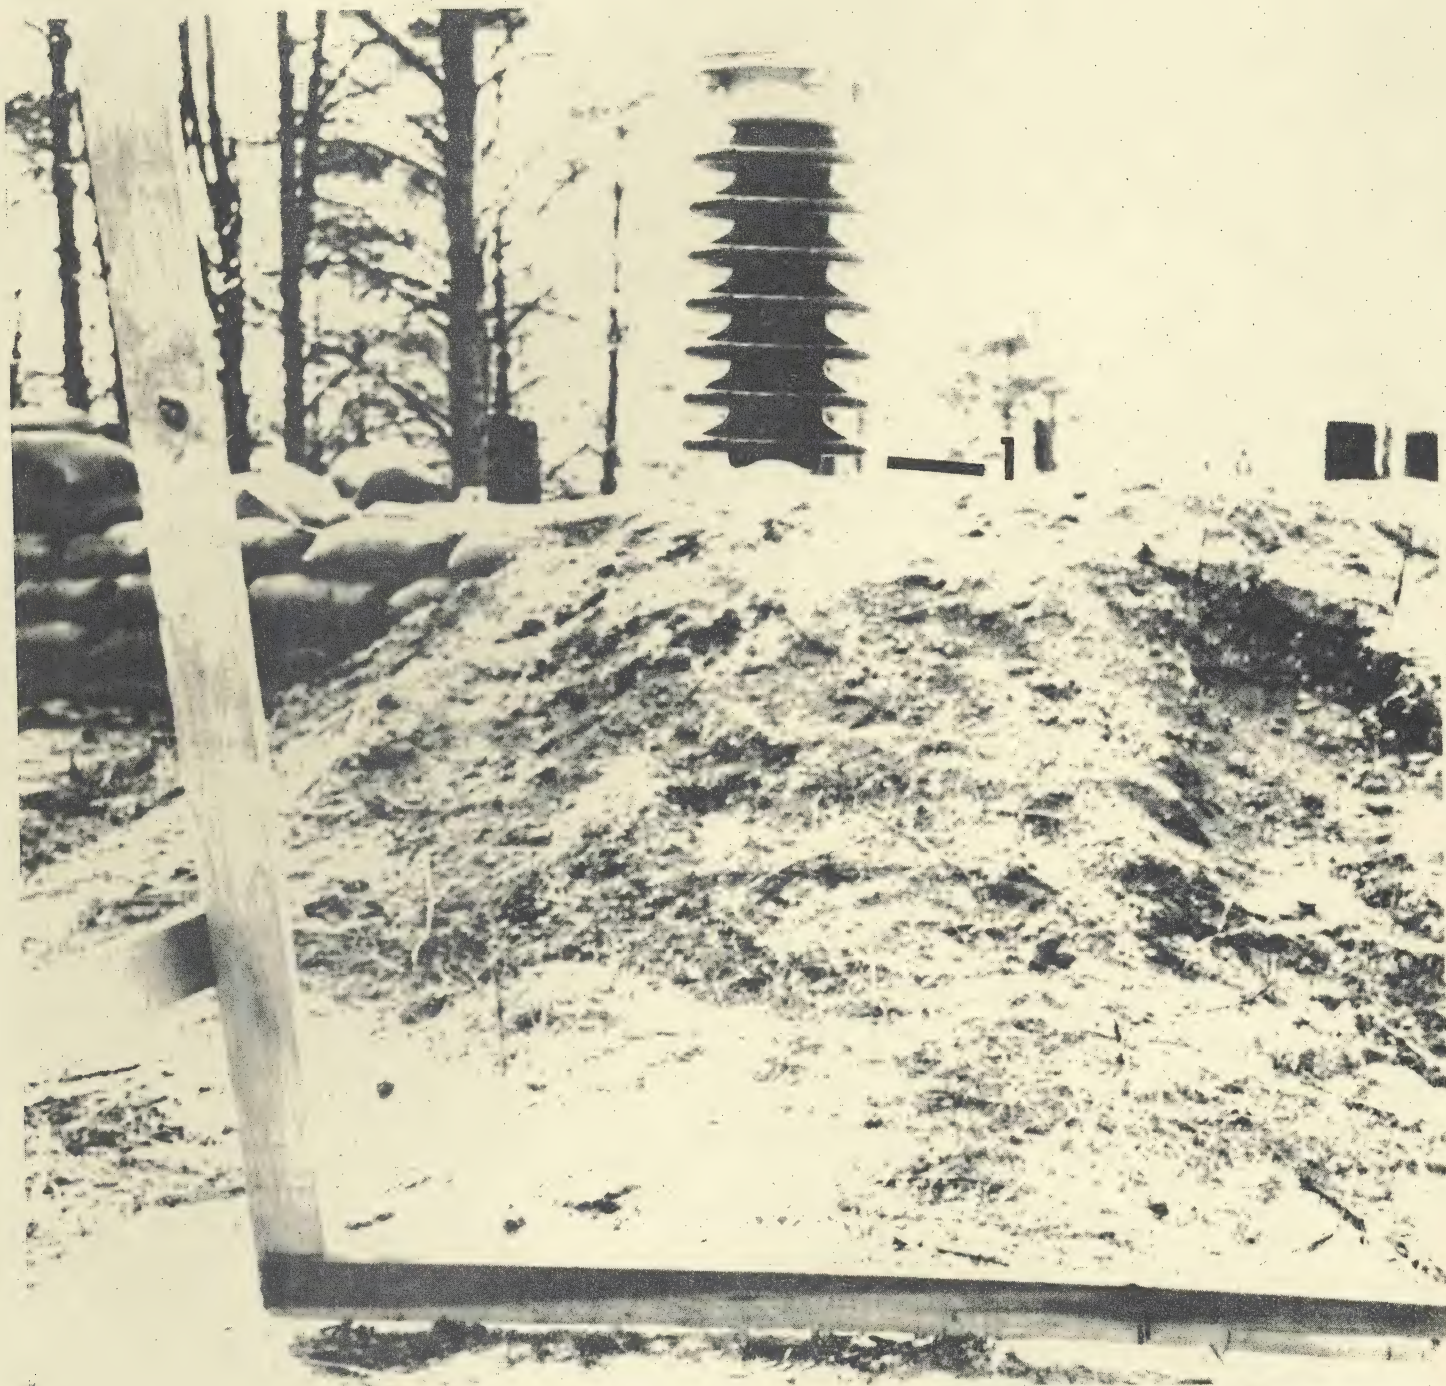
Lapp Strut - 45 cal. pistol - broke bottom insulator (1 shot).

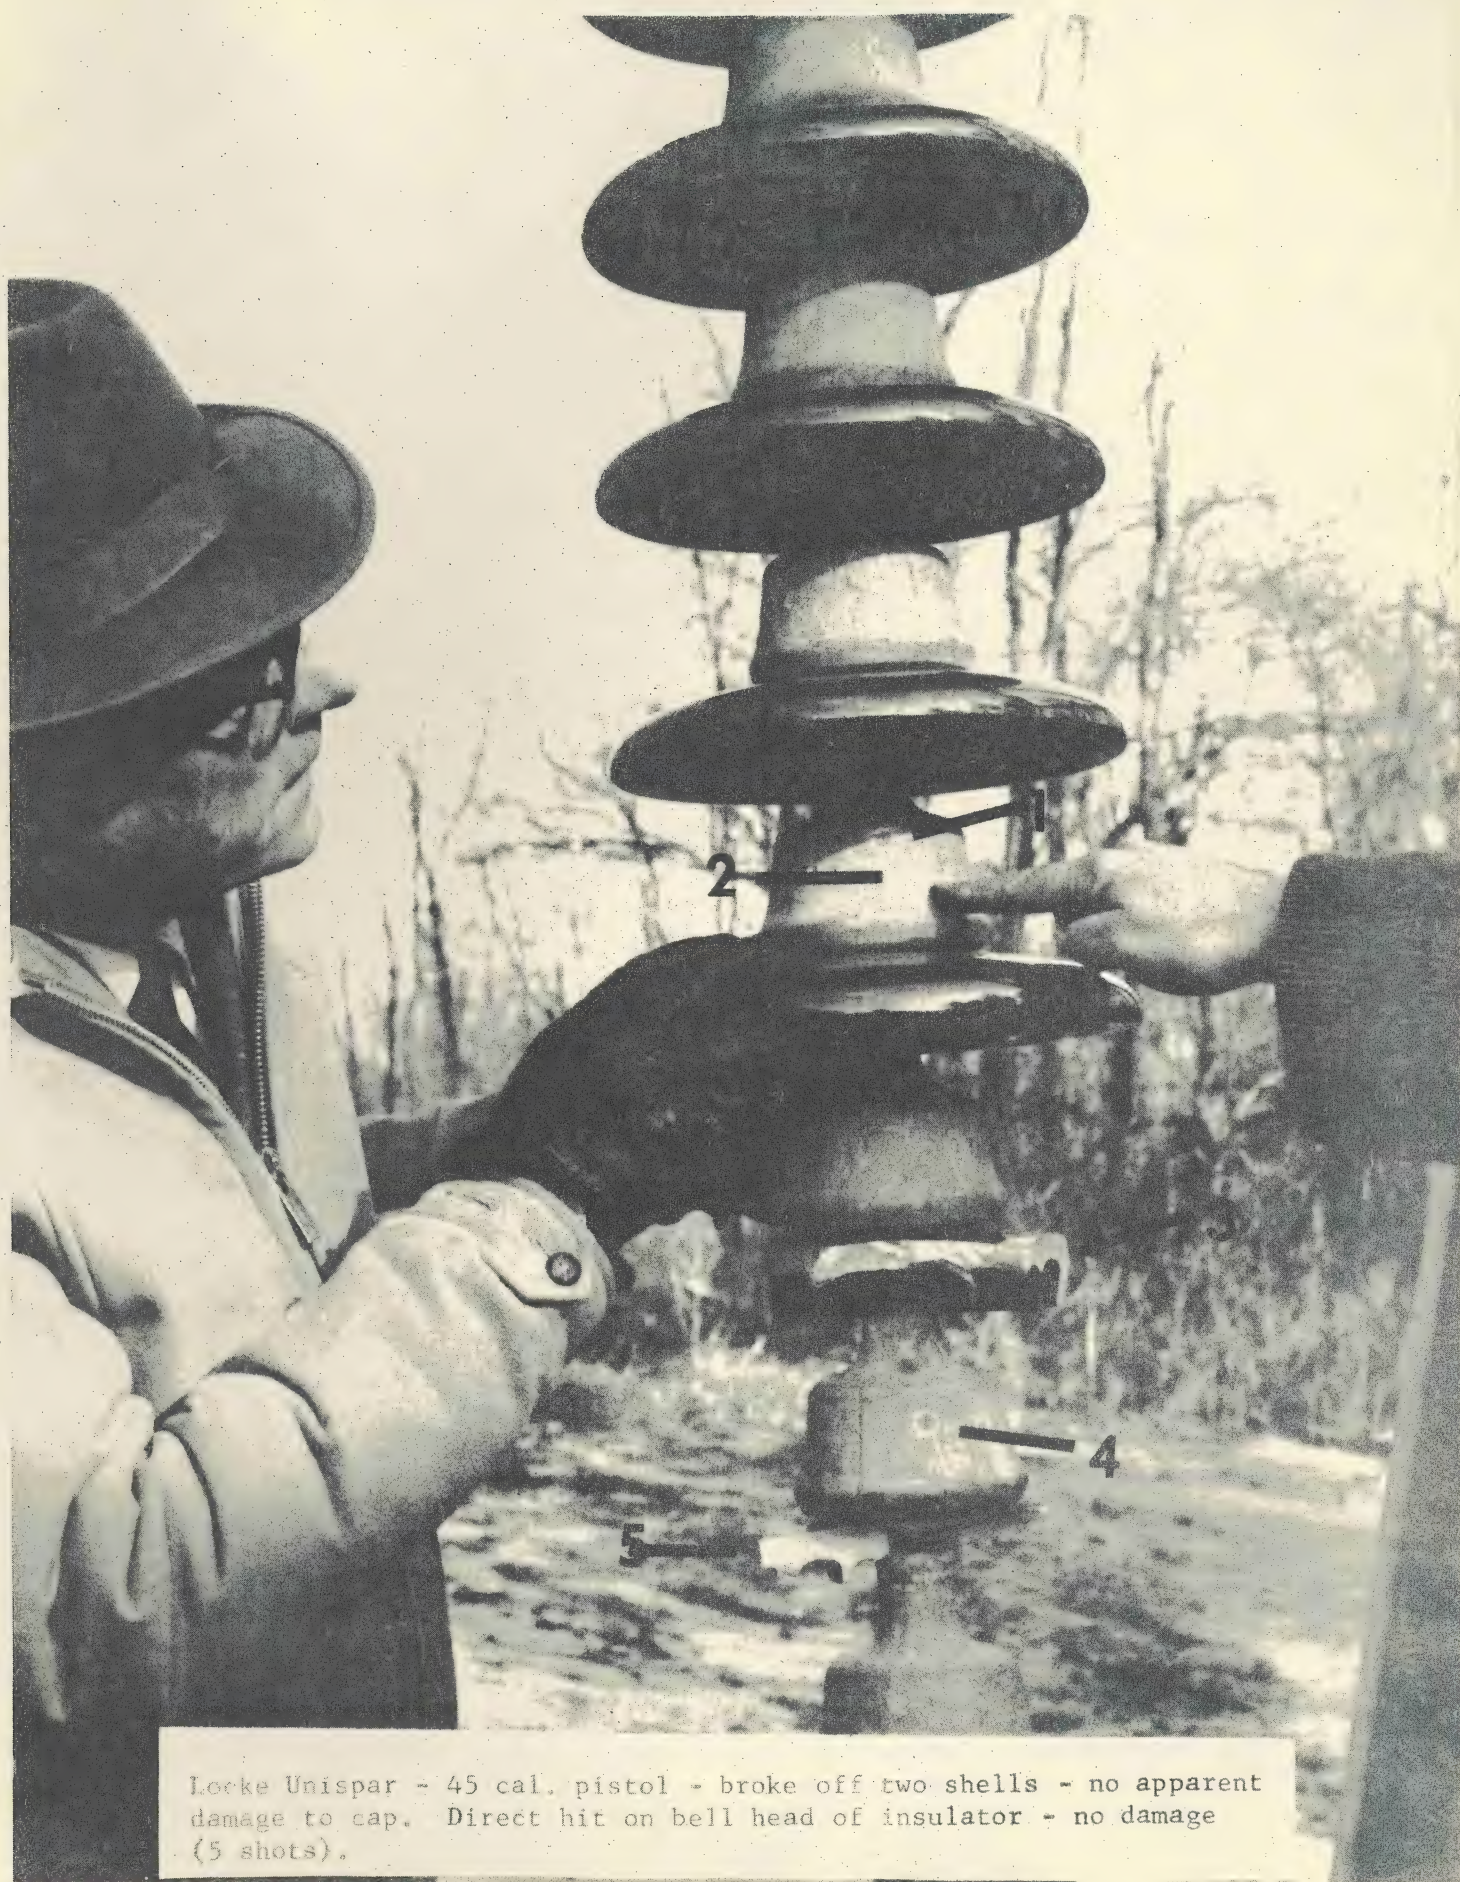
Locke Unispar - 45 cal. pistol - broke off two shells - no apparent damage to cap. Direct hit on bell head of insulator - no damage (5 shots).

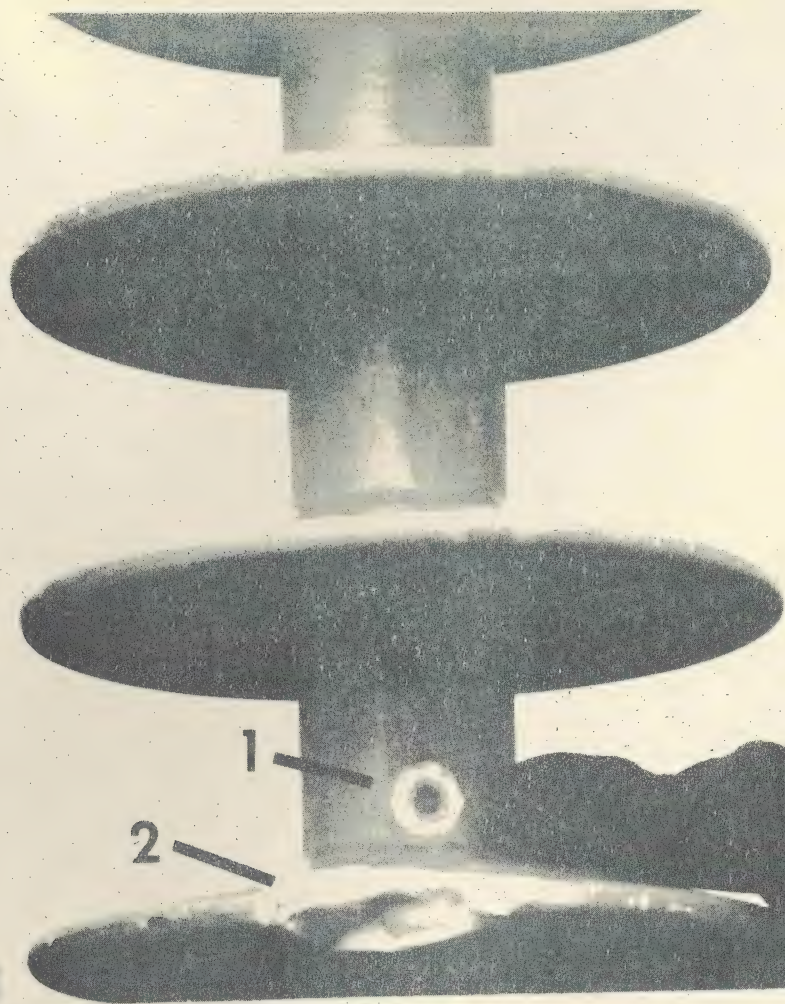
Locke Polymer - 45 cal. pistol - broke hood - no apparent damage to center column (2 shots).

In this test, it took successive hits by the M-1 rifle on the same cap to finally break the Unispar insulator. Even this punishment failed to destroy the integrity of the Polymer unit.

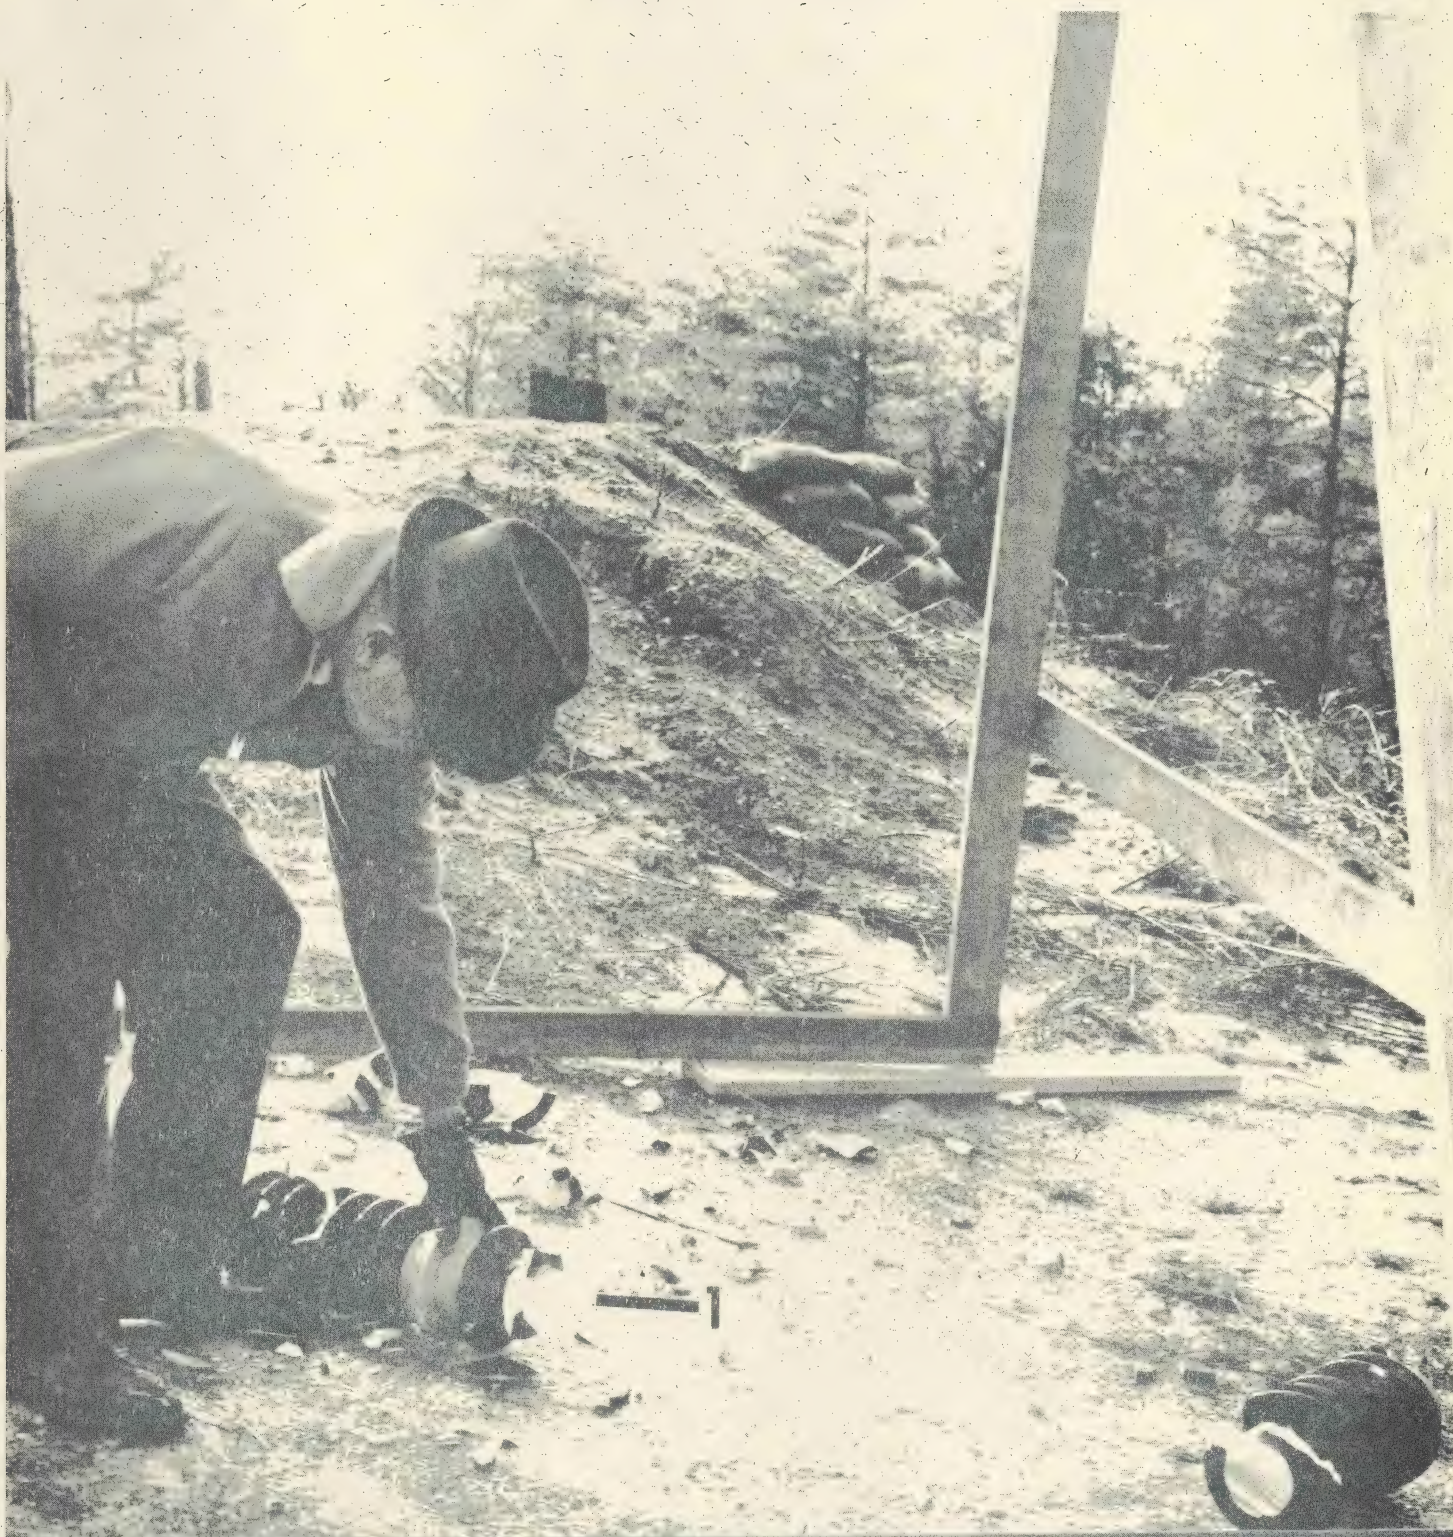
Lapp Strut - 308 Magnum - broke remaining section into several parts (1 shot)

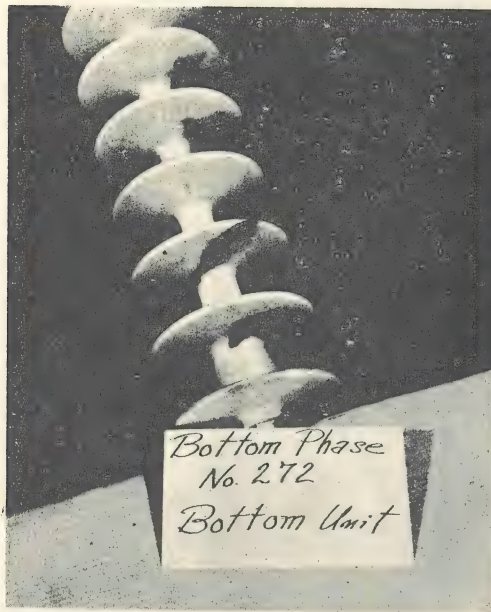
Fig. 1. Insulator returned from Jersey Central Power and Light Co. damaged by leakage currents.

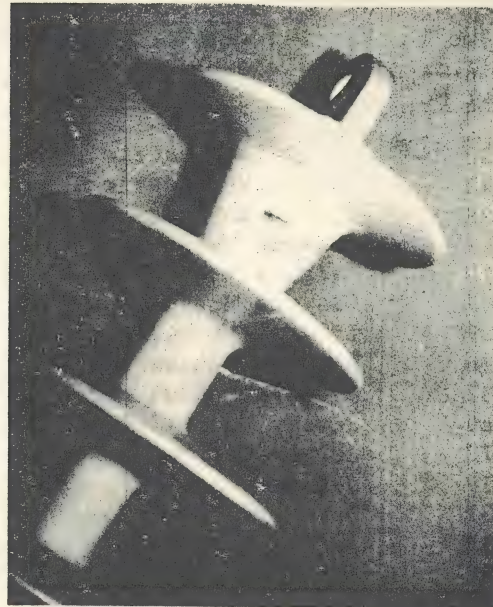
Fig. 2. Insulator returned from Indiana & Michigan Electric Co. damaged by leakage currents.

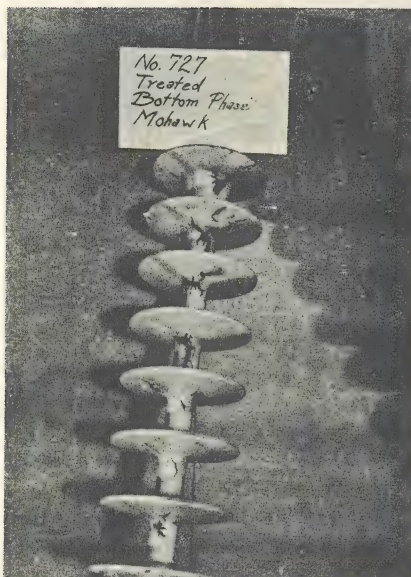
Fig. 3. Insulator returned from Niagara Mohawk Power Corp. having been in service with silicone grease coating damaged by leakage currents.

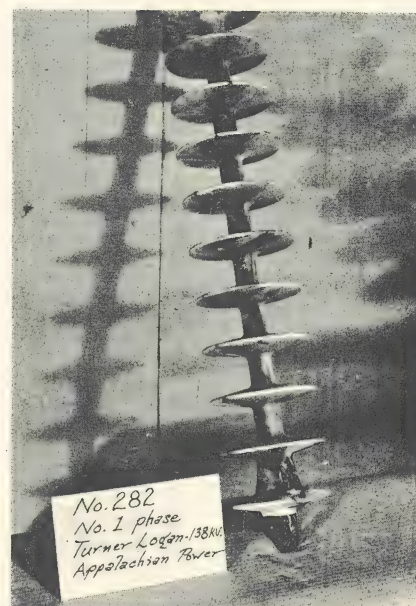
Fig. 4. Insulator returned from Appalachian Power Co. after flashover in service.

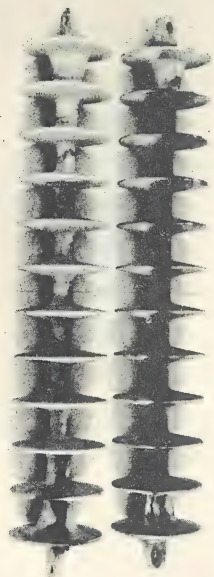
Fig. 5. Insulators returned from Tampa Electric Co. contaminated in service with heavy coating of phosphate and burned by leakage currents.

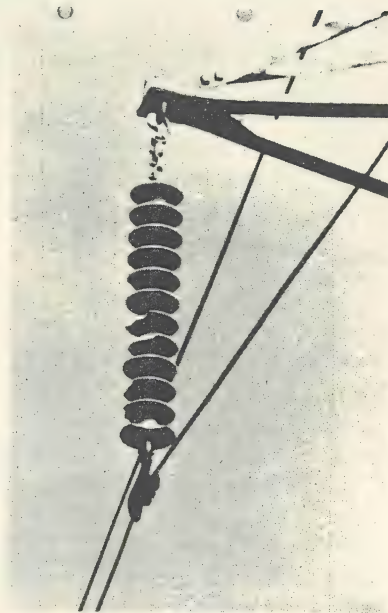
Fig. 6. Insulator on Boston Edison Co. system damaged by rifle fire.

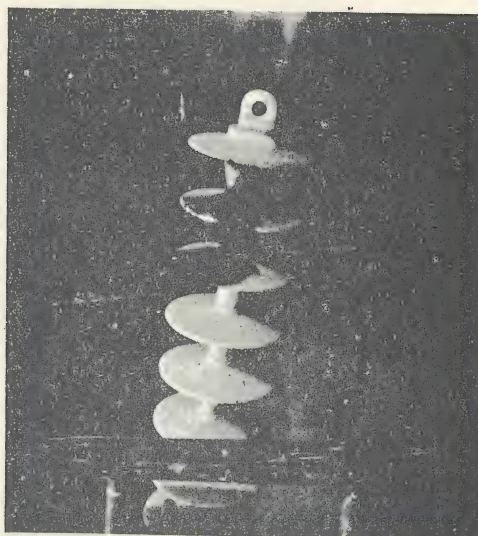
Fig. 7. Insulator damaged in laboratory test by special burning test with leakage current.

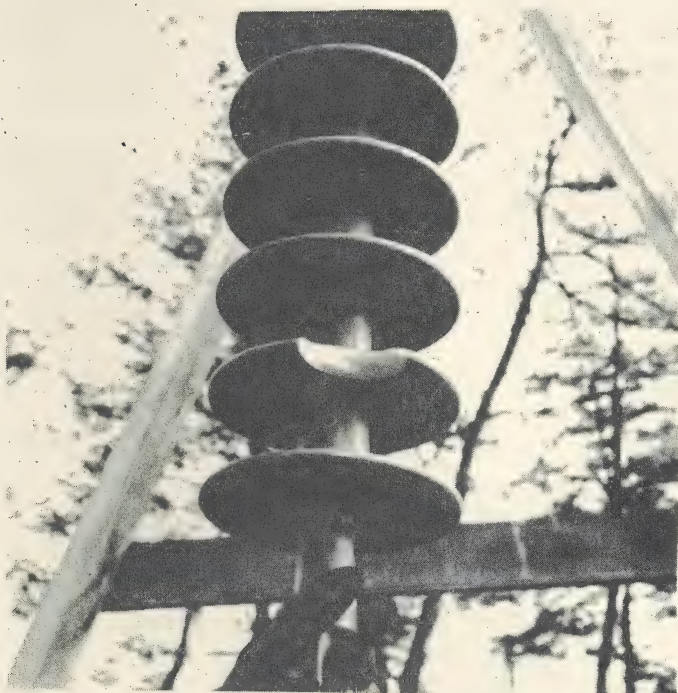
FIG. 3 --- .22 CALIBRE RIFLE DAMAGE

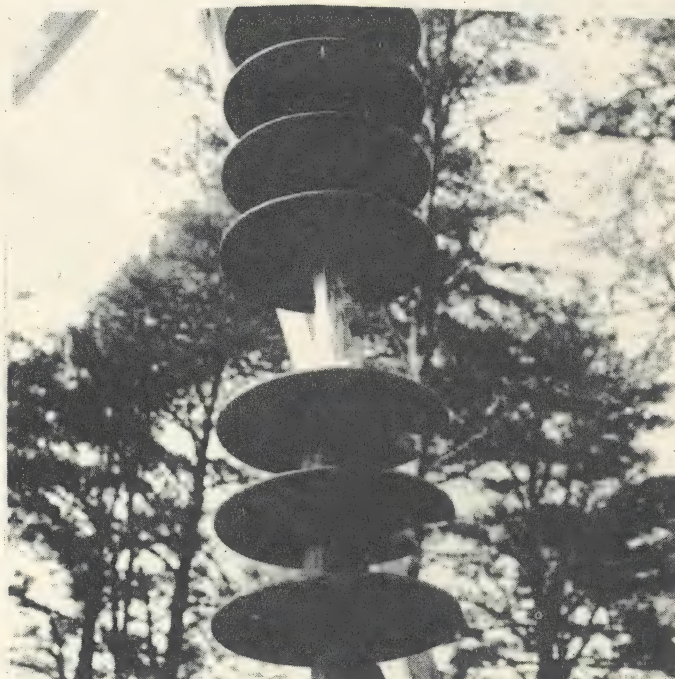
FIG. 4 --- .30/06 CALIBRE RIFLE DAMAGE

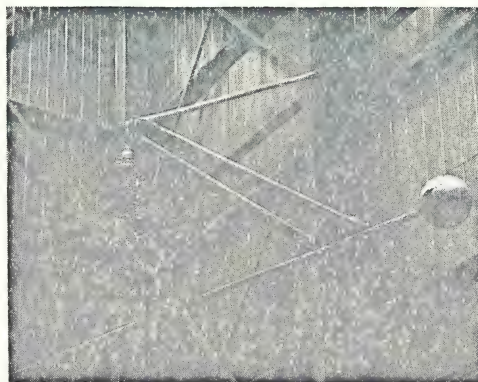
Fig. 1. Six-foot ECA crossarm with five suspension insulators. Electrical characteristics: 60-Hz flashover—714 kV dry, 431 kV wet. Impulse flashover—1174 kV positive, 1255 kV negative.

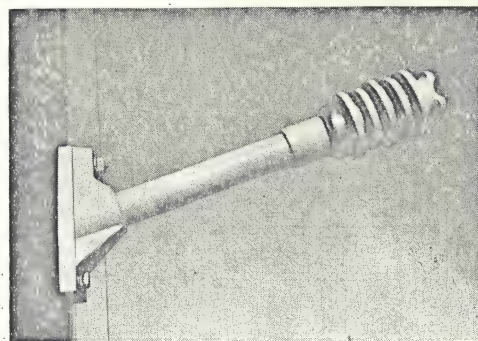
Fig. 4. ECA unit with suggested upper limit for application, at present, of 46 kV. See Fig. 8 for electrical characteristics.

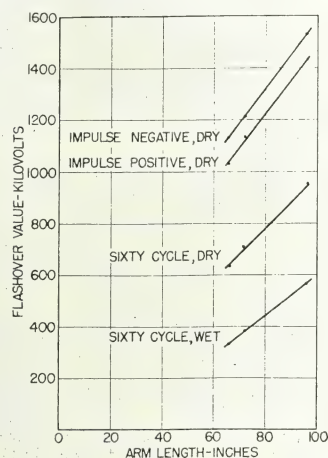
Fig. 5. Impulse and 60-Hz flashover values of several ECA crossarms. All tests conducted with five suspension insulators. Data corrected to standard atmospheric conditions.

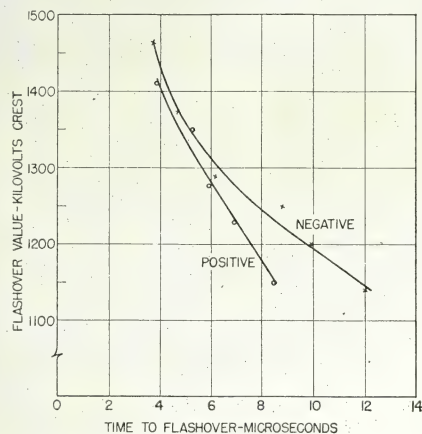
Fig. 6. Volt-time characteristic for 66-inch ECA crossarm with five suspension insulators. Data corrected to standard atmospheric conditions.

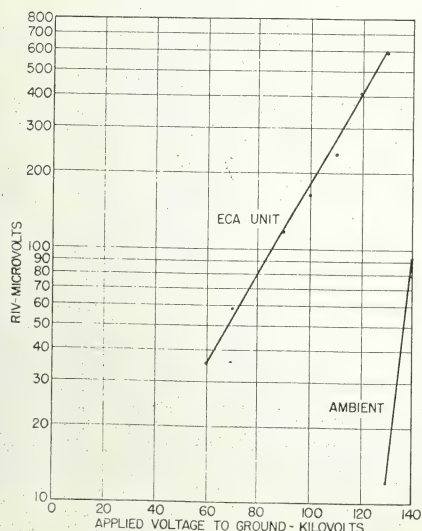
Fig. 7. Radio influence voltage characteristic of 72-inch ECA crossarm with five suspension insulators at 1000 kHz.

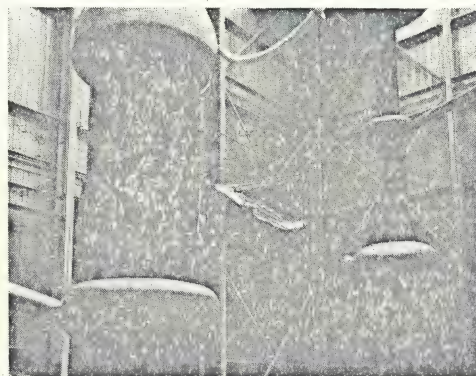
Fig. 8. (a) Impulse and 60-Hz flashover values for ECA units of type shown in Fig. 4. Data corrected to standard atmospheric conditions. (b) ECA crossarm undergoing 60-Hz flashover test.

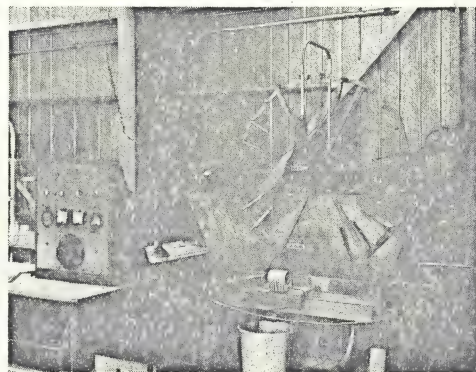
Fig. 9. Tracking wheel for study of relative tracking resistance of insulating materials.

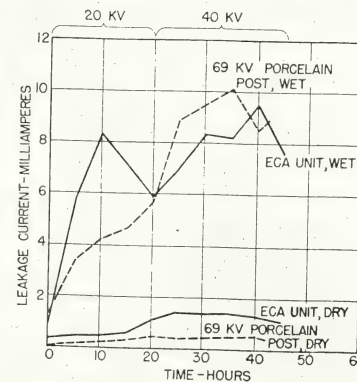
Fig. 10. Leakage current variation as a function of time during wet cycling tests for ECA of Fig. 4.

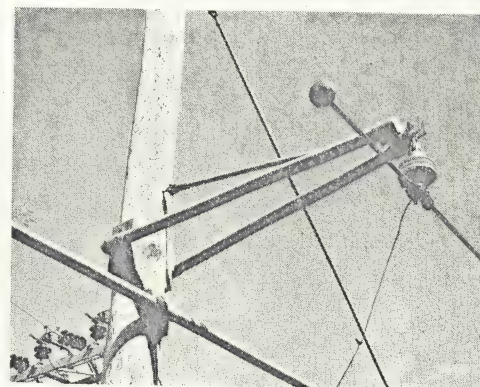
Fig. 11. Six-foot ECA crossarm with one 6-inch suspension insulator undergoing sustained 60-Hz test at 80 kV. Unit has been energized since November 1963.
