| Number | Title | Author | Company | Date |
|---|---|---|---|---|
| 1796-63-8 | BASIC TEXT OF PRESENTATION ON NEW POLYMER INSULATOR HIGH VOLTAGE TRANSMISSION LINES AT PRESS MEETING ON MAY 8, 19633 | Peltosalo, A.E. | Insulator Dept<br>Baltimore, MD<br>General Electric | 5/8/1963 |
| IEEE CP<br>63-1039 | A POLYMER INSULATOR FOR HIGH VOLTAGE TRANSMISSION LINES | Vose, FC<br>Nichols, FS | General Electric<br>Balto & Pittsfield | 3/26/1963 |
| IEEE CP<br>64-36 | SOME CHARACTERISTICS OF POLYMER INSULATORS FOR HIGH VOLTAGE TRANSMISSION LINES | Vose, Fred C. | GE-Insulator Dept<br>Baltimore, MD | 11/11/1963 |

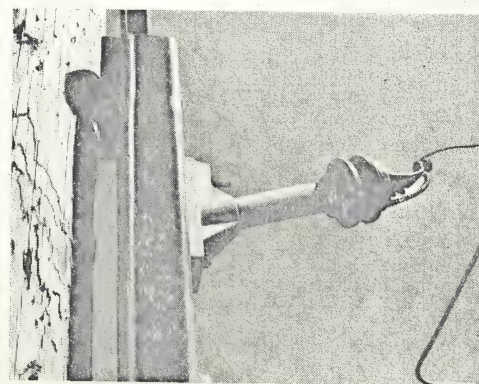
Fig. 12. ECA standoff designed for 15-kV distribution service, energized at 80 kV to ground since June 1965.

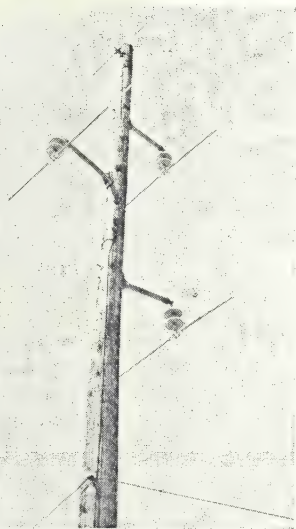
Fig. 16. Application of ECA suspension unit at 69 kV on new construction.

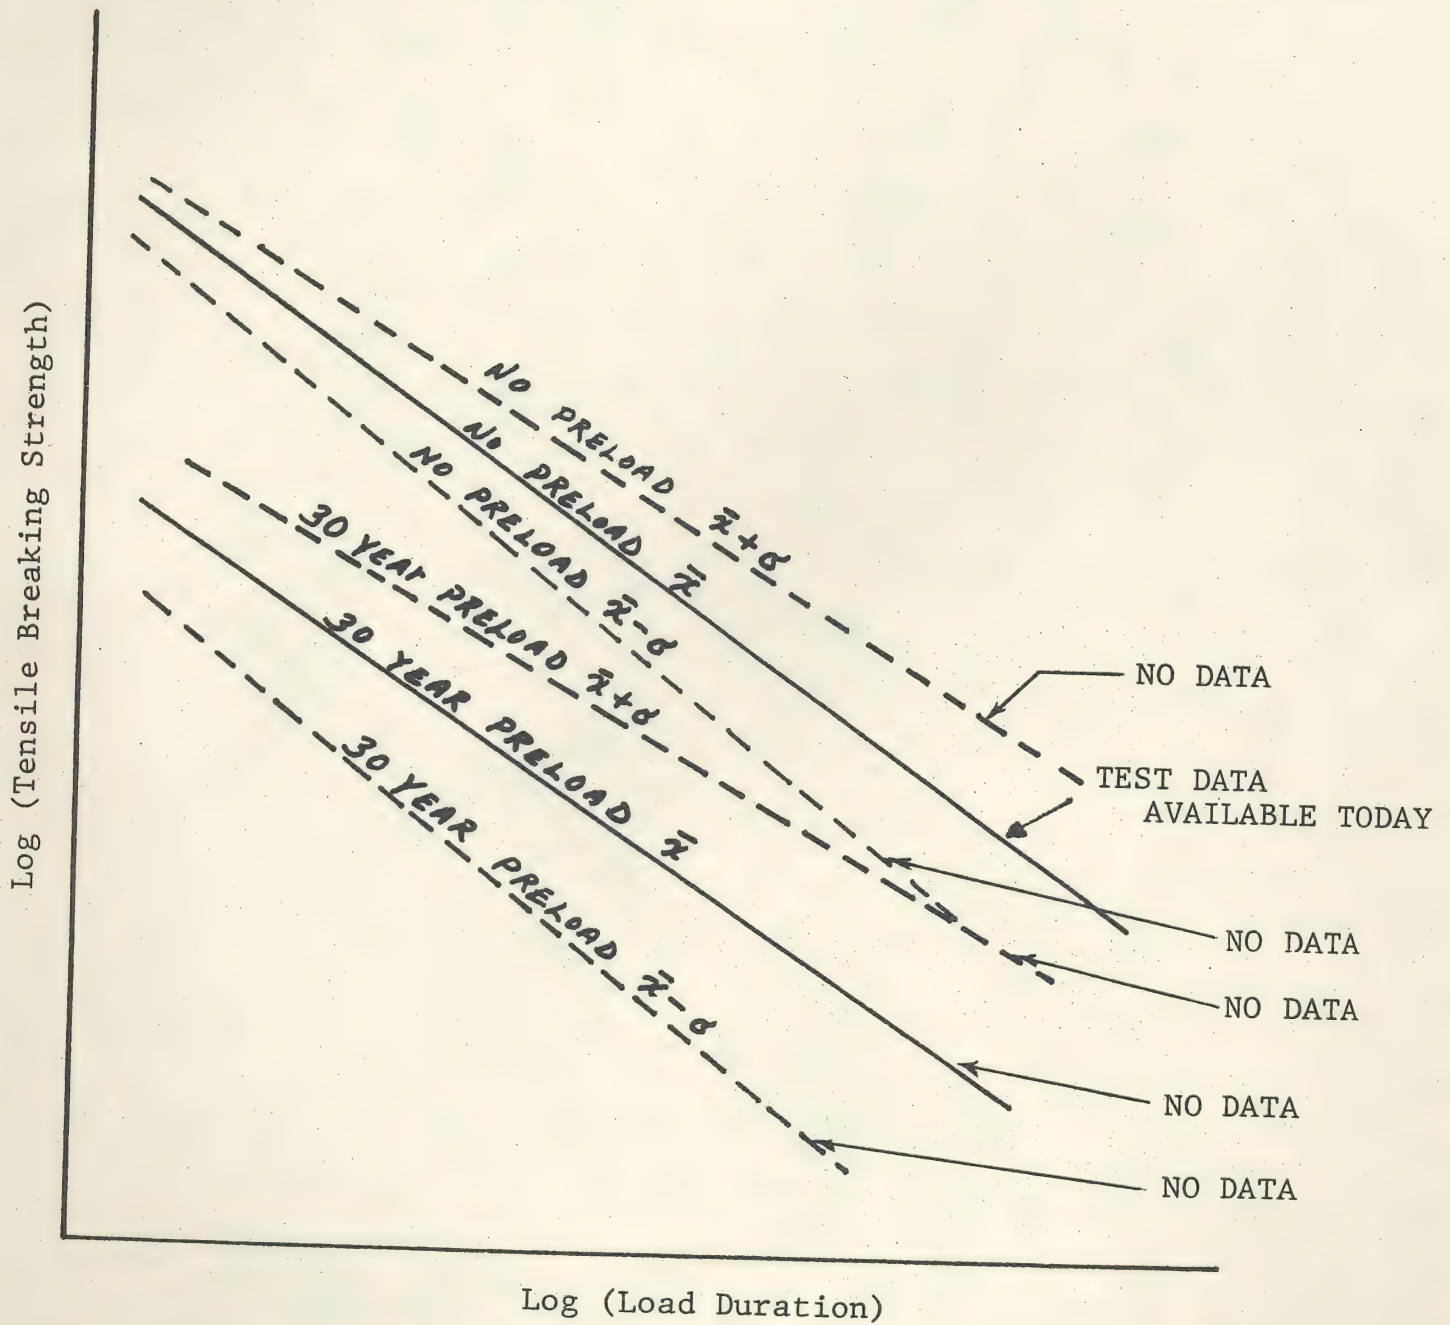
Figure 1. Hypothetical Load Duration - Strength Curves for Non-Ceramic Insulator

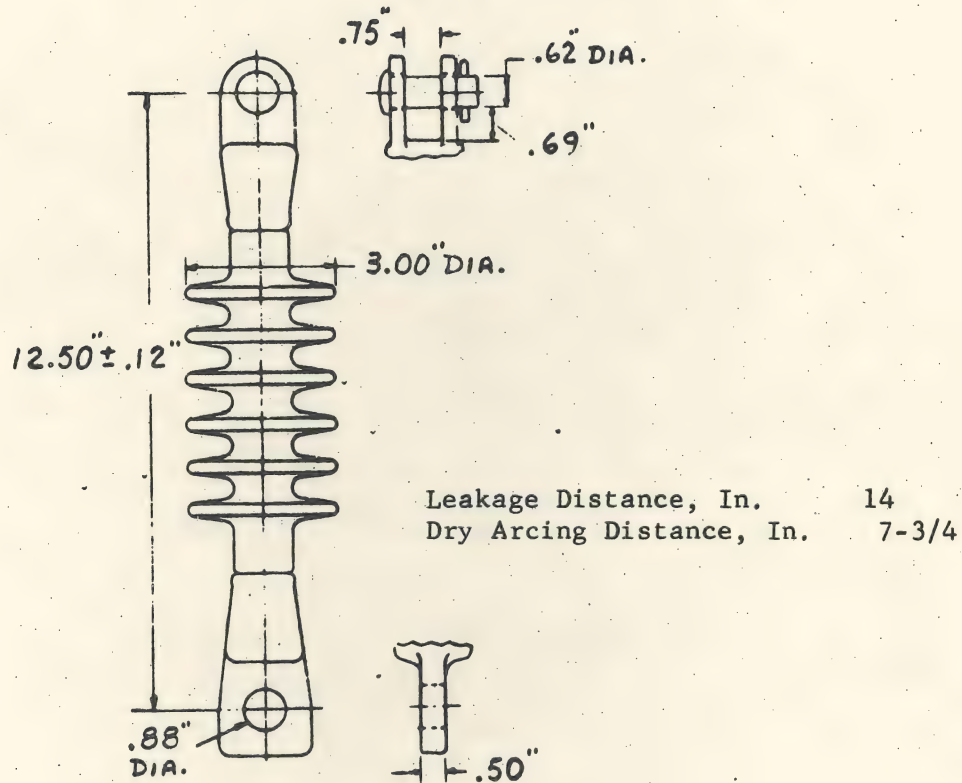
Figure 1 -- 15 KV GEPOL Insulator Dimensions

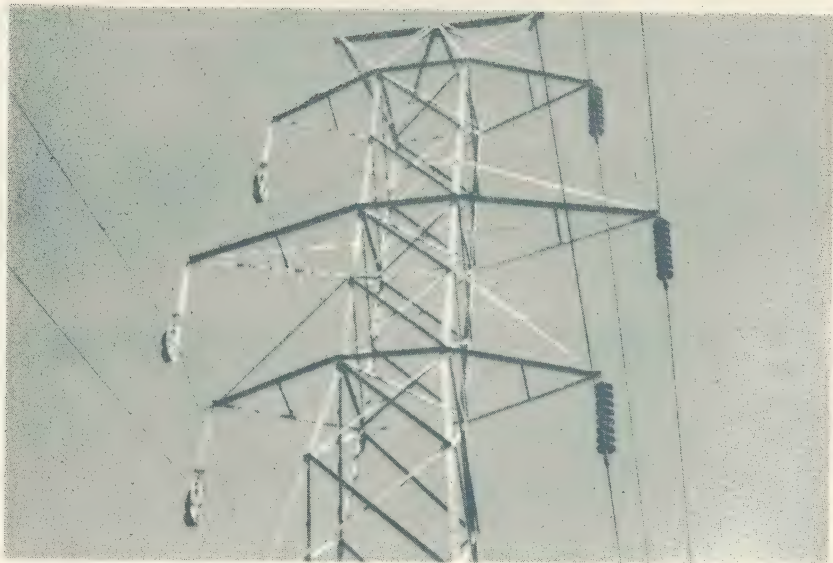
Figure 1. GEPOL and porcelain insulators on a 115 KV transmission line.

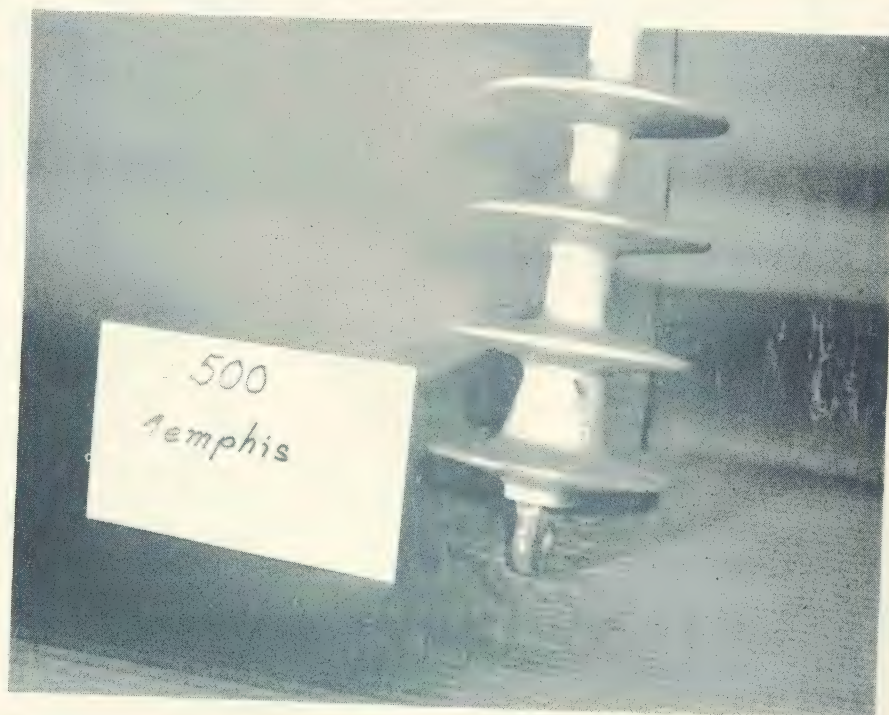
Figure 8. The 115 KV GEPOL insulator showing the initiating puncture failure through the sidewall.

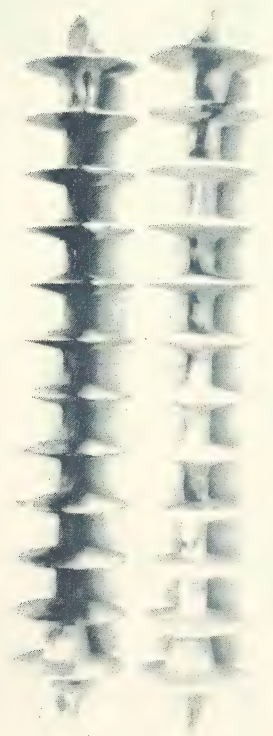
Figure 9. Extreme type of failure while in service in a highly contaminated coastal area.

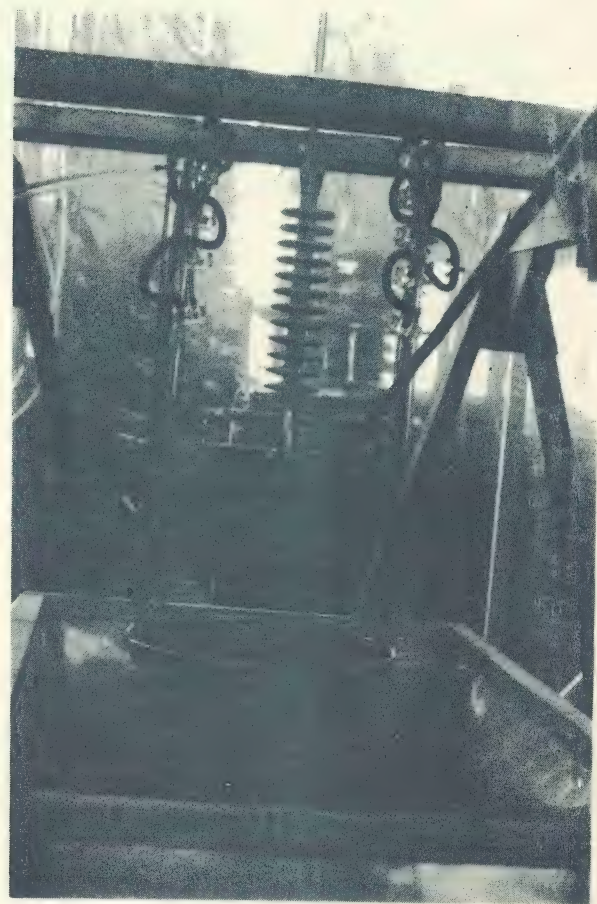
Figure 10. The salt-sugar spray test as run in the R&D Center on a 34 KV GEPOL insulator.

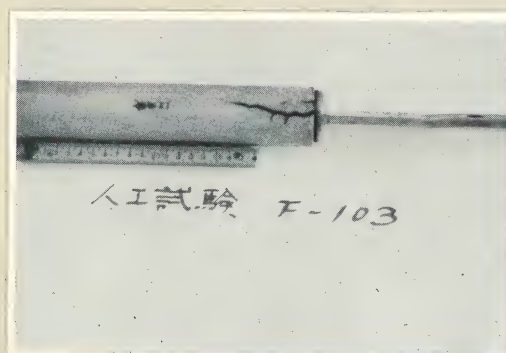
Fig.11. Tracking observed on No.6 specimen,  
cycloaliphatic epoxy resin, by water  
spraying leakage current test.

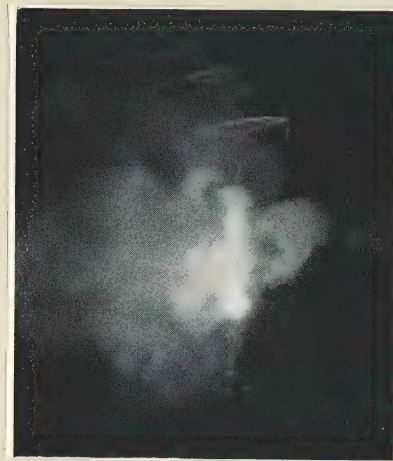
Fig. 13 shows arc withstand test view of outdoor resin long-rod insulators and the specimens after the power arc test using 4,000A x 30 cycles.

(a) Power arc test  
4,000 A x 30 cycles

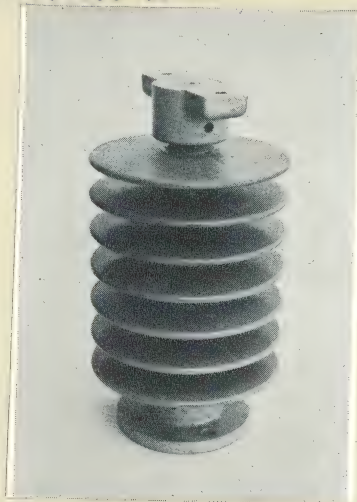
(2) Fig. 15 shows support insulator for tunnel use and Table 11 shows characteristics of it

Fig. 15. Support insulator for tunnel use

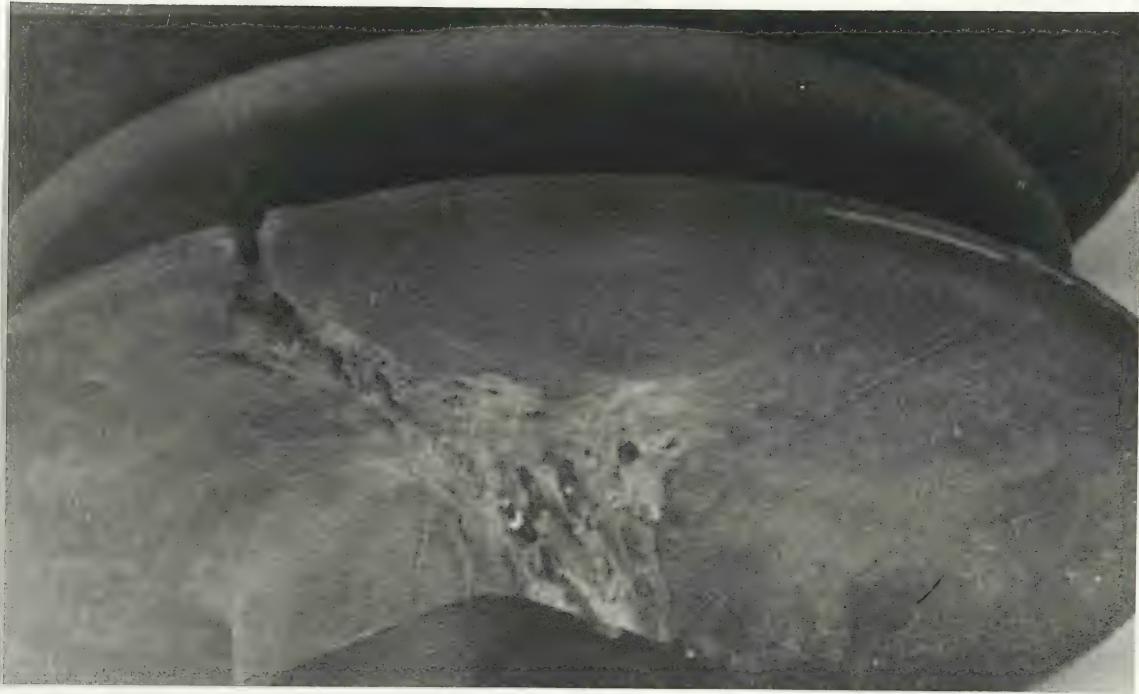
After about 5 years the bottom insulator in the chain failed at the hot end. The damage caused can be seen in Fig. 2

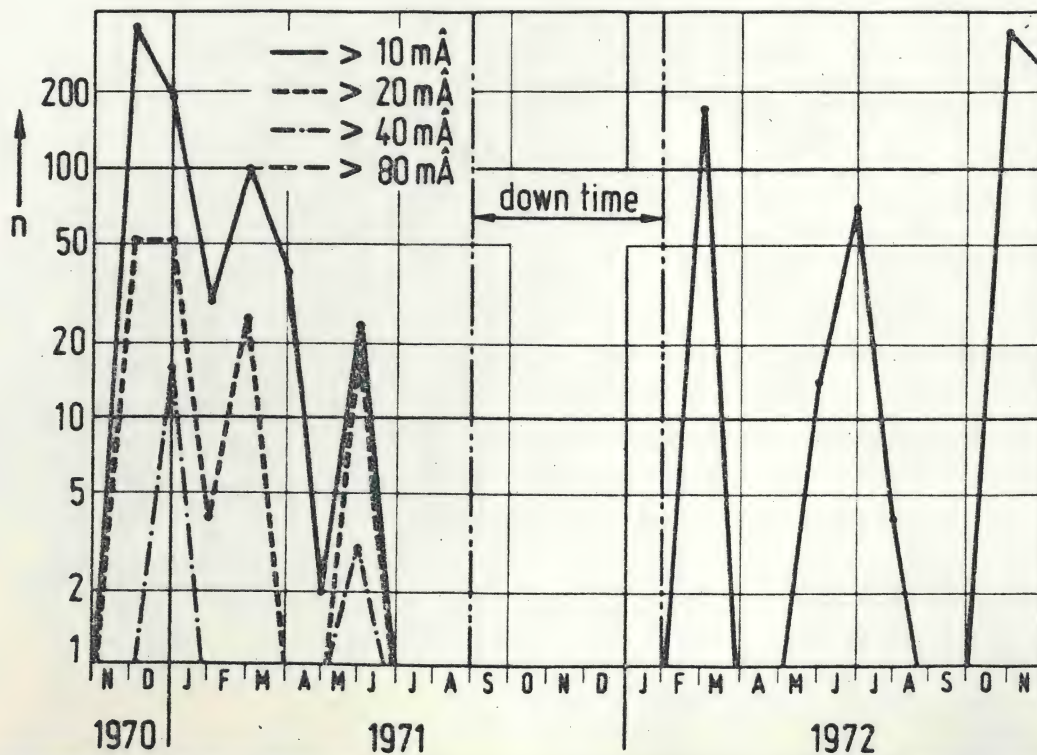
Fig. 3 shows the record of leakage current pulses on a 220-kV-chain of another insulator type.

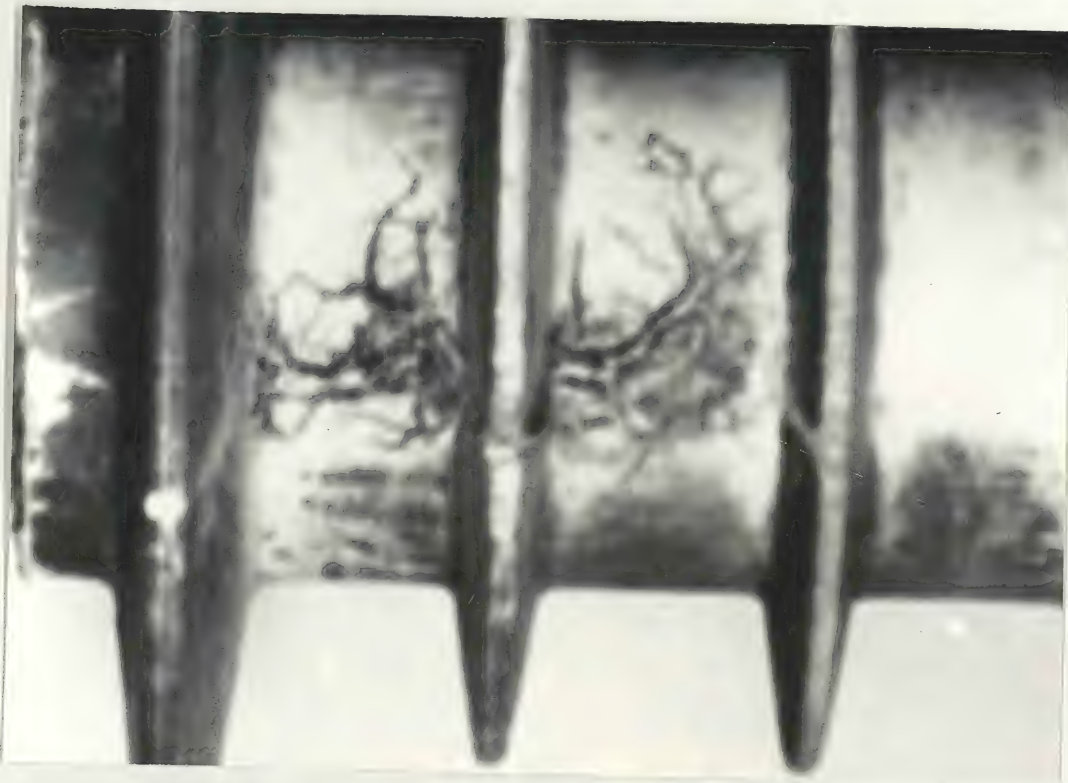
Fig. 4 shows as an example tracking occurred on a 20-kV-post-insulator which did not pass the test.

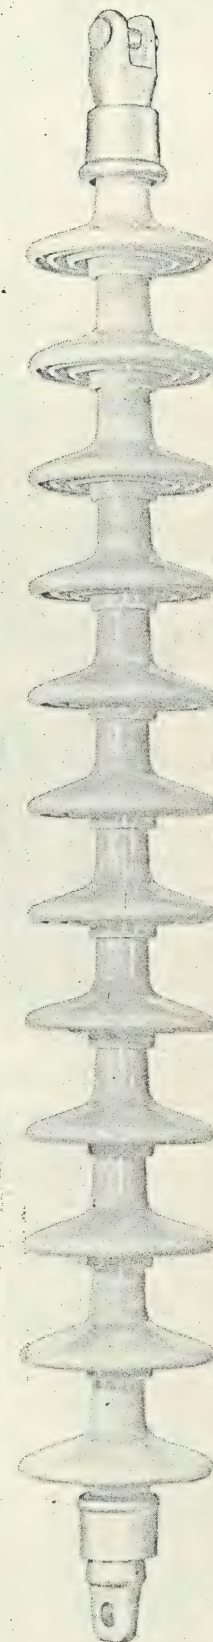
Construction of the Joslyn USI consists of a strong 0.85" diameter fiber glass rod which provides mechanical support for the conductor. The porcelain insulator skirts provide the electrical insulation and protect the fiber glass rod. The porcelain skirts do not share any of the mechanical load. End fittings are high-strength forged steel, specially designed for the 40,000 pound Proof Tested assembly.

12-Shell USI.  
71 inches long.  
Weighs 96 lbs.  
See page 6  
for characteristics.

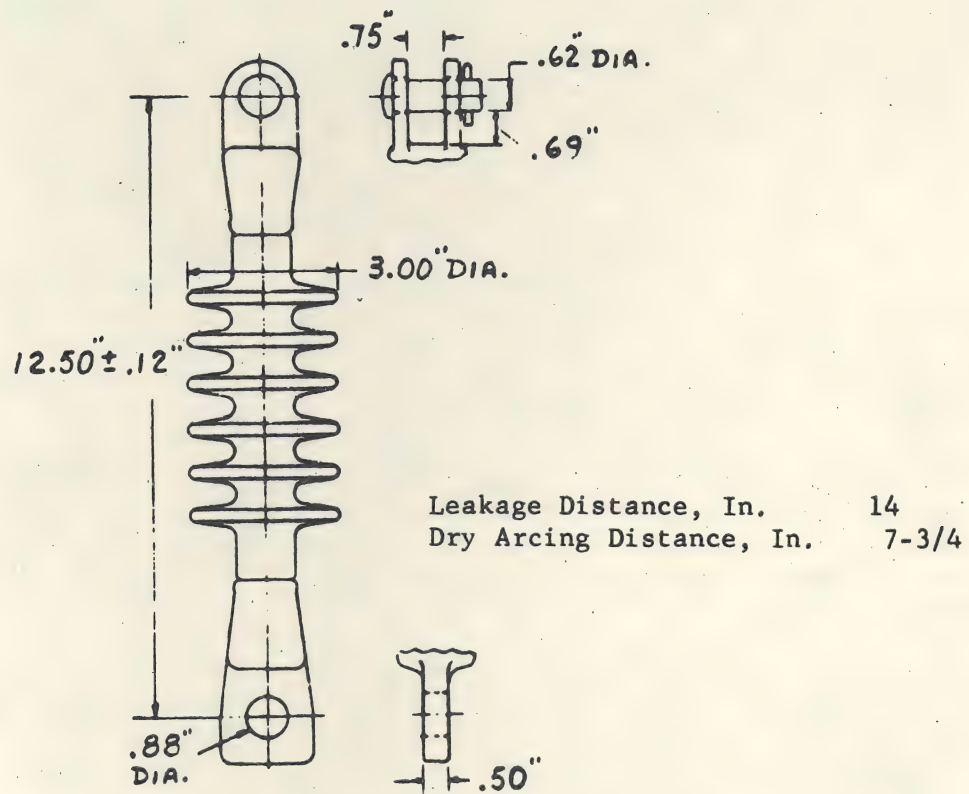
Figure 1 -- 15 KV GEPOL Insulator Dimensions

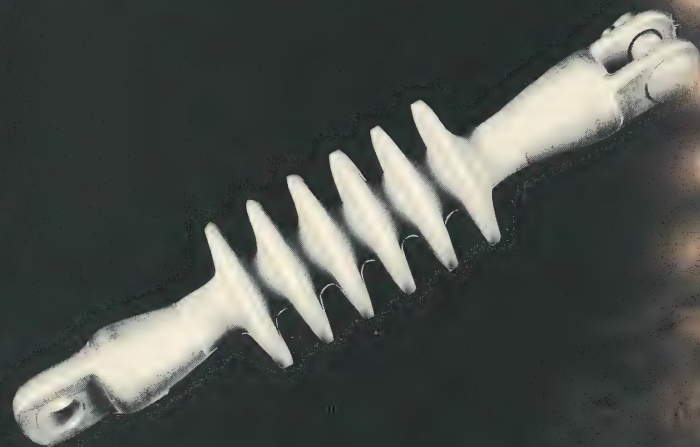
Fig. 1. The new lightweight 15-kv GEPOL suspension insulator features very high impact strength polymer body with long leakage distance and a fiber-glass rod for mechanical support.

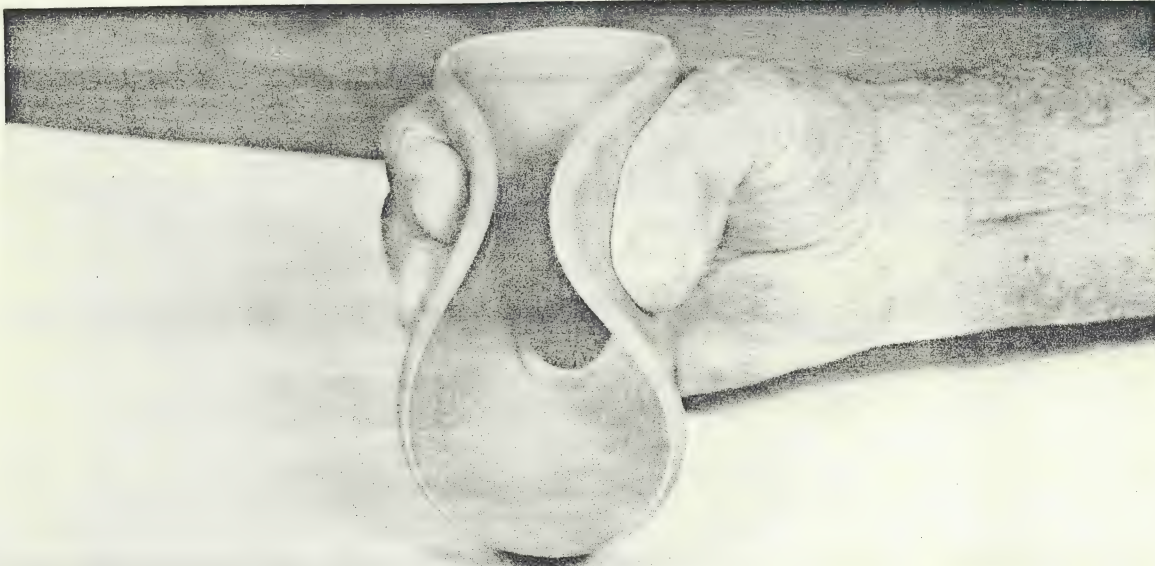
Weathersheds are highly flexible, as this picture demonstrates. Because of this fact Hi-Lite insulators will not be damaged in ordinary handling.

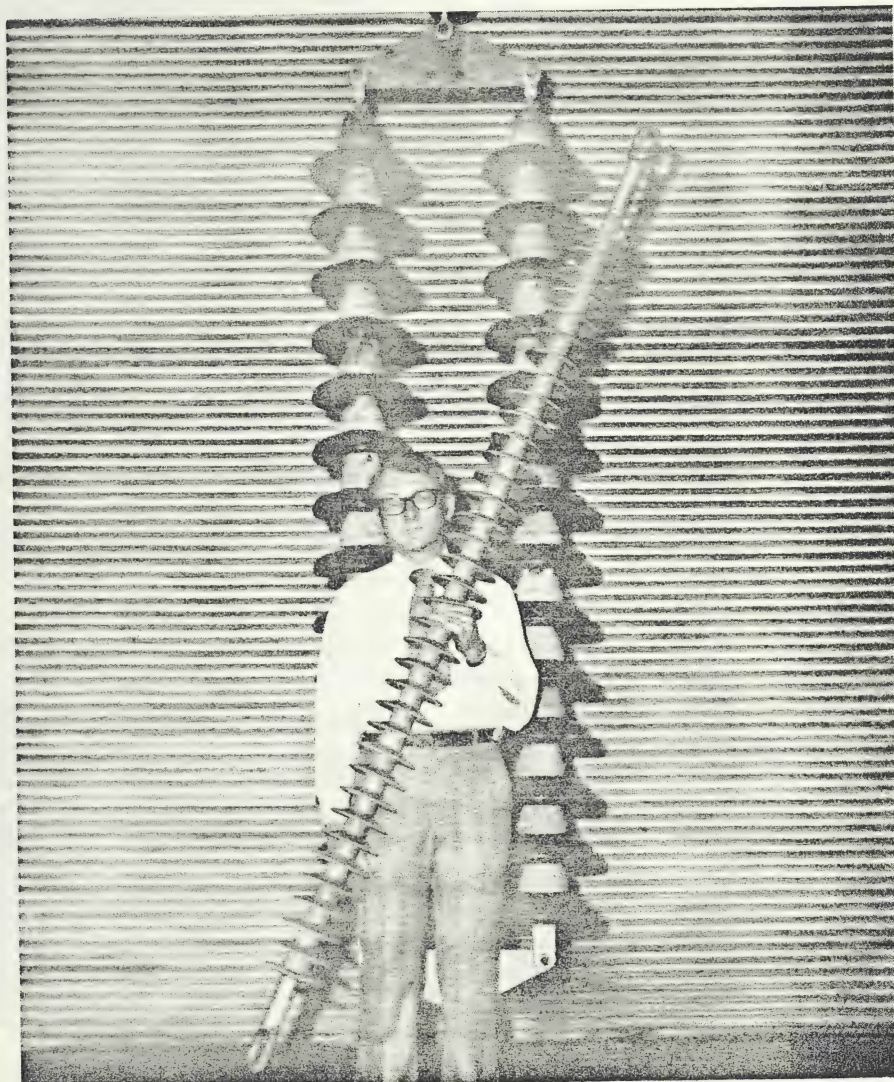
For a working strength of 40,000 pounds in a typical 230-kv application, 36 pounds of Hi-Lite insulator replaces 500 pounds of porcelain.

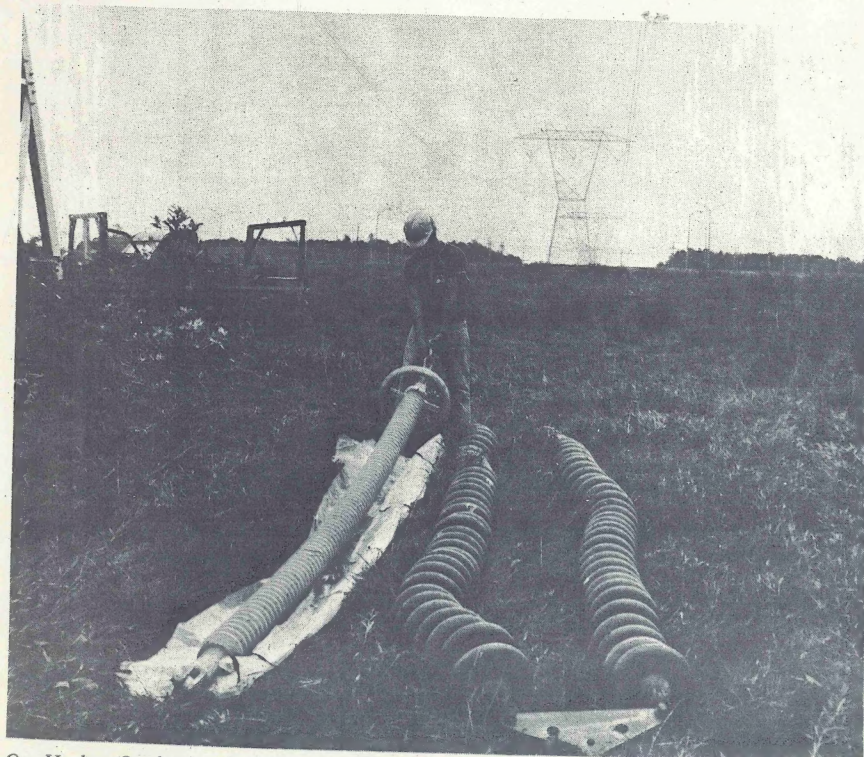
*On Hydro-Quebec's 735-kv transmission lines a single element synthetic insulator weighing only 32 kilograms may replace two-string porcelain insulators (right) weighing 548 kilograms.*

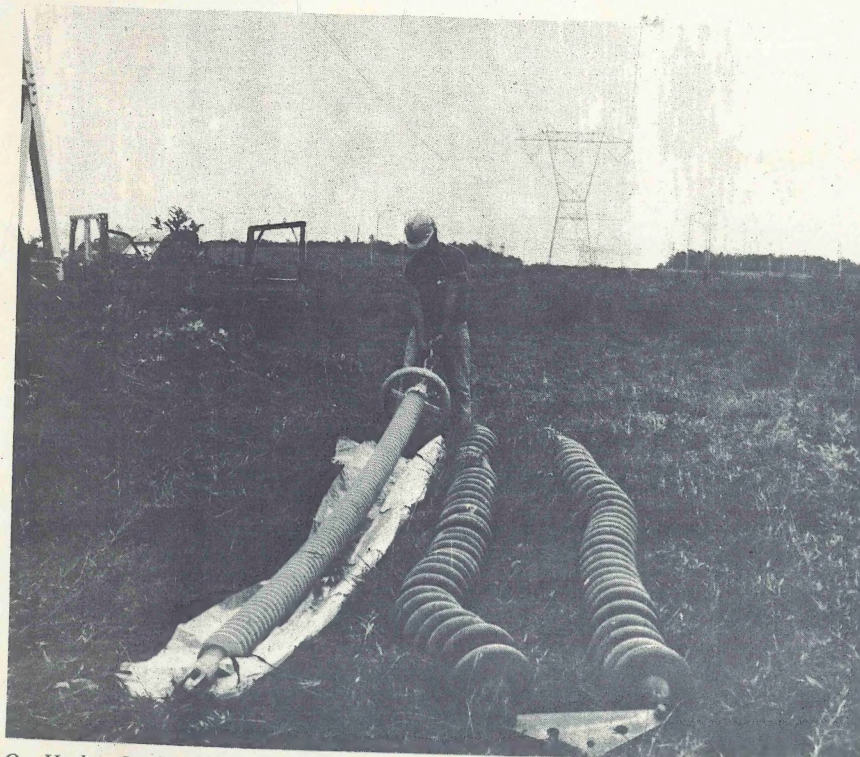
*On Hydro-Quebec's 735-kv transmission lines a single element synthetic insulator weighing only 32 kilograms may replace two-string porcelain insulators (right) weighing 548 kilograms.*
