The Audion Control Box also displayed simplicity and efficiency.^{‡‡}

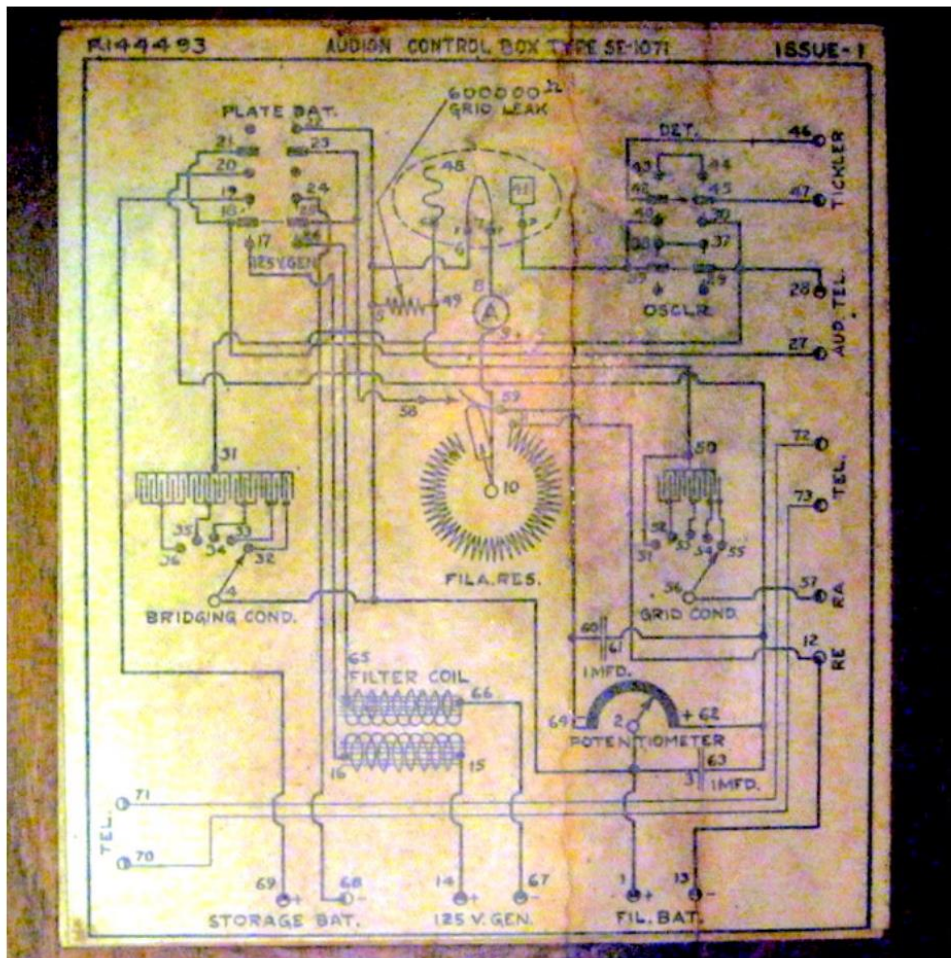
Note, top right, a connection for a tickler coil, suggesting that the IP-501 and its vacuum tube accessory made up a regenerative receiver. Along with its big antennas, that could explain some of the success of NDB.
