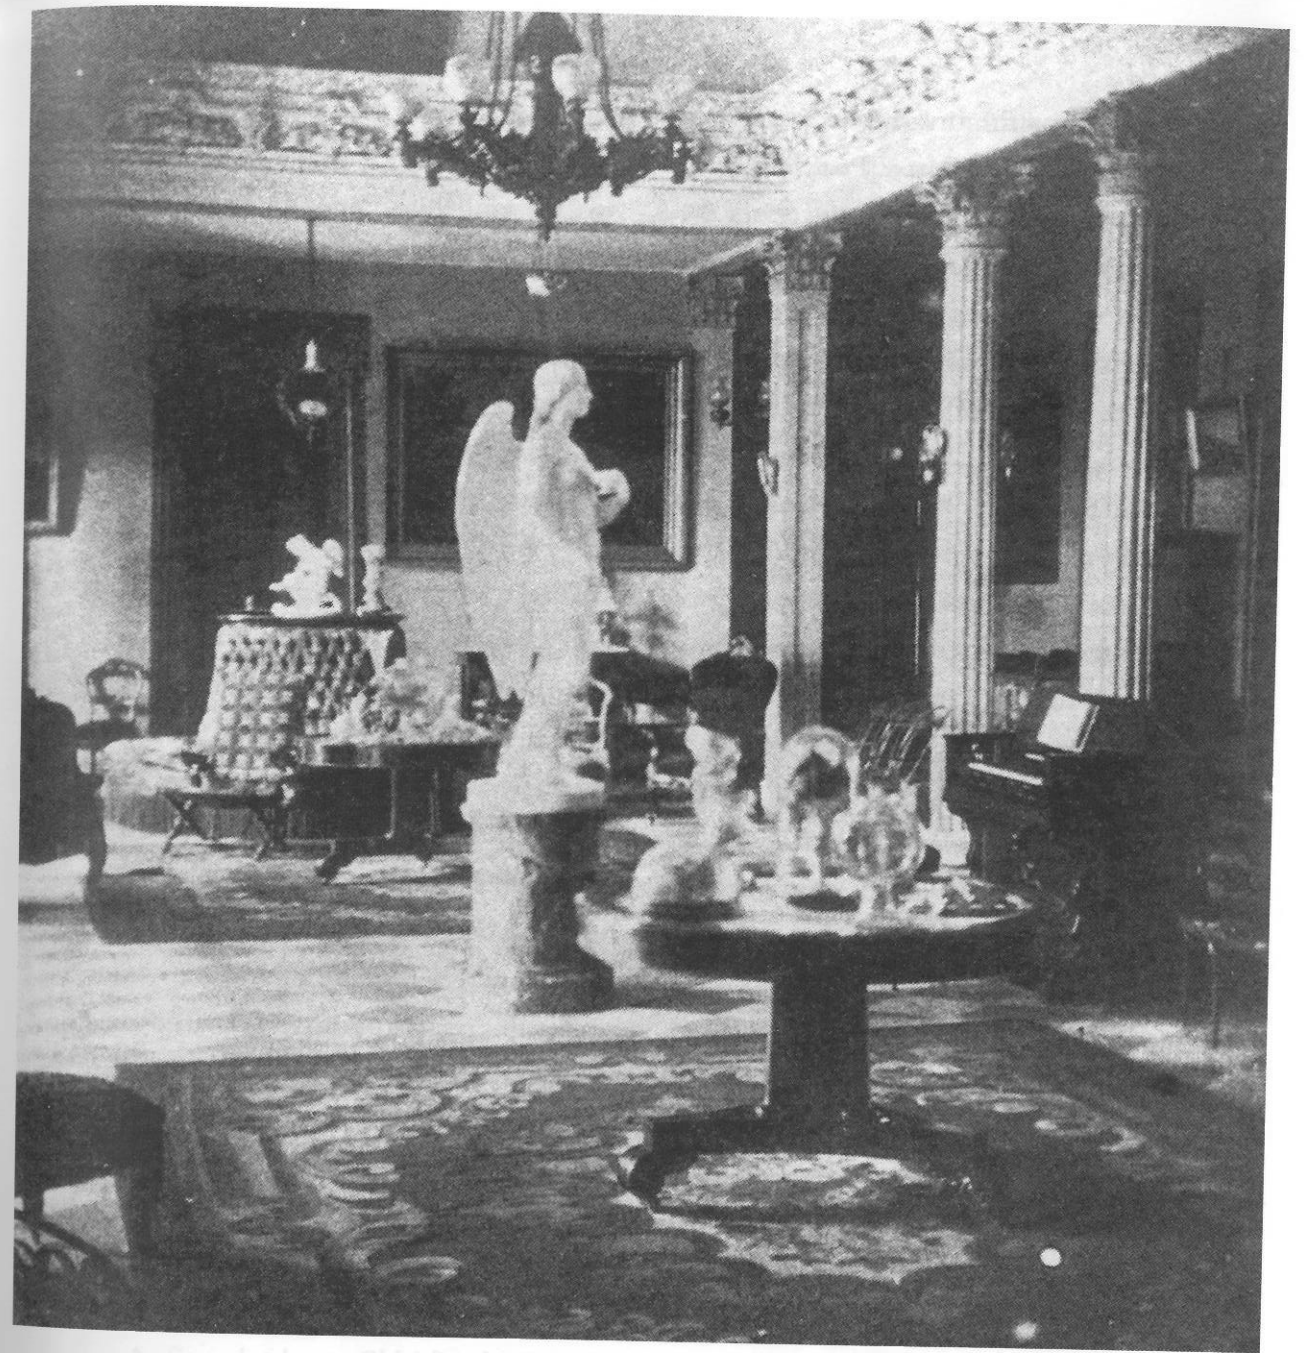
In 1859-1860, the Acklens completed their last addition to Belmont. The new Grand Salon measured 58' by 28'6", with a 22' ceiling. (C.C. Giers, photographer, ca. 1870, Belmont Mansion Association)

Heiman understood architectural principles of proportion and balance, well evidenced in his 1859–1860 addition to Belmont. The salon was to be three times as deep as the now incorporated gallery. Maintaining the historic ceiling height of the gallery would have been claustrophobic to the design. Proportionally, had the accepted height been maintained, the room would appear much smaller than its actual size (58'x 28'6"). Heiman wisely arched the ceiling to a height of 22' creating a massive barrel vault, one of the architectural glories of Belmont. With the assistance of Heiman, the Acklens created one of the largest rooms of any domestic interior in the state prior to the Civil War. Only Rattle and Snap, the George Washington Polk home in Maury County, comes close to having a room of comparable size.

To encircle the salon at the height of the old gallery ceiling, Heiman designed a classically detailed, multi-faceted plaster cornice, featuring spread-winged eagles as the principle element. Had the ceiling not been arched in Heiman's salon, the wide multi-faceted cornice would have been ponderous and overwhelming. This is far from the fact in reality; it is now the prin-

Harking back to his classicist youth in Prussia, Heiman removed a number of original square gallery posts in the center of the old gallery opposite the stair, replacing them with a column screen of four fluted Corinthian columns visu-

ally dividing the new salon from the old porch. These columns were centered on a new staircase much more fitting for the use of Adelia Acklen's new space.
