**A STRUCTURAL INVESTIGATION OF
36 REID STREET
CHARLESTON, SOUTH CAROLINA**

Submitted to Craig M. Bennett, Jr.
April 26, 2016

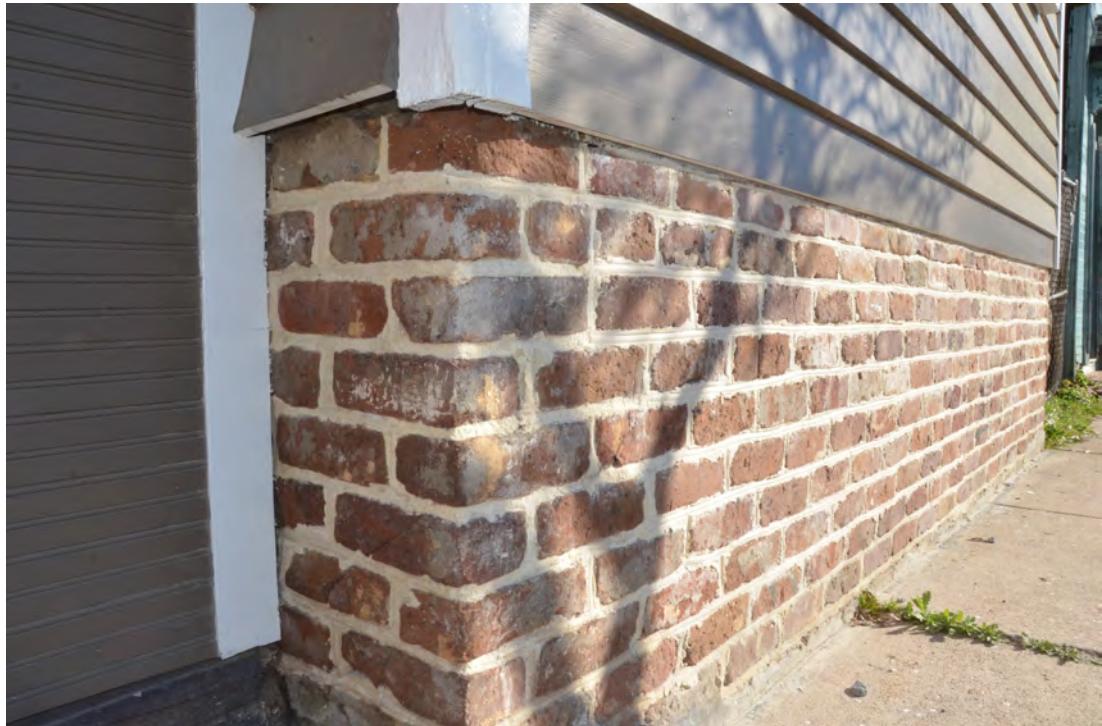
Figure 18. Repainted South Foundation Wall.

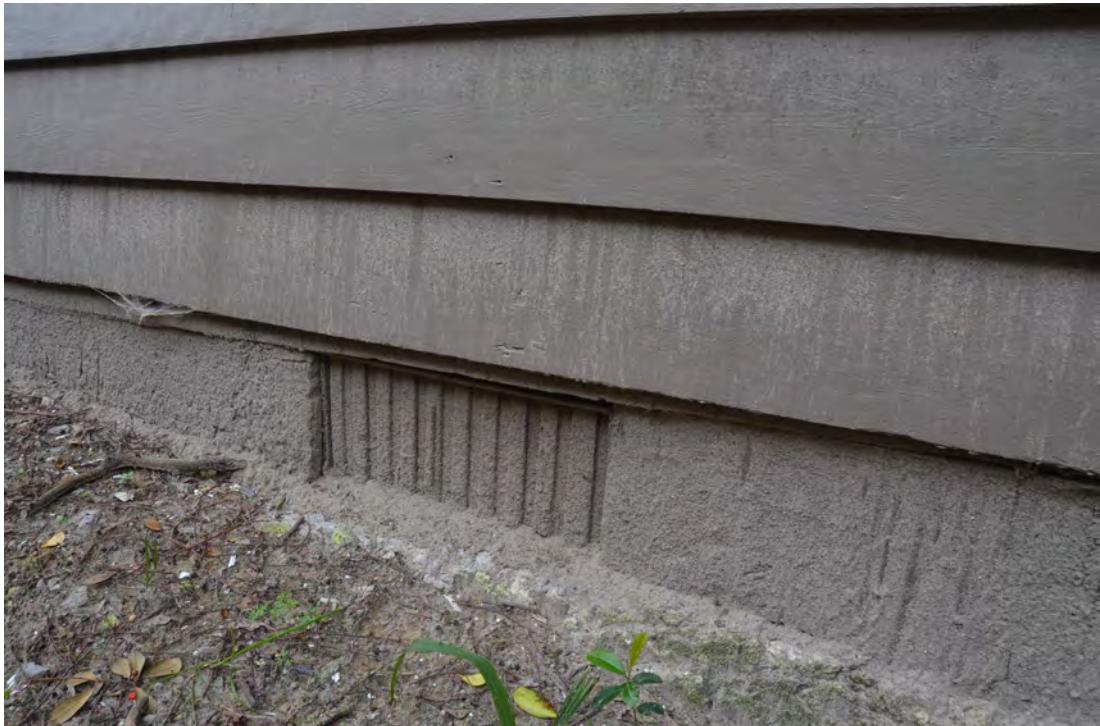
Figure 22. North Foundation Wall After a Heavy Rain.

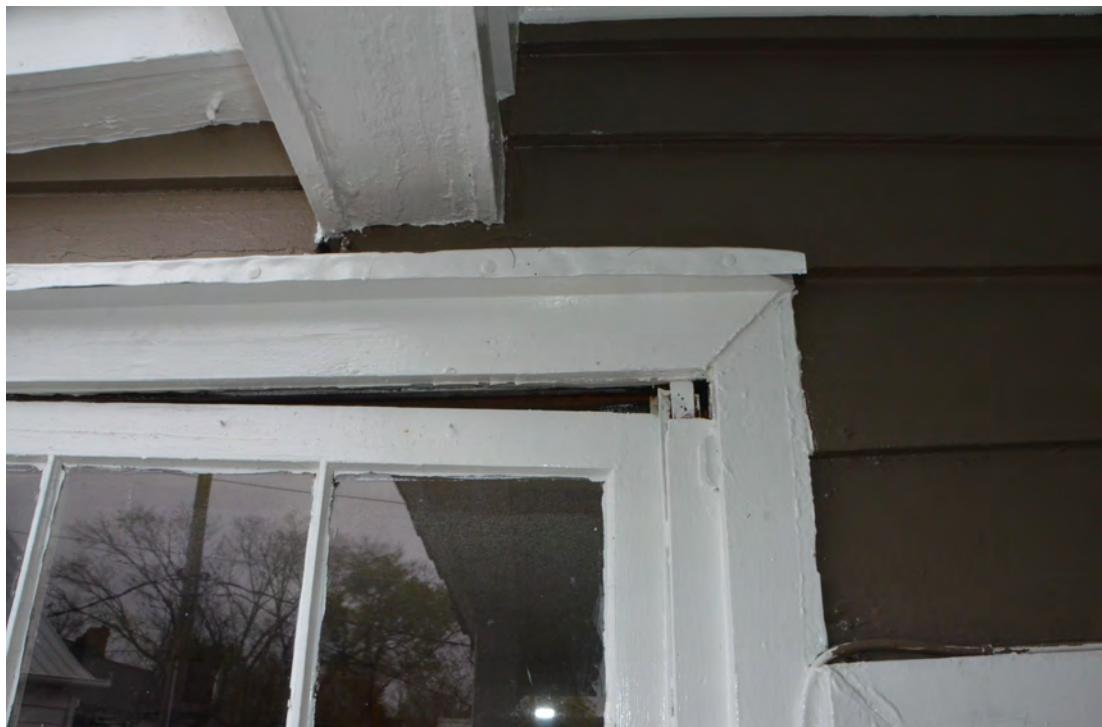
Figure 34. Shifting of Fenestrations on the 2nd Level.

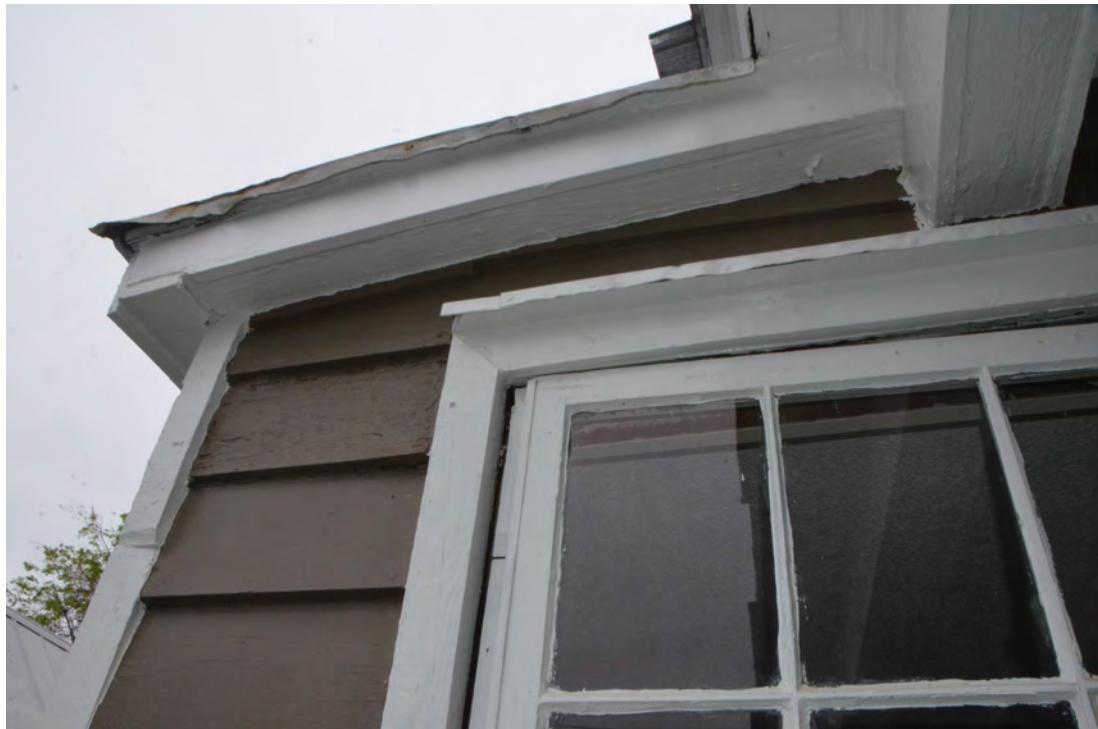
Figure 35. Shifting of Fenestrations on the 2nd Level.

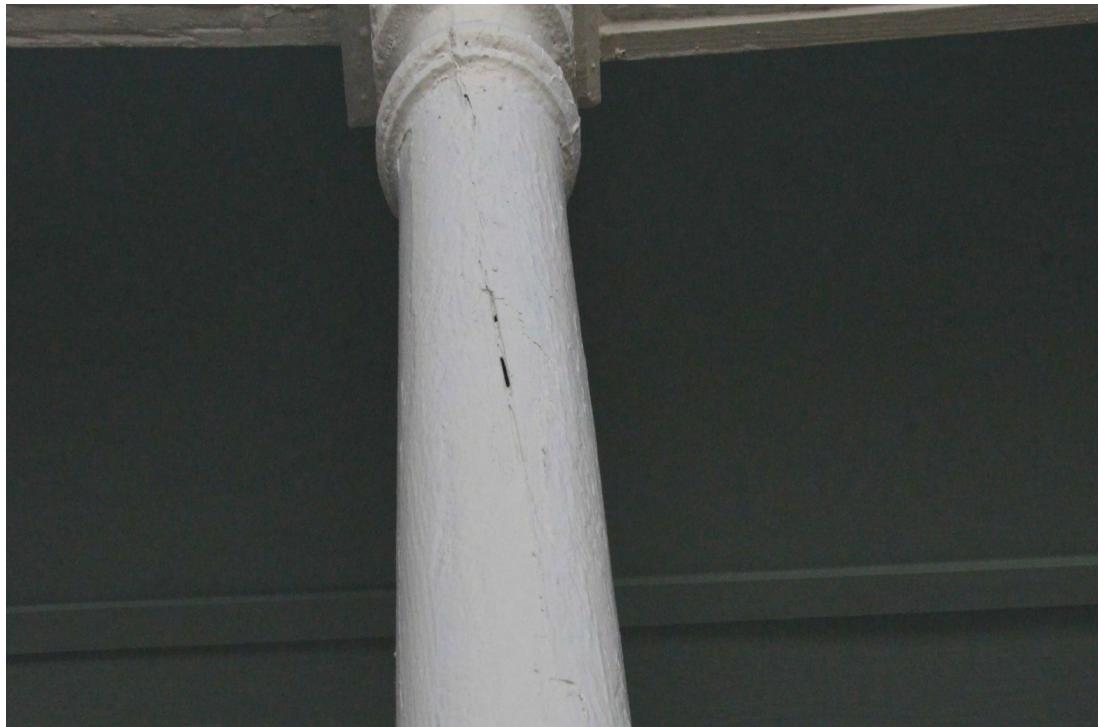
Figure 45. Splitting Columns.

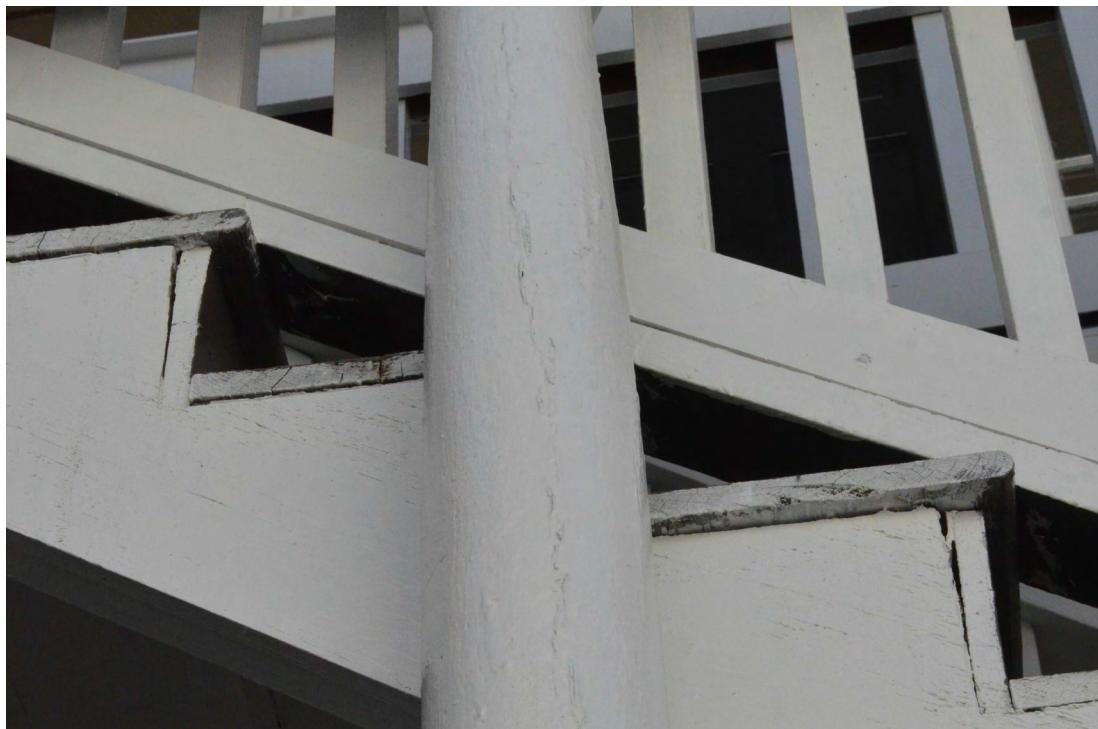
Figure 46. Splitting Columns.

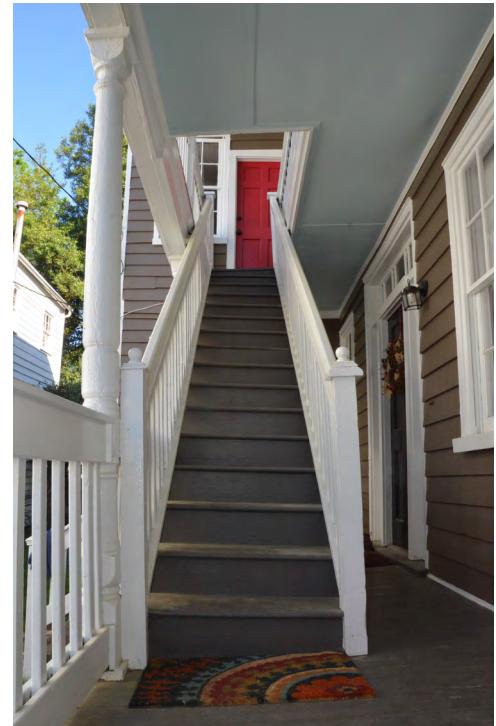
Figure 52. Outward Bowing of the Piazza Columns.

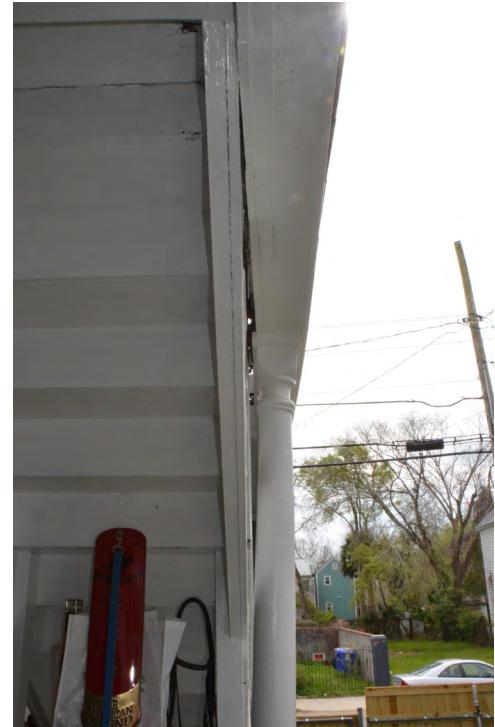
Figure 53. Outward Bowing of the Piazza Columns.

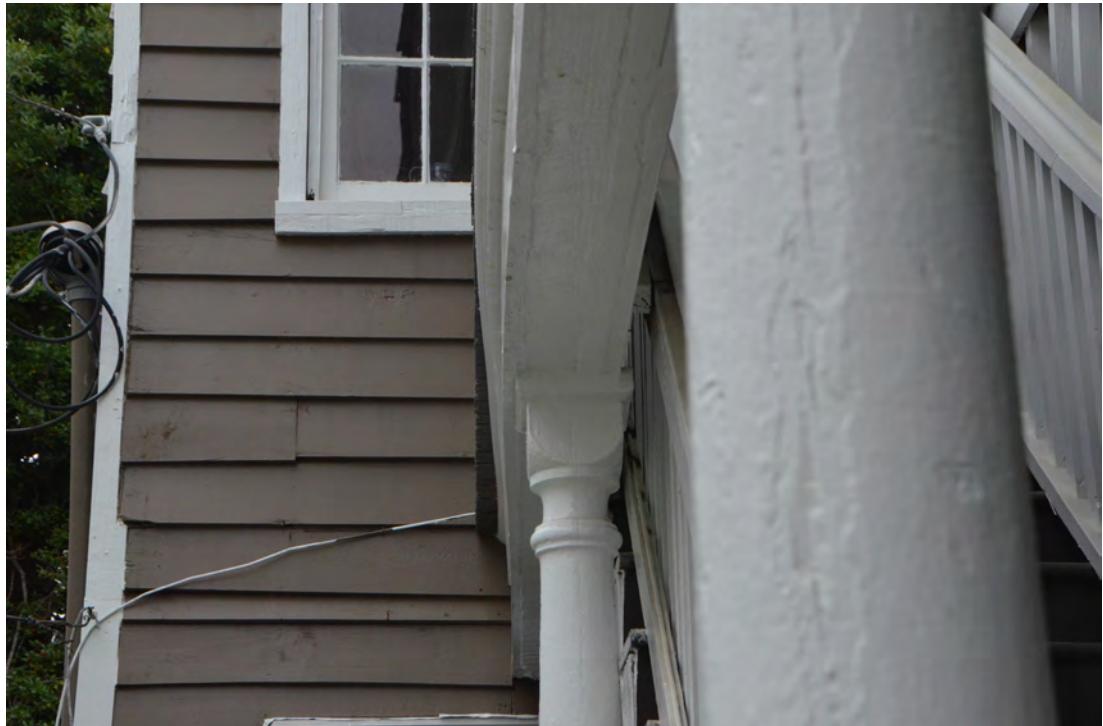
Figure 56. Outward Bowing of the 2nd Floor Framing Edge Beam.

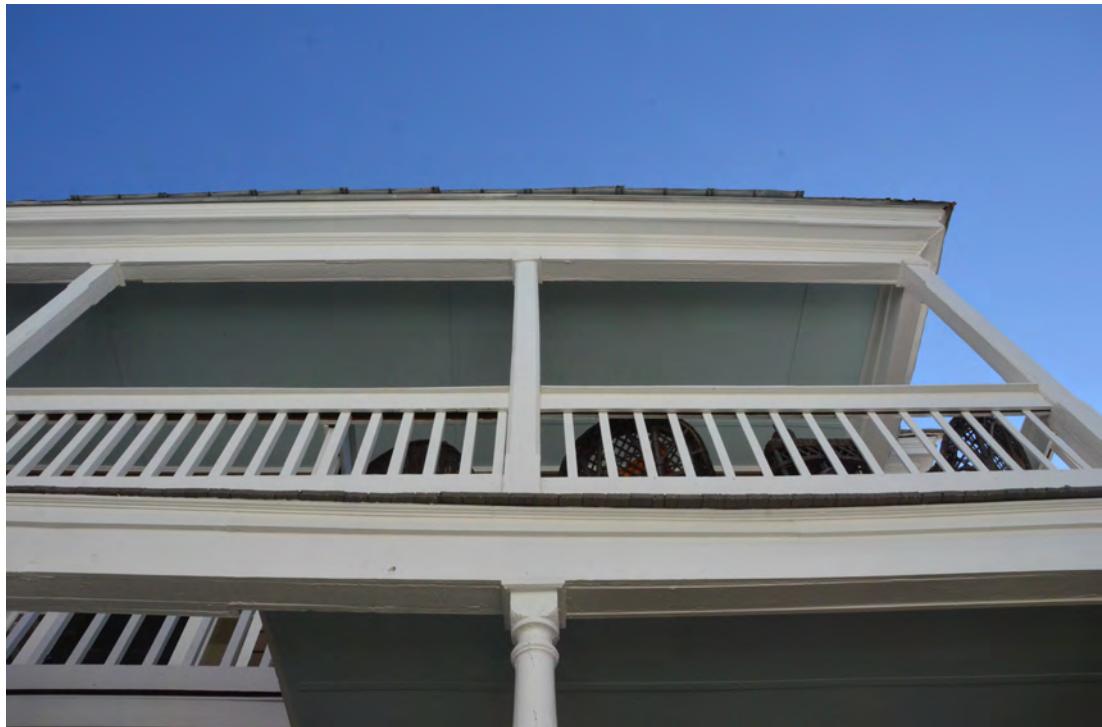
Figure 57. Deflection of the Edge Beam at the South Column.

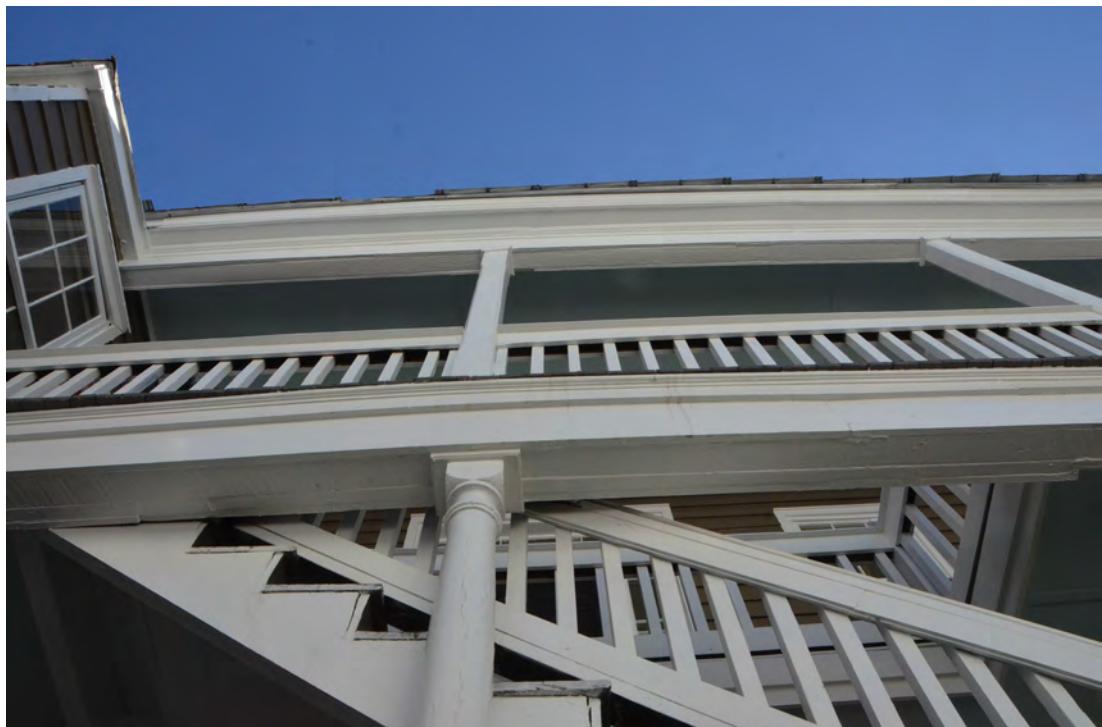
Figure 58. Upward Bowing of the Edge Beam at the North Column.

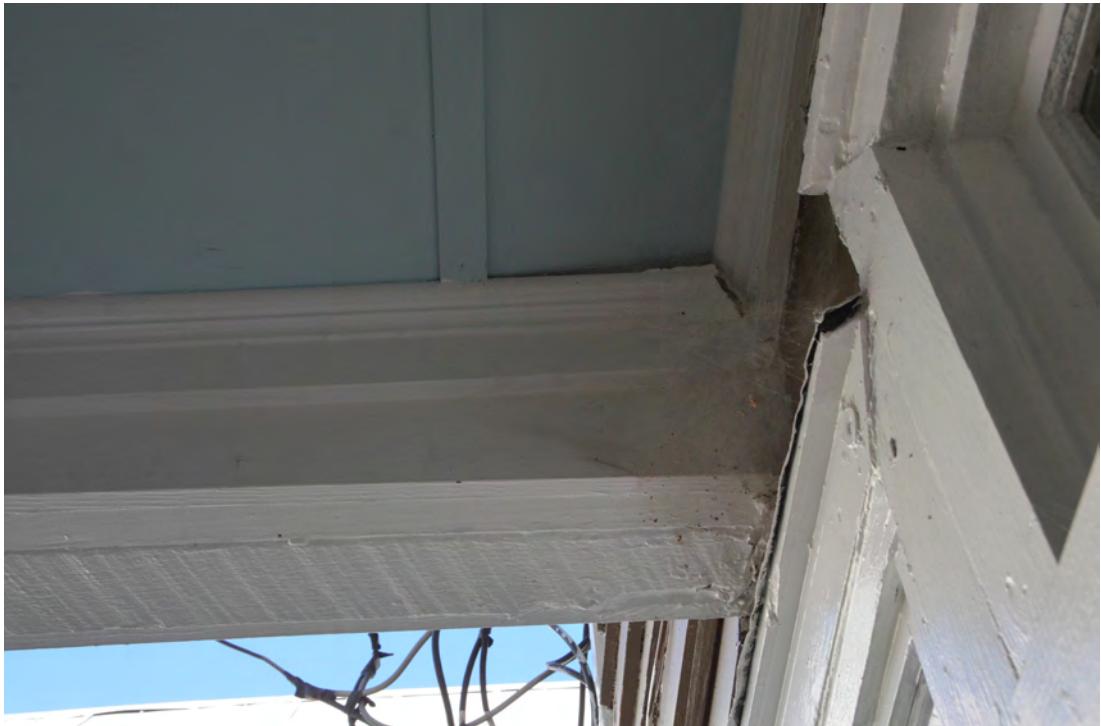
Figure 60. Twisting of the 2nd Floor Framing Edge Beam at the Kitchen Addition.

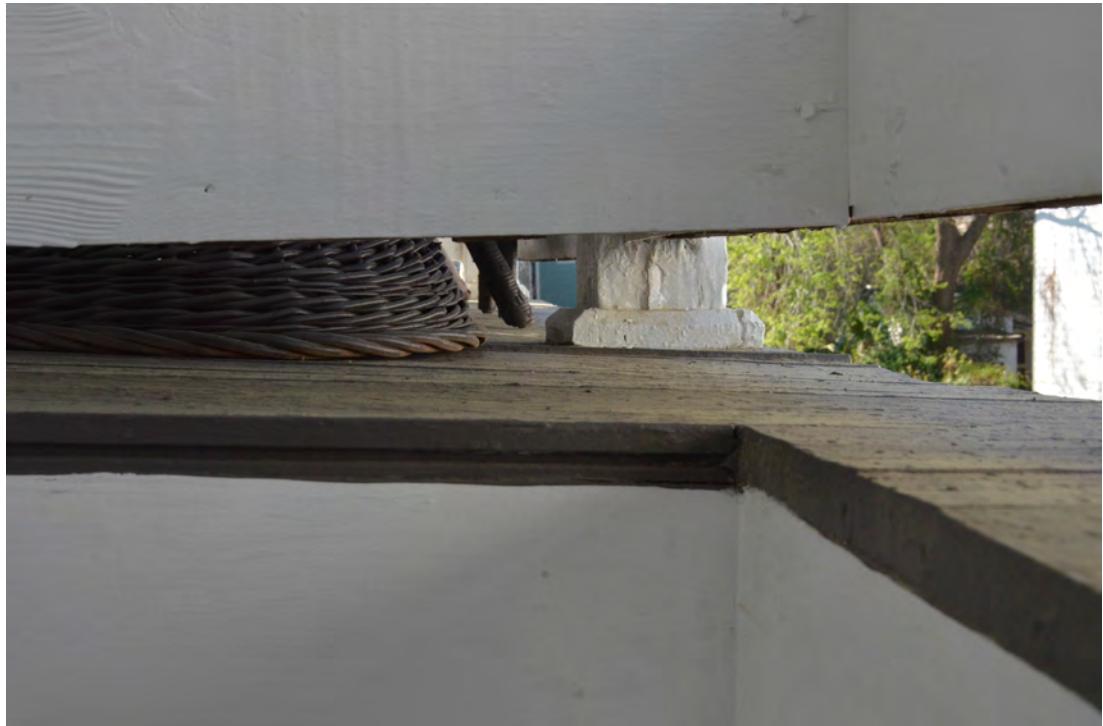
Figure 62. Buckling of the Floor on the 2nd Level of the Piazza.

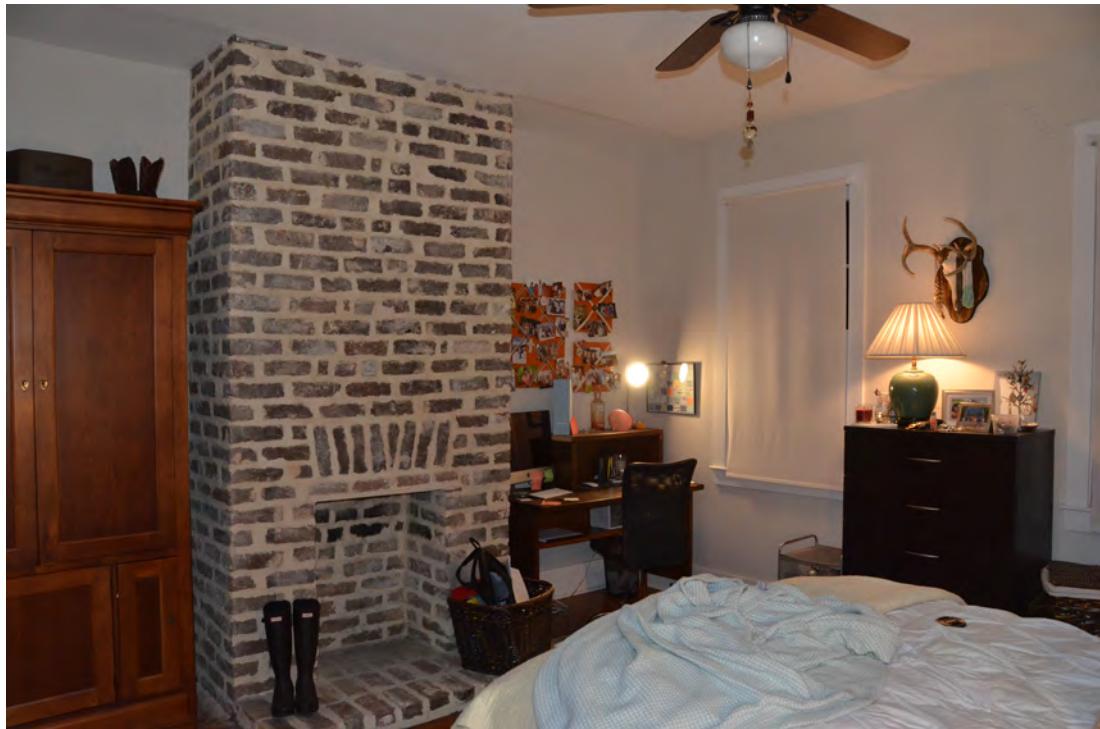
Figure 69. Visible Ghost Marks in line with the Fireplace.

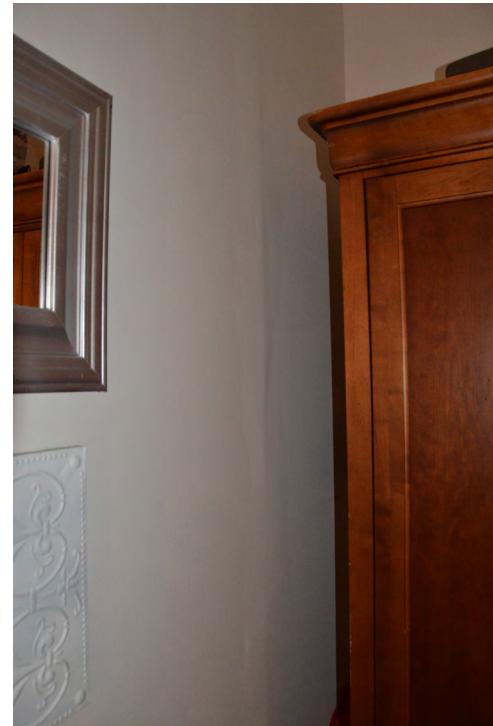
Figure 70. Ghost Marks from a Former Wall.

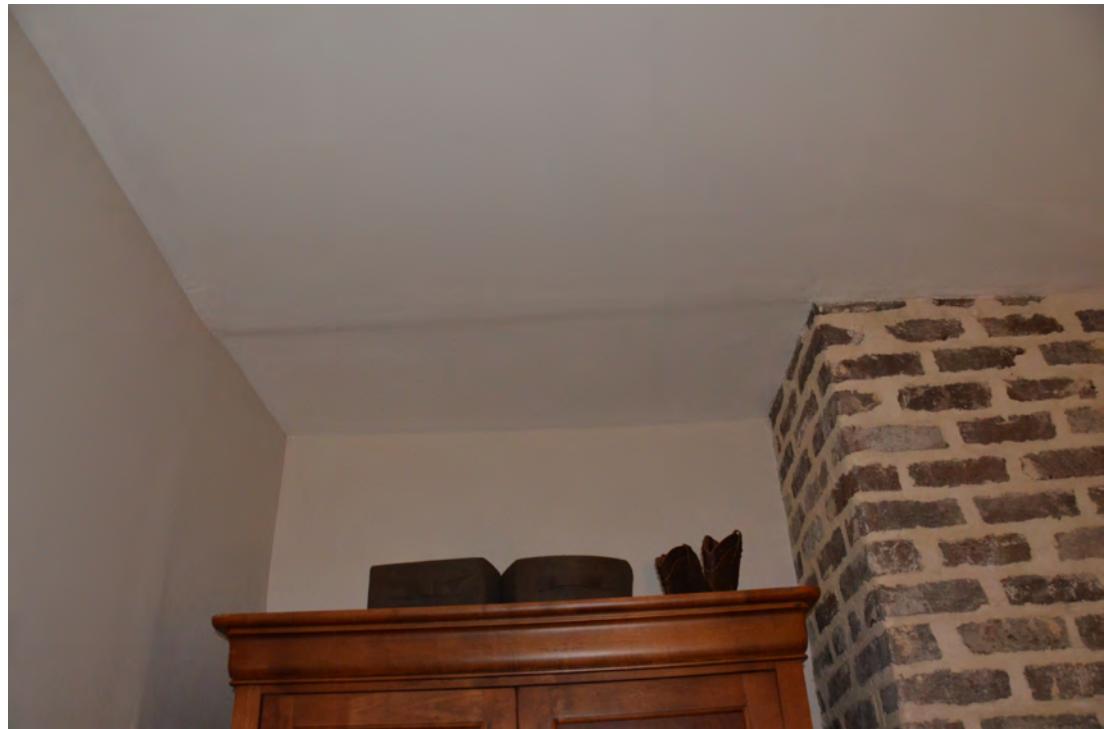
Figure 71. Ghost Marks from a Former Wall.

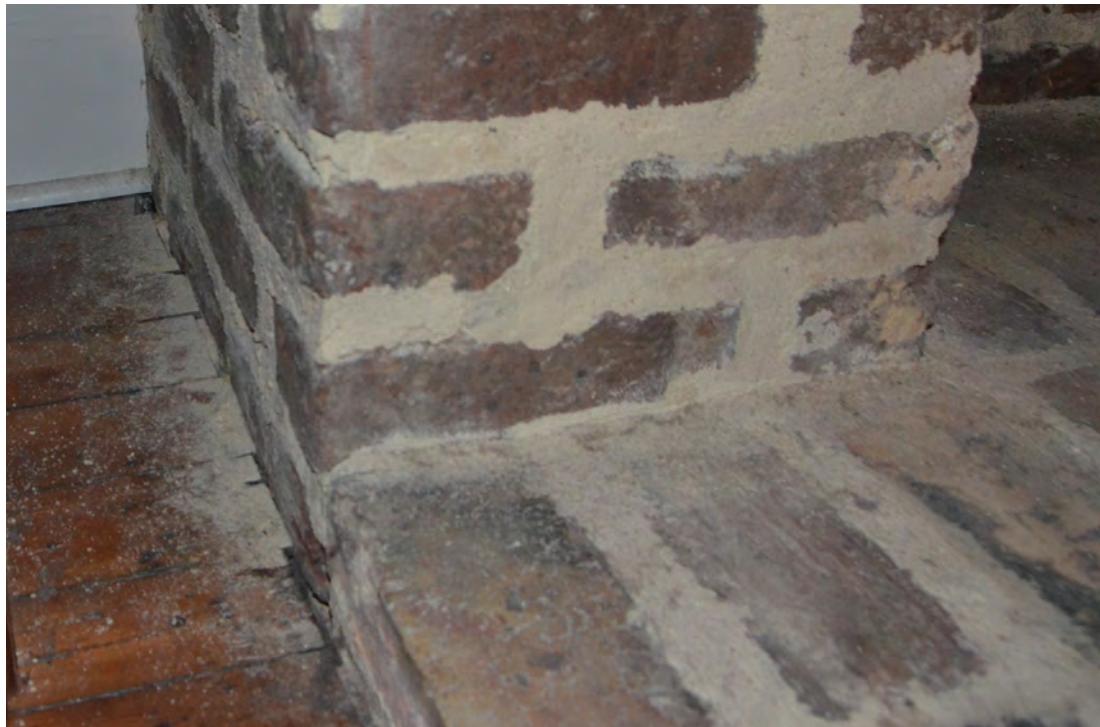
- The floor boards that abut the north and south sides of the fireplace in the front bedroom are not evenly cut resulting in gaps between the floor and masonry. This abnormality indicates that this may not have been the original construction intention. It may be possible that the fireplace was to be enclosed with plaster or flanked on the north and south by millwork. (Figure 83)
- The plaster is failing beneath the window in the east wall of the living room. (Figures 84 and 85)
- There is an area of soft plaster in the east wall of the back bedroom.
- The ceiling in the kitchen addition is visibly sloping to the west; however, the floor appears to be level. (Figures 86 – 88)
- The bathroom floor slopes to the west approximately one inch over a length of five feet. However, the adjacent entry hall is level.

Figure 87. Jagged Flooring at the Fireplace.

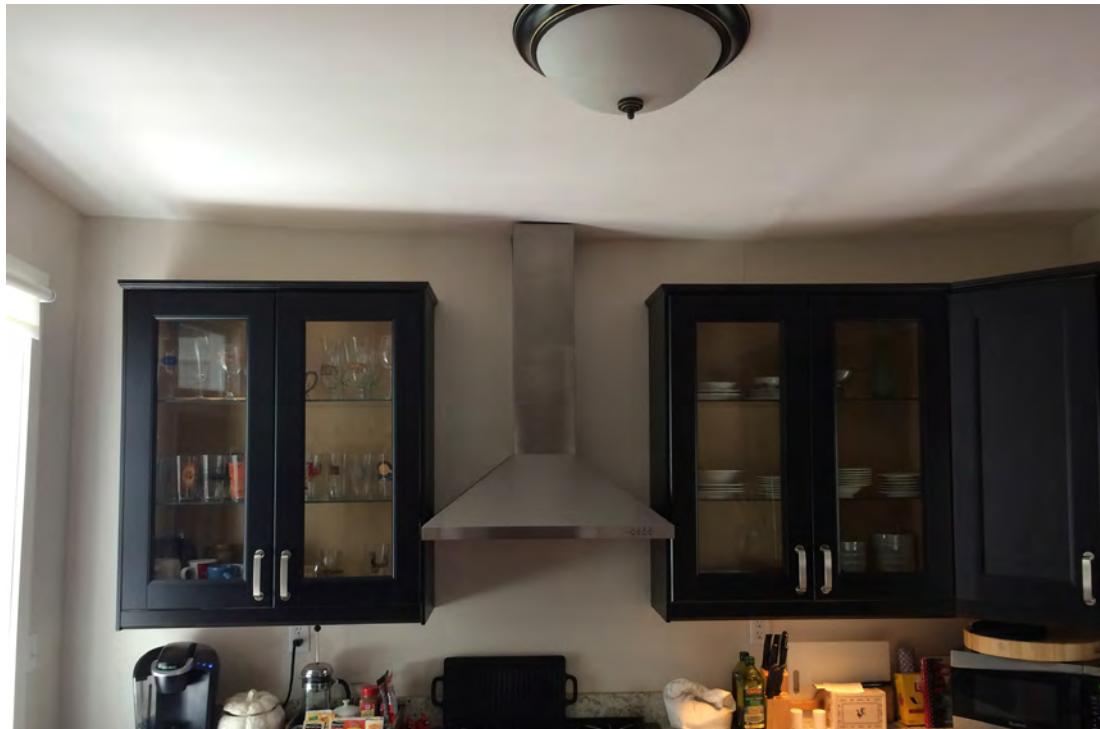
Figure 91. Ceiling Deformation in the Kitchen Addition.

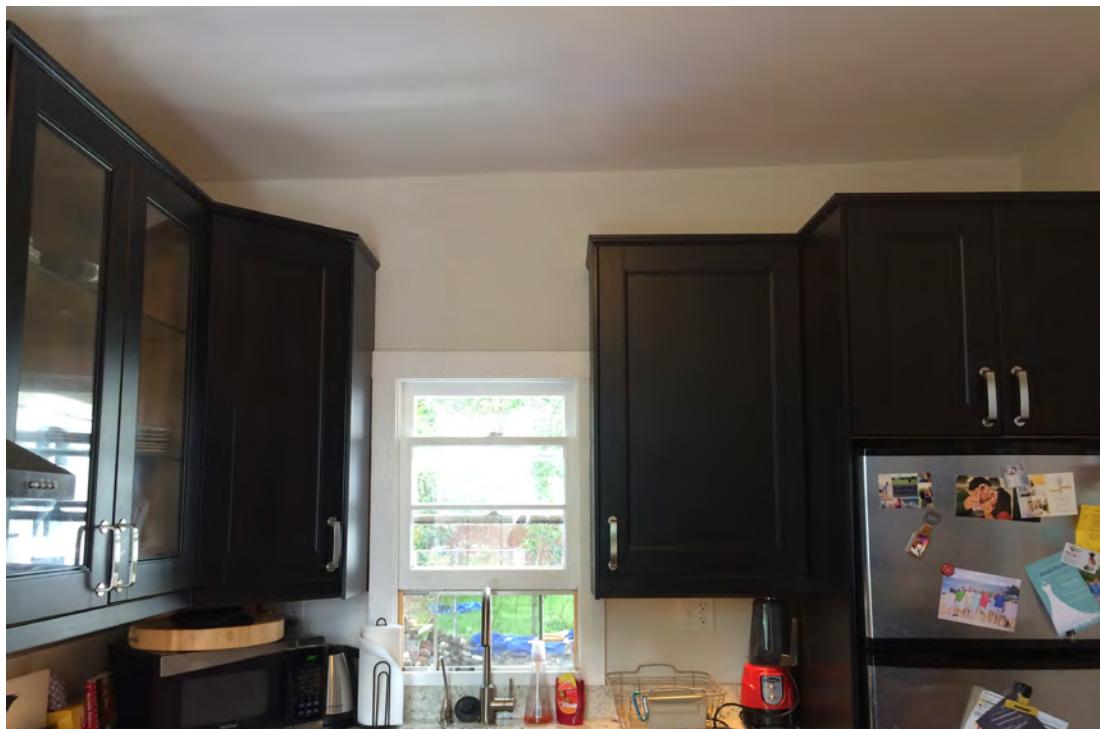
Figure 92. Ceiling Deformation in the Kitchen Addition.

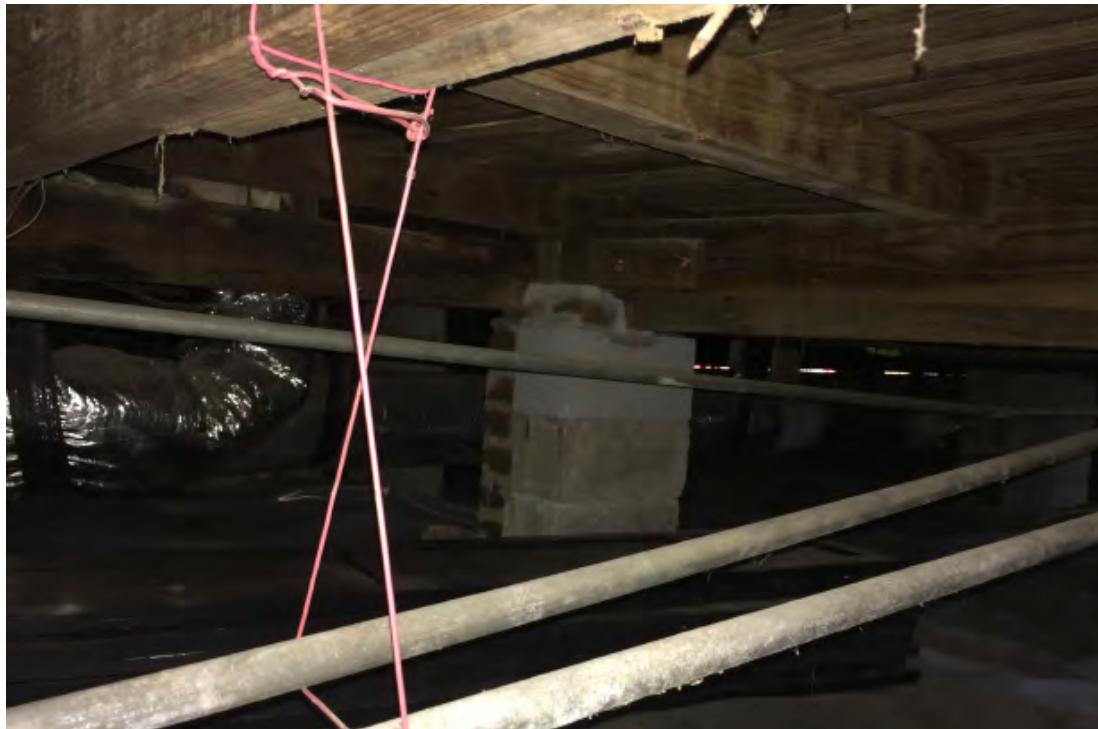
Figure 93. New CMUs beneath the house strengthening the masonry piers.

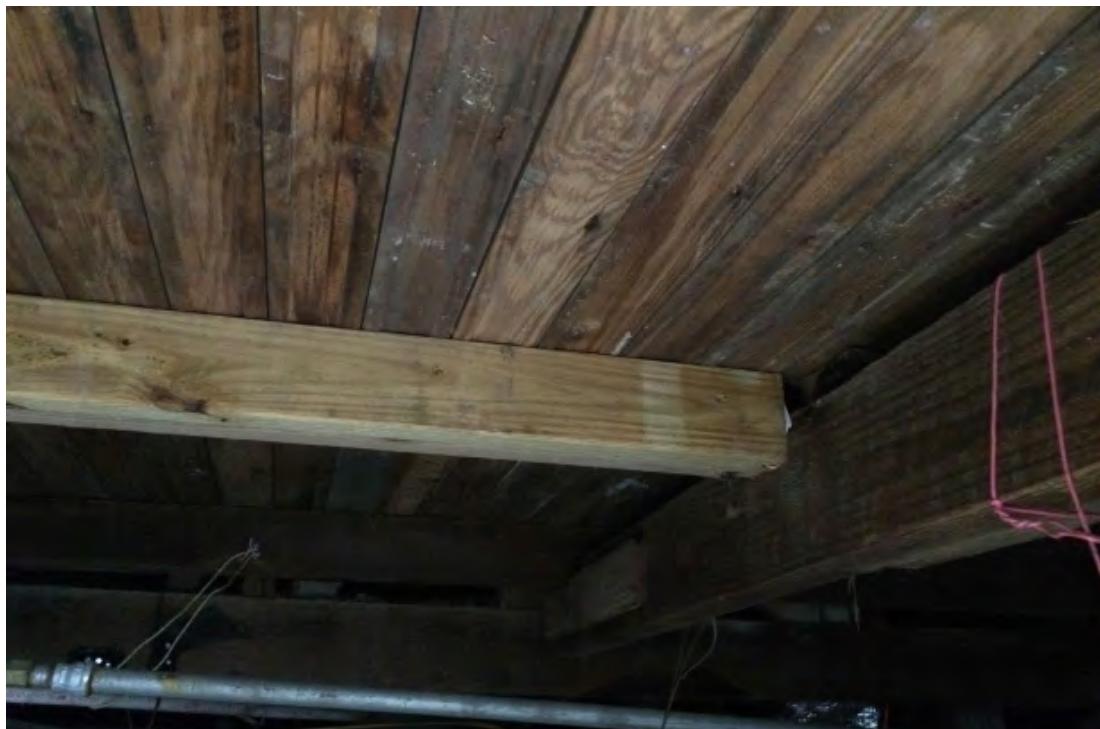
Figure 96. New framing beneath first level of the piazza.
