NATIONAL PARK SERVICE
Washington D.C. 20240HISTORIC PRESERVATION CERTIFICATION
APPLICATION — PART 2

Part 2 DESCRIPTION OF REHABILITATION

1. NAME OF PROPERTY: Railroad Car Shop
 Address of property: Street 44 Line Street
 City Charleston County Charleston State SC Zip Code 29403

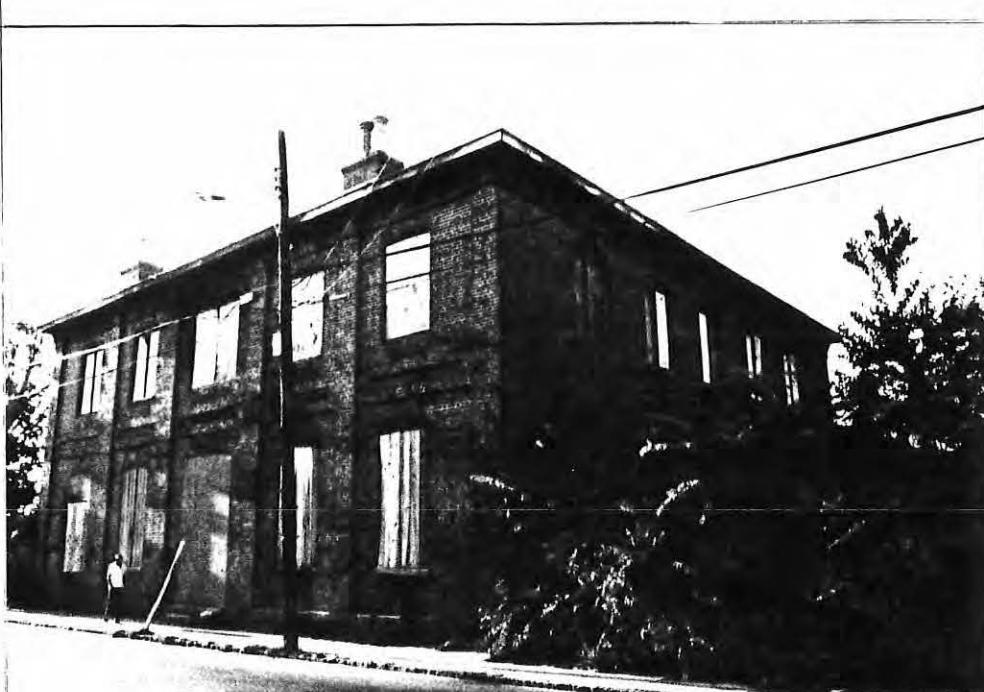
#5

Two-story Section
viewed from the southeast

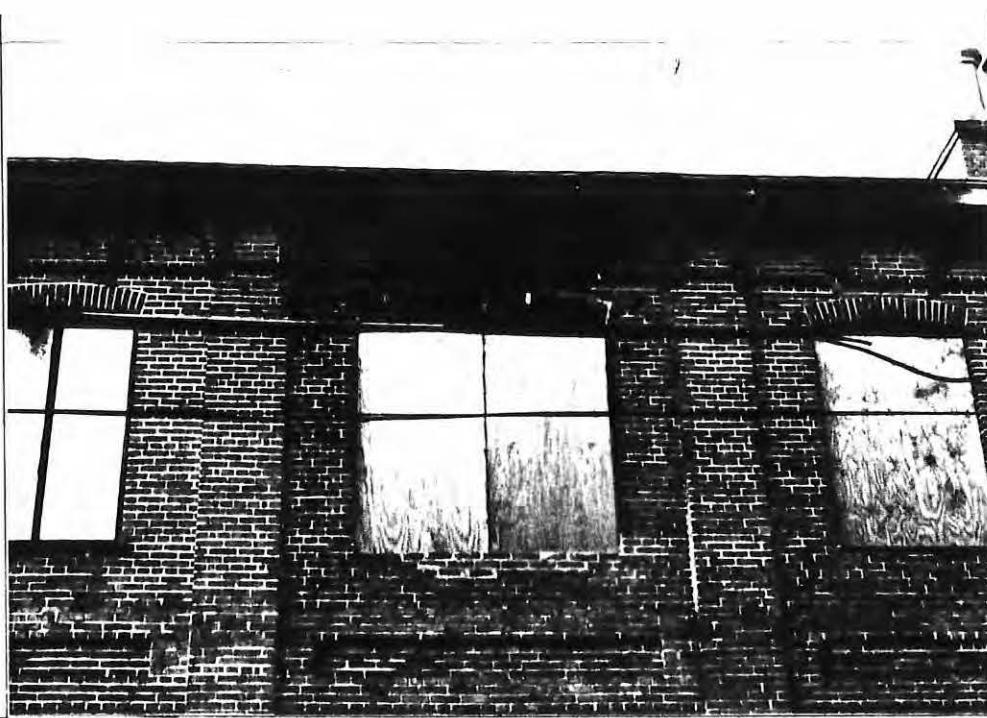
Note sash and jamb
deterioration

Note plyboard infill

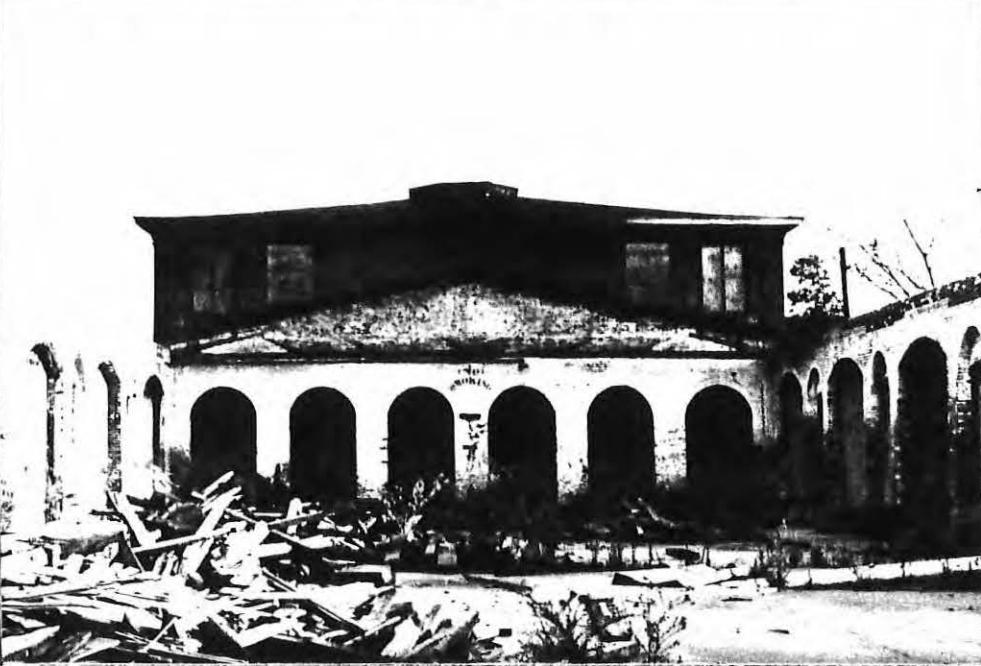
#27

General view of arches
leading into 2-story
section

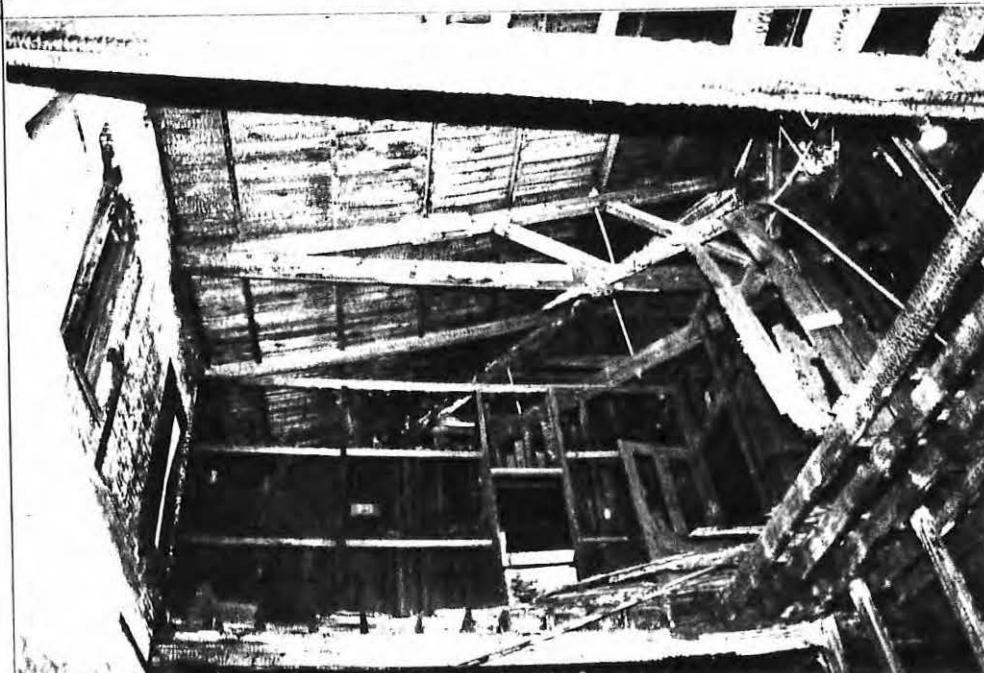
#34

Existing original trusses in both the two-story section and 1-story northern four bays exist in fair to poor condition.

General view of truss and
roof system: 2-story
section

Trusses will be repaired and retained as a major architectural feature of the building. The new stair towers have been designed to support the two-story section's existing trusses at mid-span.

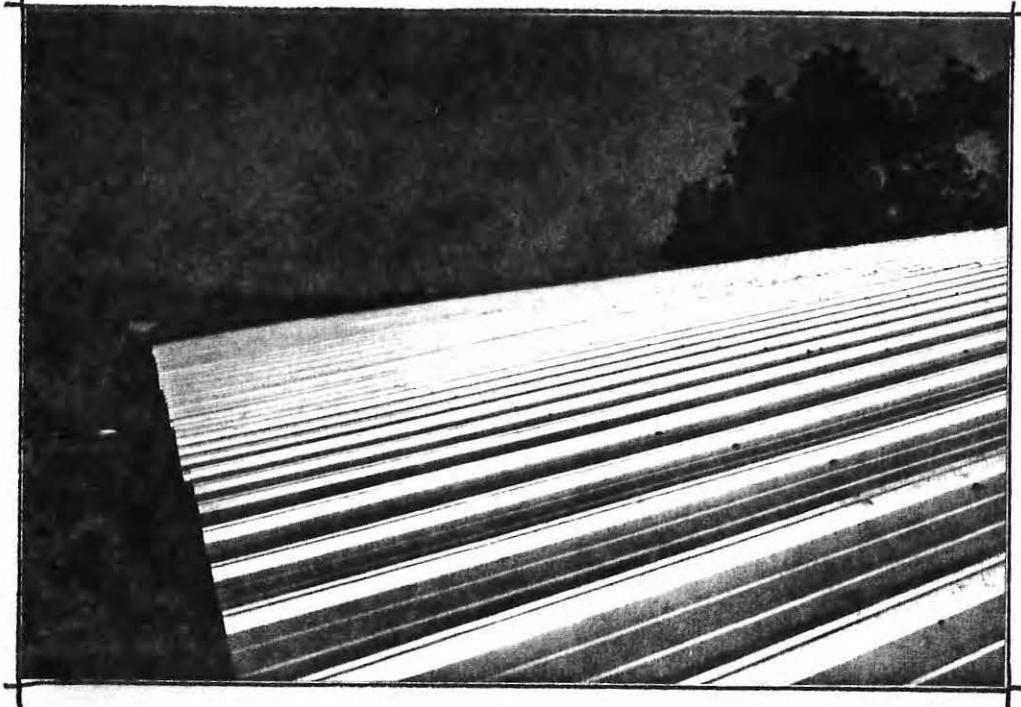
6)

Detail of Tin Roof
